**HABITAT ADVISORY VISIT, WINDRIDGE  
FARM, RIVER BEANE, HERTFORDSHIRE.  
UNDERTAKEN BY VAUGHAN LEWIS,  
WINDRUSH AEC LTD ON BEHALF OF OLIVER  
KAN**

**SEPTEMBER 2005**

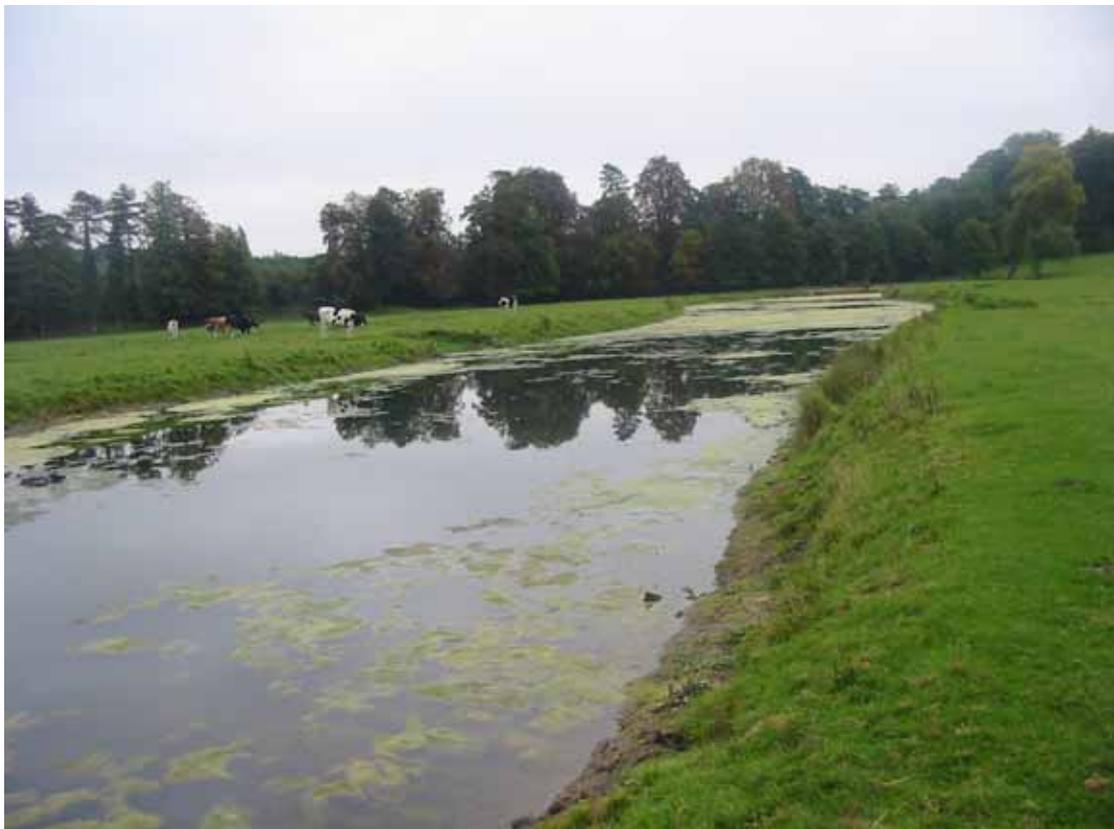
The Canal had recently been restored, with a large volume of sediment and numerous fallen trees removed. The brick and flint dam at the downstream end of the Canal had also been reconstructed. However, a combination of a leak under the dam and the very low flows experienced in 2005 had resulted in very low retained water levels (<1m generally) in the 'Canal'.

In addition, cattle in the surrounding fields had exerted very heavy grazing pressure on the banks. Extensive growth of filamentous algae was present due to a combination of low flows, the shallow depth of the lake and high nutrient levels.

- The key issue limiting the potential of the Windridge Farm fishery for wild trout was lack of flow. There is no doubt that this was particularly acute in 2005, but it will remain an issue in all years unless abstraction is reduced within the catchment.
- A consequence of the lack of flow is the need to decide on how flow is apportioned between the various channels. Ideally, if the weir at the lower end of the Canal can be sealed, the bulk of the flow would be directed along the original channel of the River Beane.
- It is vital that grazing cattle are prevented from damaging the banks of the various channels. Fencing, either permanent or temporary electric, should be erected to prevent access to the banks.

- The extensive growth of filamentous algae can be reduced by the application of barley straw to the fishery in March. The straw should be applied at the rate of approximately 2.4 small bales/ha, ideally contained within a 'sausage' constructed from the netting used to wrap Christmas trees. These 'sausages' need to be hung near to the water surface, as the barley straw only functions in the presence of sunlight and oxygen. The barley straw should be replaced in May/June as necessary. Further details are available for the Centre for Aquatic Plant Management website: [capm.org.uk](http://capm.org.uk).

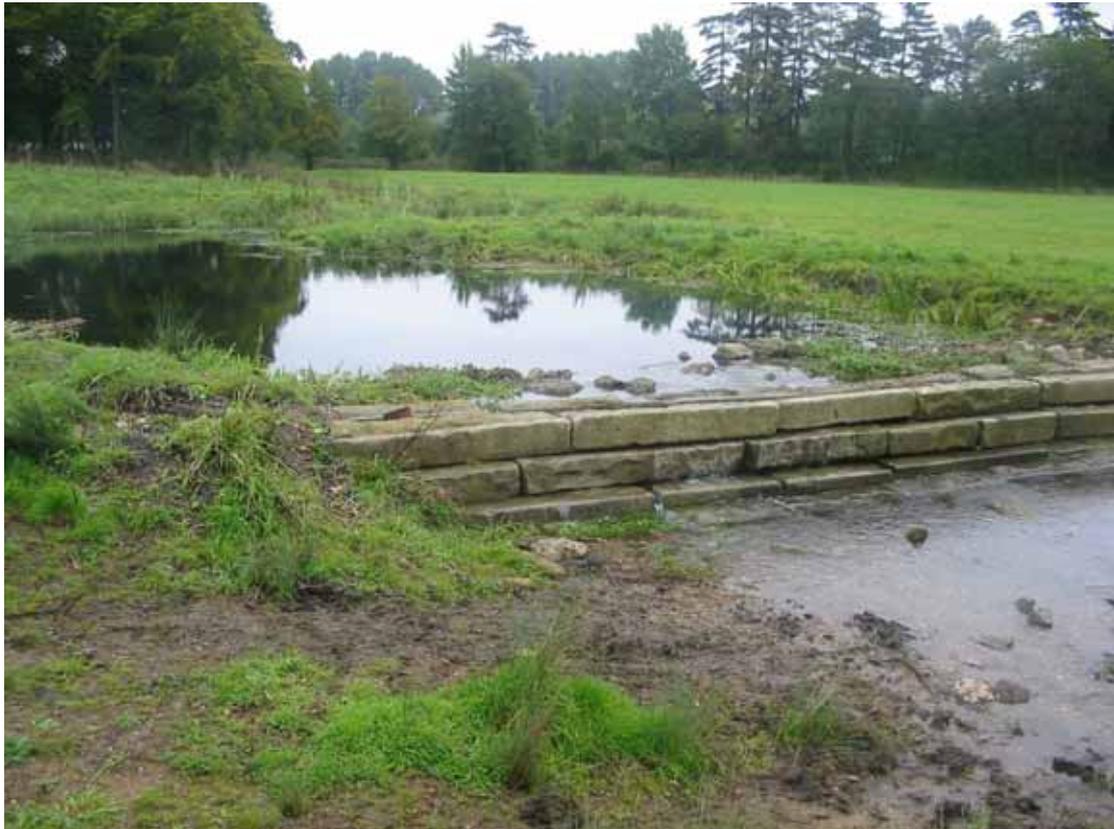
The Canal was fed at its upper end via a constructed weir.

### **Feed into the Canal via constructed weir**

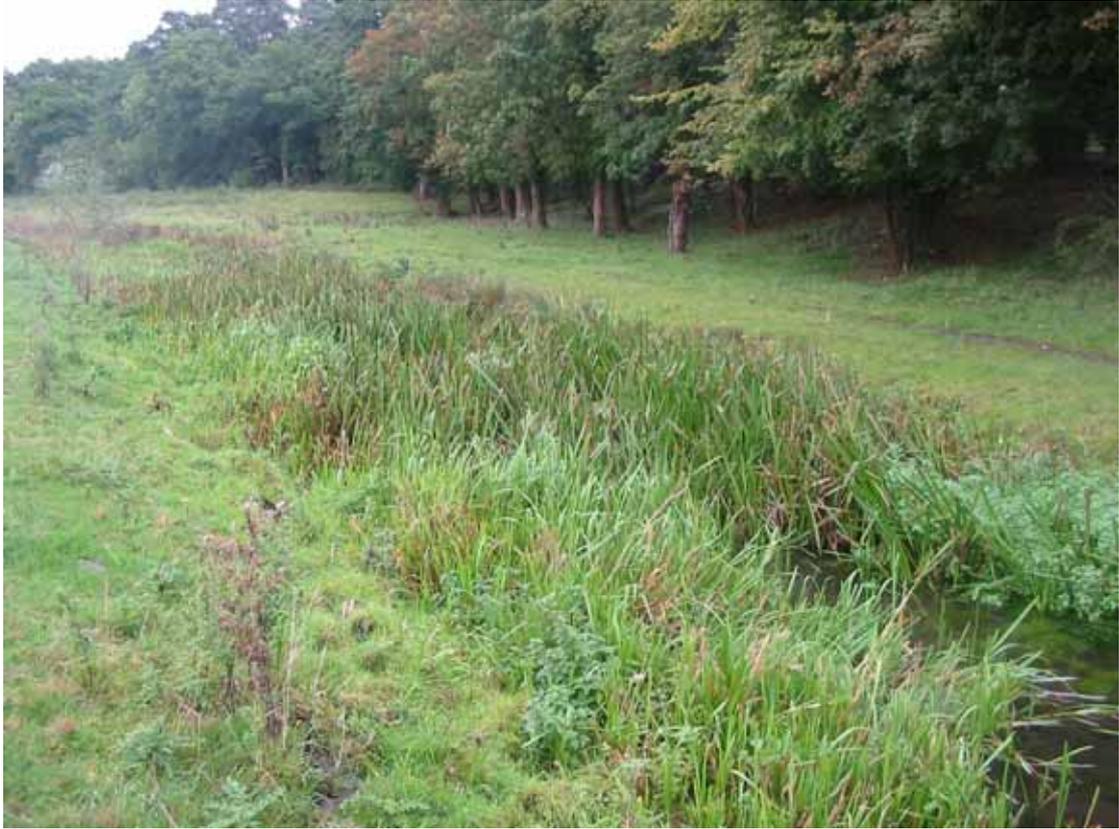
A length of the original River Beane flowed parallel to the Canal. This channel was between 2m – 4m wide, with a mixed sand and gravel bed, heavily overlain by fine sediment over much of its length. There were extensive stands of emergent vegetation including reed sweet grass *Glyceria maxima*, branched bur-reed *Sparganium erectum* and water forget me not *Myosotis scorpioides*, which totally occluded the channel for much of the reach length. Submerged vegetation was dominated by starwort *Callitriche* Spp, lesser water-parsnip *Berula erecta*, and some small stands of Water crowfoot *Ranunculus* spp.

**Typical section of the original channel of the River Beane, showing its overgrown nature**

- The growth of the emergent weed is very extensive during the summer months, largely as result of dredging undertaken historically, and the reduction in flow due to abstraction. This has resulted in an over-wide channel and an associated reduction in water velocity. Removal of all emergent weed is neither practical nor desirable. However, it is possible to manage the weed in order to maintain sections of open water. This can be achieved by either manual cutting (chain scythes), mechanical cutting (hydraulic powered cutter mounted on 360 excavator) or by the use of herbicide. Of these options, the best in terms of its cost, lack of environmental disturbance and practicality is probably the herbicide.

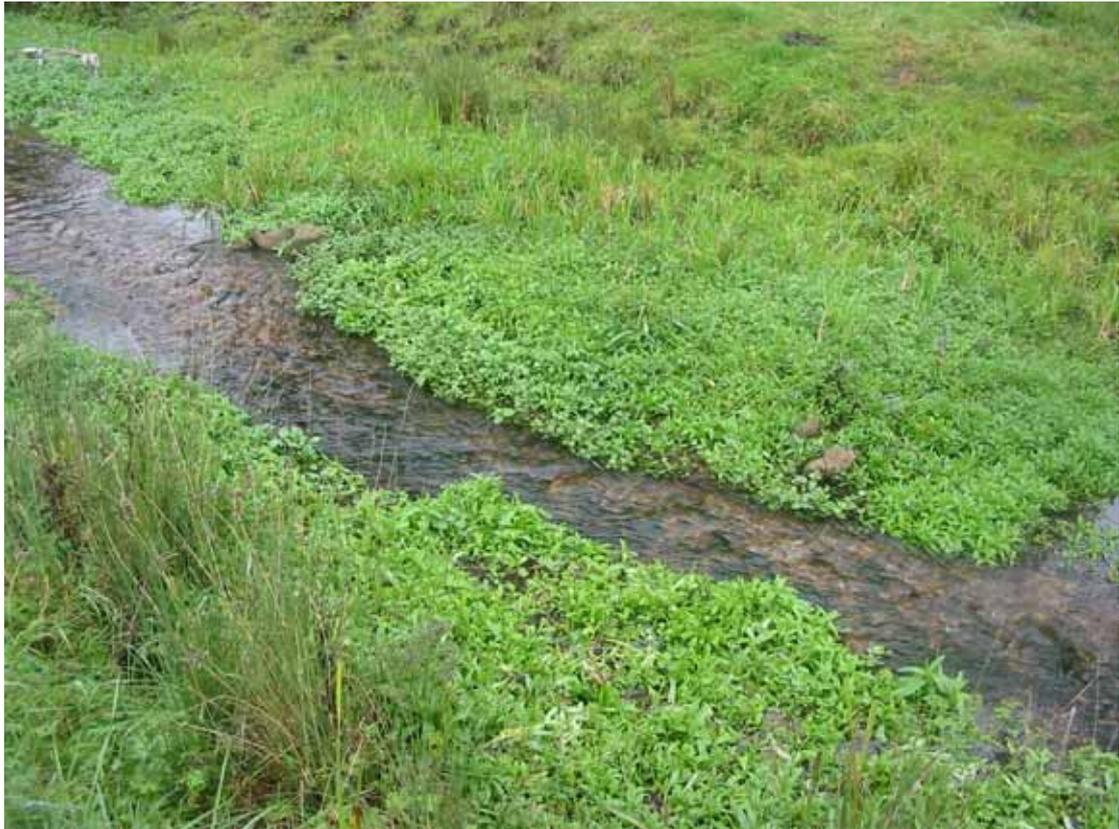
Short sections of channel with a clean, gravel dominated substrate were present where the gradient was steeper and damaging dredging had not been undertaken historically.

**A section of the channel with gravel dominated substrate, and a wide fringe of marginal vegetation**

- The quality of the existing gravel can be improved by establishing a regime of cleaning spawning gravels each September. This can be achieved by either manual raking, or by the use of high-pressure water jets. Care must be taken to clean riffles rotationally, with only short sections being treated annually. It is important that the Environment Agency are contacted prior to any cleaning of gravel, due to the possible discoloration of water in the river resulting from the operation. The same concerns dictate that downstream neighbours should also be forewarned of the operation.

- The quality of the existing spawning gravel could be improved by selective narrowing of overwide riffles by the installation of faggot bundles. Narrowing of the channel can significantly increase water velocity, increasing scour and hence decreasing the amount of fine sediment deposited on the gravel, whilst increasing the abundance of valuable marginal cover for swim-up fry. Arisings from the coppicing or pollarding can be used to create faggots, roughly 2m long with a diameter of approximately 300mm. Once manufactured, the faggots can be used to locally narrow the channel, either from the margins or by the construction of small mid-channel islands. The faggot bundles should be pinned in place using wooden stakes and backfilled with secured brushings. The top of the faggots should be set at approximately 100-150mm above mean summer water level. Further details of faggoting techniques are provided in the Wild Trout Trust's "Guide to Improving Trout Streams".

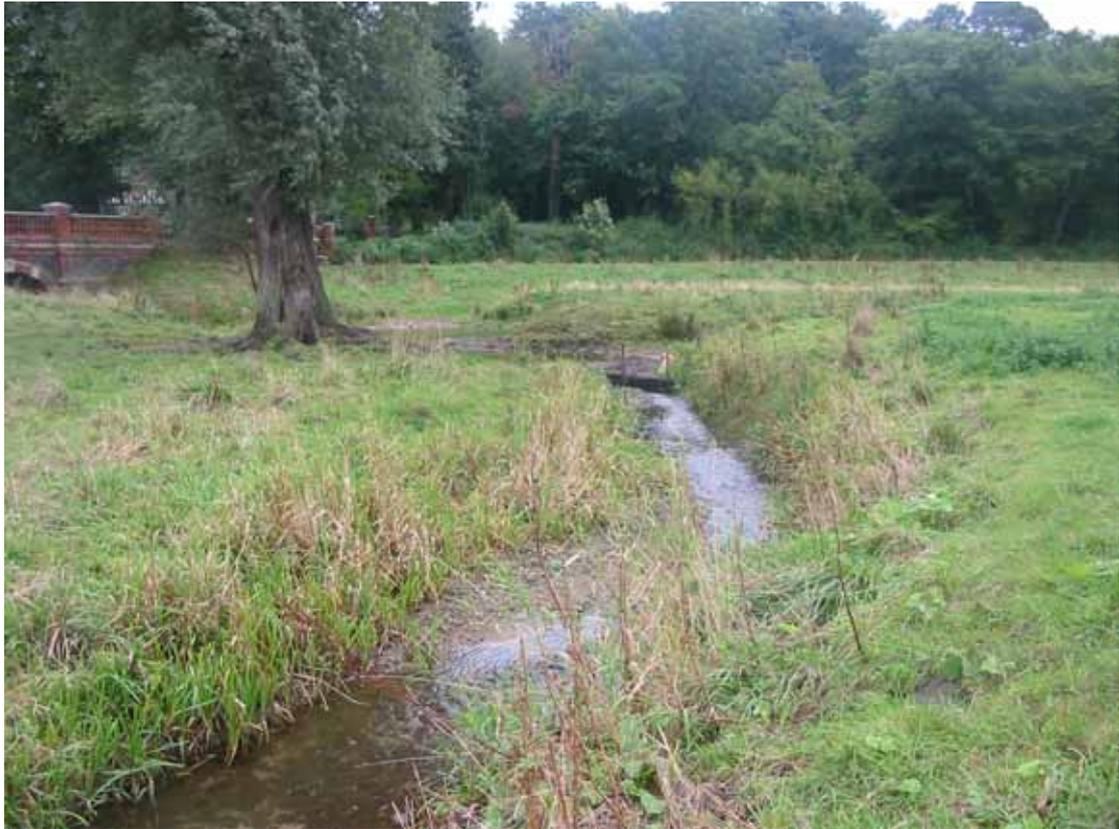
Flow in the reach of original River Beane channel was augmented by overspill water from the Canal passing along a small carrier, particularly during high flow periods. A second carrier further upstream fed water in the opposite direction, i.e. from the River Beane to the Canal. This stream was 1m- 2m wide, with a steep gradient, and sections of gravel-dominated substrate.

### **Small carrier feeding the Canal from the River Beane**
