**ADVISORY VISIT TO THE RIVER CHESH AT
THE OLD RECTORY ESTATE, SARRATT,
BUCKS
UNDERTAKEN BY VAUGHAN LEWIS,
WINDRUSH AEC LTD, ON BEHALF OF WILL
HOBHOUSE
OCTOBER 2005**

1.0 Introduction

2.0 Habitat assessment

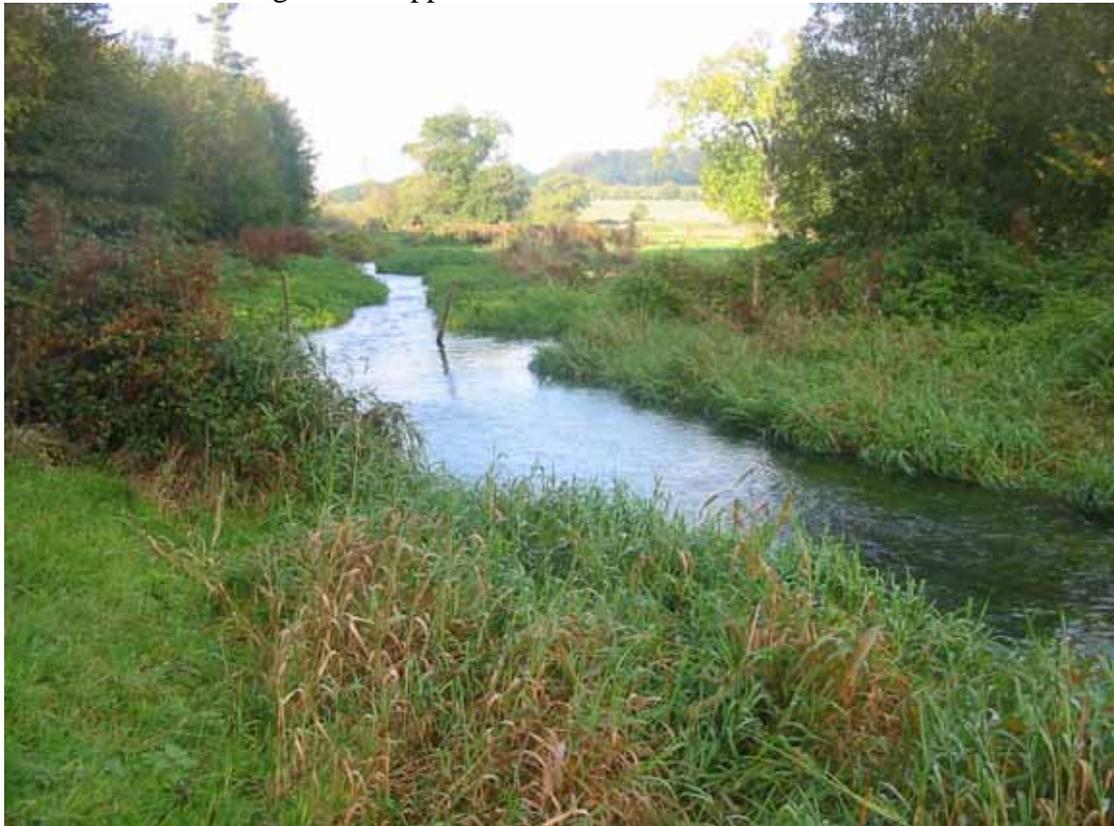
Downstream of the cress farm, the river had a relatively steep gradient, with a well-defined, moderately meandering channel of between 2m and 4m in width. The substrate was dominated by a mix of clean gravel and sand, suitable for spawning brown trout *Salmo trutta*. Instream vegetation was abundant with stands of lesser water-parsnip *Berula erecta*, and Water crowfoot *Ranunculus* spp. The well-vegetated marginal areas were comprised largely of reed canary grass *Phalaris arundinacea* and sedge *Carex* spp.

River Chess downstream of cress farm

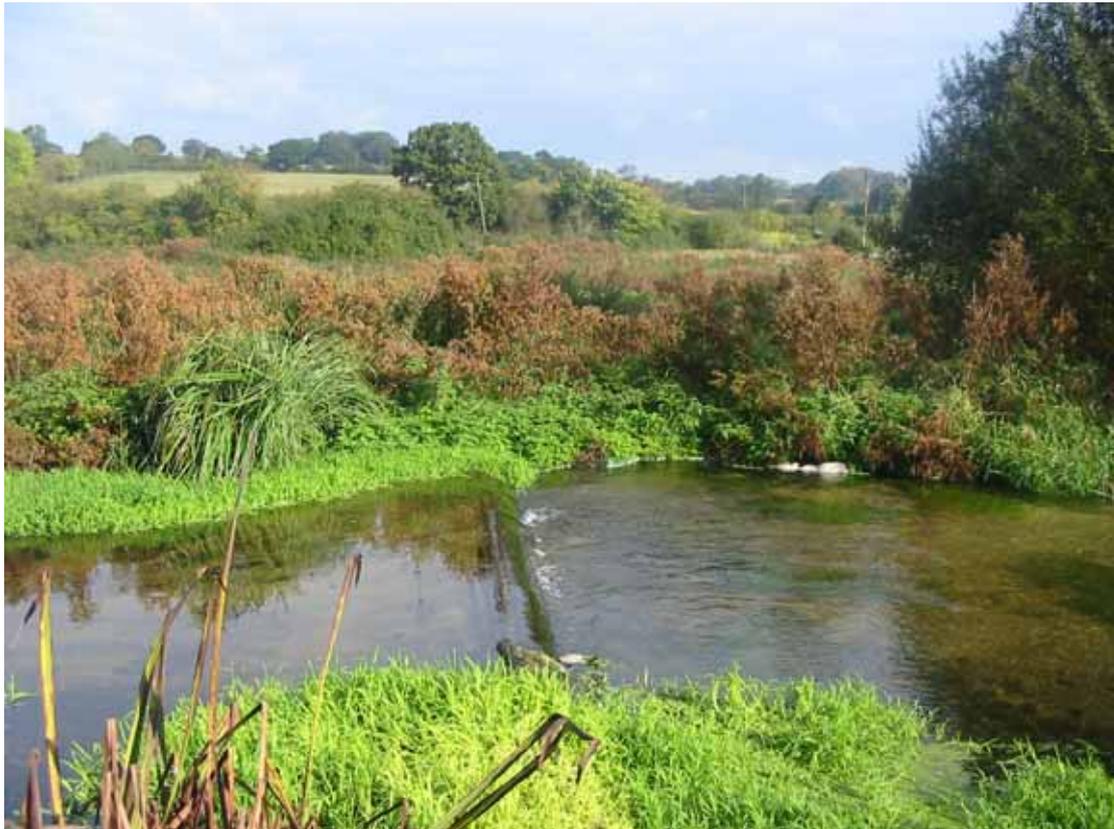
Further downstream, a number of small weirs had been constructed using telegraph poles, backed with corrugated iron sheets. These were retaining a head of water up to 30cm in height. As a consequence, a significant volume of fine sand and silt had accumulated on the upstream side of the weir, significantly reducing its value as trout habitat. Some of the weirs were in a poor state of repair, having been shored up with corrugated iron sheets.

Example of telegraph pole/corrugated iron weir

- The small weirs present are, on balance, having a detrimental impact on the ecology of the river and should be removed or modified. This can easily be undertaken in late summer/early autumn, when river levels are low, birds have finished breeding and the trout spawning season has yet to commence. Whilst total removal of the weirs would be the best option in most locations, it would be possible to cut out the centre of some of the weirs, reducing the height of the impoundment. Provided that the remaining edges of the weir are well keyed into the hard bank and securely fixed to the bed, they can remain, training a central scouring flow along the channel.

It is likely that subsequent to the removal/modification of the weirs, the river will narrow due to increase growth of marginal vegetation, whilst the growth of water crowfoot in the channel might be expected to similarly increase. These changes are likely to more than compensate for the loss of the weirs with respect to the retention of existing water levels in the river.

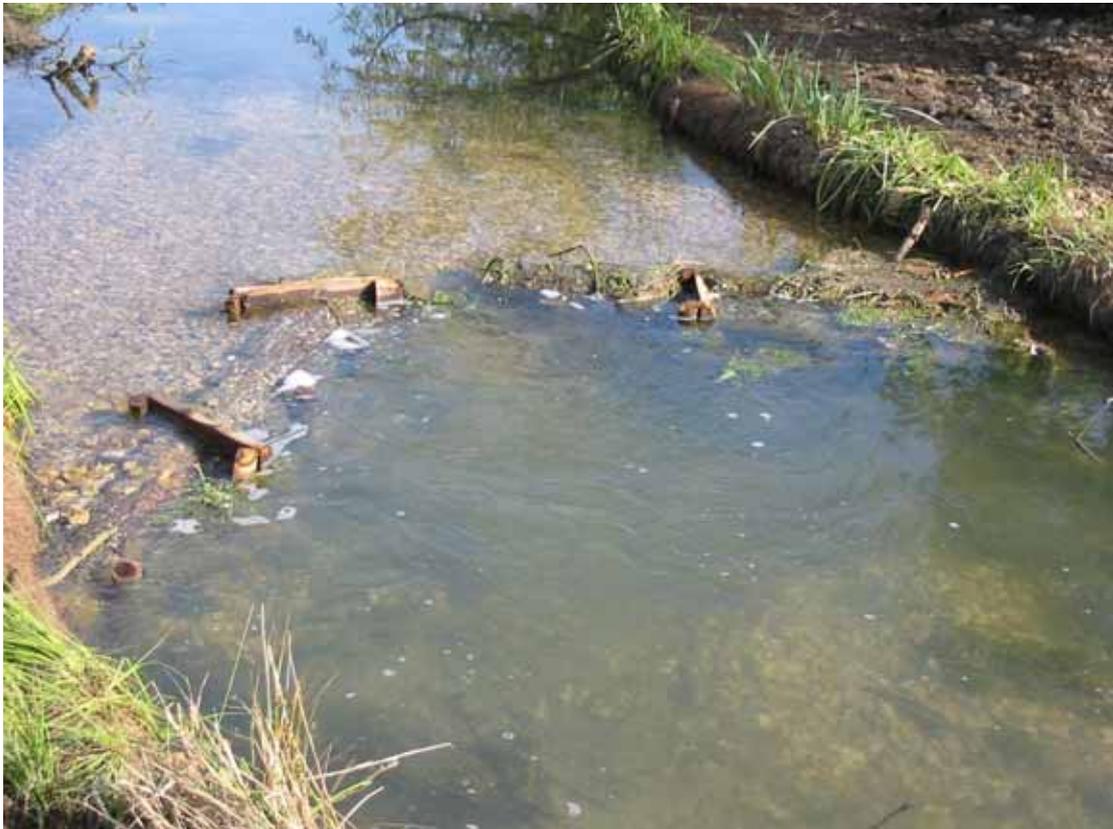
Upstream facing wooden 'v' groyne showing pool scoured downstream

Another option for the use of LWD to sort gravel is by the installation of upstream facing 'V' shaped groynes at strategic locations on gravel shallows. These groynes will actively scour out small pools, with the resulting cleaned gravel piles providing potentially excellent spawning sites for brown trout.

- Additional feature could be created within the channel by installing sets of paired opposing triangular wooden groynes at strategic locations. These would increase scour, sorting of the substrate and would raise water level locally. The groynes could be constructed from locally sourced tree trunks, with the top of the groynes set approximately 15cm above mean summer water level. The groynes should be

constructed some 6-8 river widths apart. Upstream facing 'v' shaped groynes could also be installed in the centre of the channel in order to scour deeper pool areas and associated downstream gravel shallows.
