**ADVISORY VISIT TO BRED A ESTATE, RIVER DON,
ABERDEENSHIRE ON 11 MAY, 2005**

**Sponsored by Orvis and undertaken on behalf of the Wild Trout
Trust**

By Dr Andy Walker, Ellwyn, Moulin, Pitlochry PH16 5ER

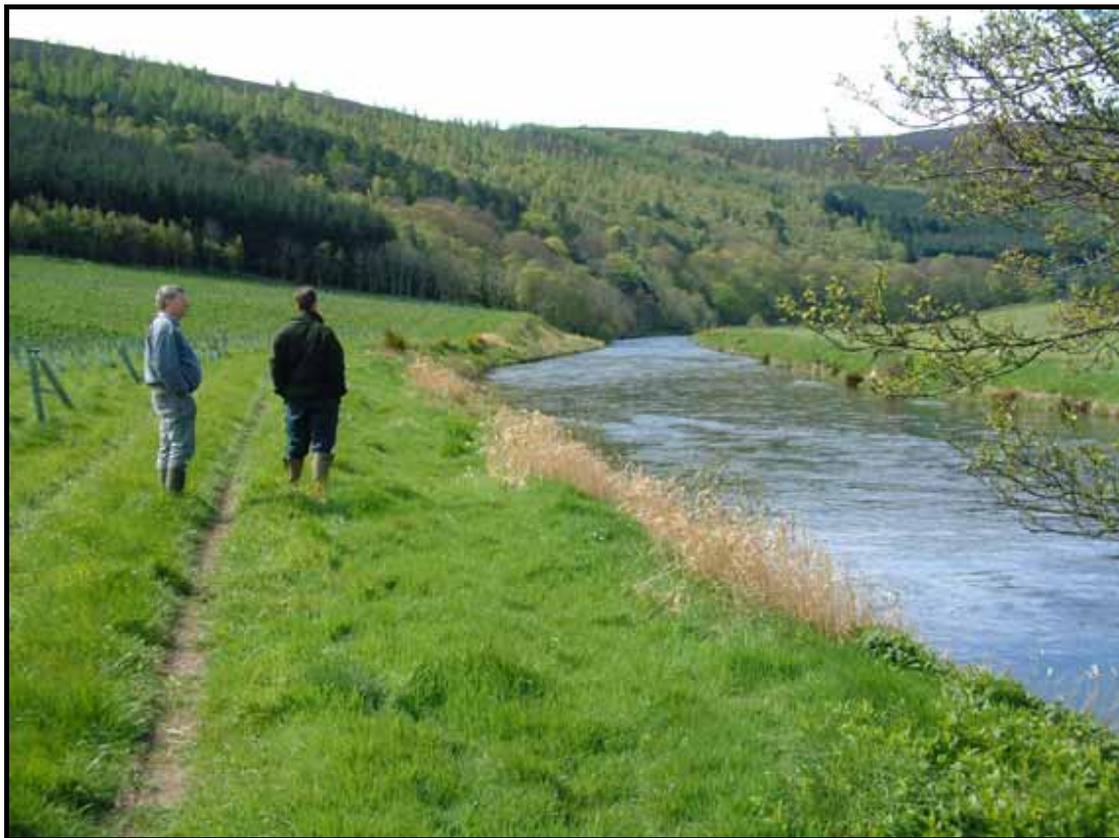
Plate 1: Mixed woodland near the top of Breda Beat

Within Breda Estate, the River Don runs through well-consolidated banks, with good marginal vegetation and showing very few signs of erosion. Towards the top of the beat, the river runs alongside a steeper hillside cloaked with mixed conifer and

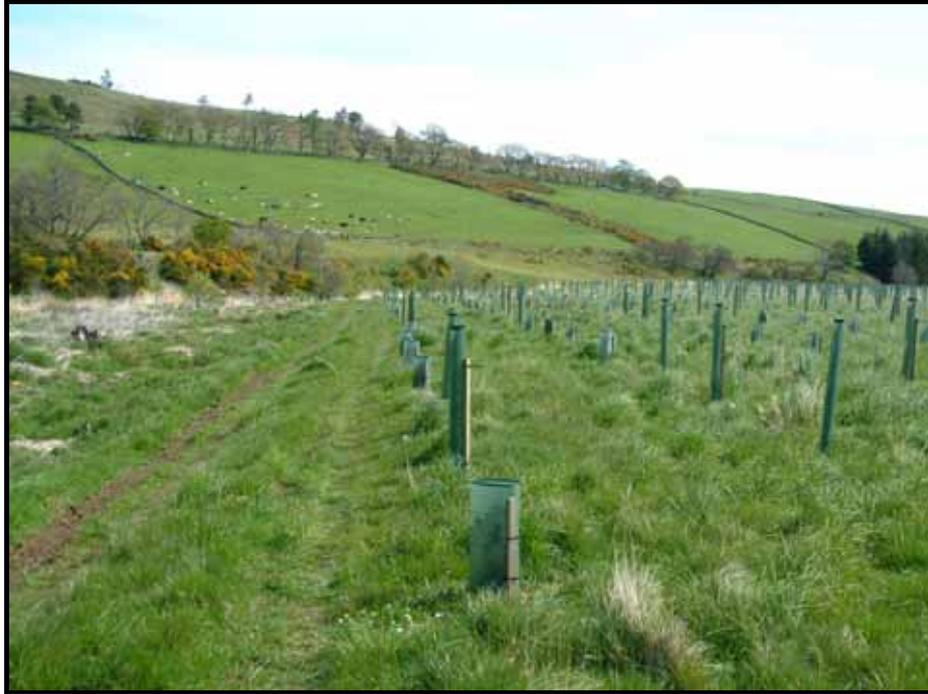
hardwood trees, but much of the remainder is open farmland with few established trees. However, large areas have recently been planted with hardwoods.

Plate 2: Large areas near the river have been planted with hardwoods

- The potential of the Breda fishings will be enhanced by the various wild habitat improvement schemes that are currently underway on the estate. The reduction in grazing pressure along the bank will permit growth of dense overhanging vegetation, useful as overhead cover for trout. More riparian bushes should be encouraged where feasible.

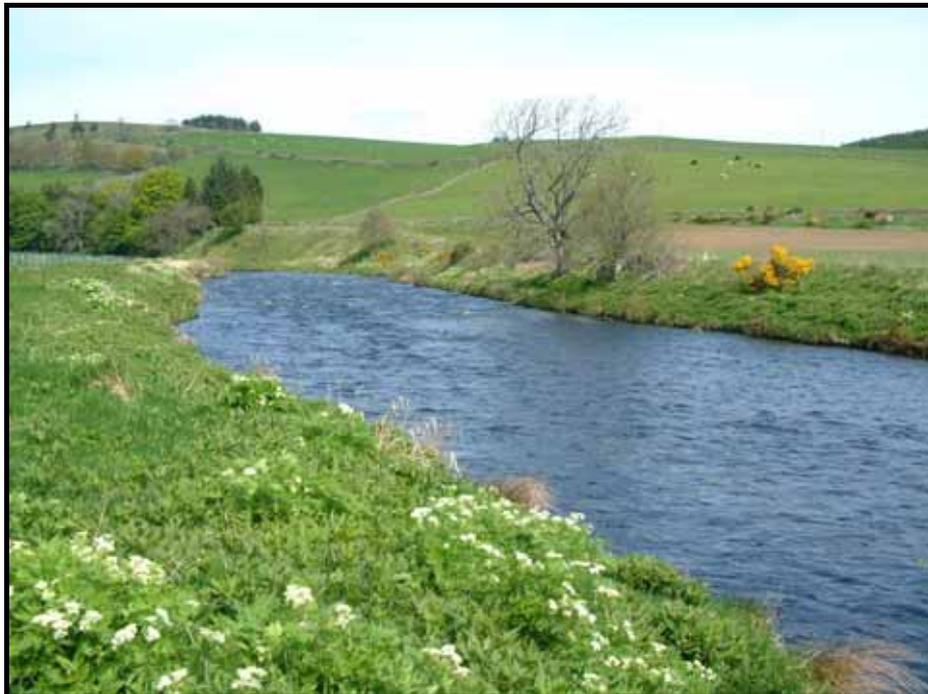
Plate 3: Mainly open countryside

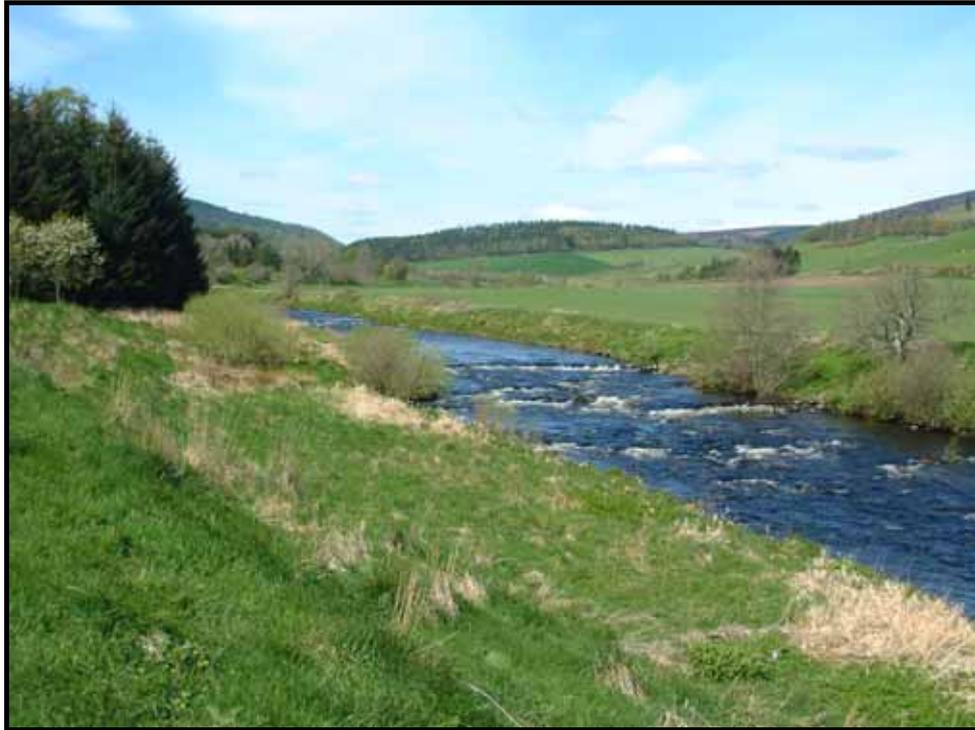
Plate 3: Rocky ledges in one section

It seems inadvisable to consider any further physical engineering of the river channel, or the installation of gabions, boulders, or other means of manipulating the flows. The channel is sufficiently deep already and there is plenty of turbulence from the existing rocks and boulders to provide good resting and feeding habitat for trout and ample fishing opportunities. In any case, there would be a high risk of bankside erosion and potential disputes with neighbouring fishing beats. At one of the main salmon pools, an old downwards-pointing boulder groyne has caused a downstream cut into the bank and created a back-eddy. However, the erosion was relatively modest and arguably not serious enough to warrant remedial action, although Mr McLean felt that the pool had deteriorated to an extent over the years. It would be feasible to fill in part or all of the cut section with rubble, but the tendency would be for the river to scoop it out again. The solution would be to remove the old groyne, but this could damage the pool further. With the flows prevalent during the visit, the tail of the run below the eddy, like most of the beat, looked eminently fishable for trout or for salmon and it might be wiser to leave the pool as it is.

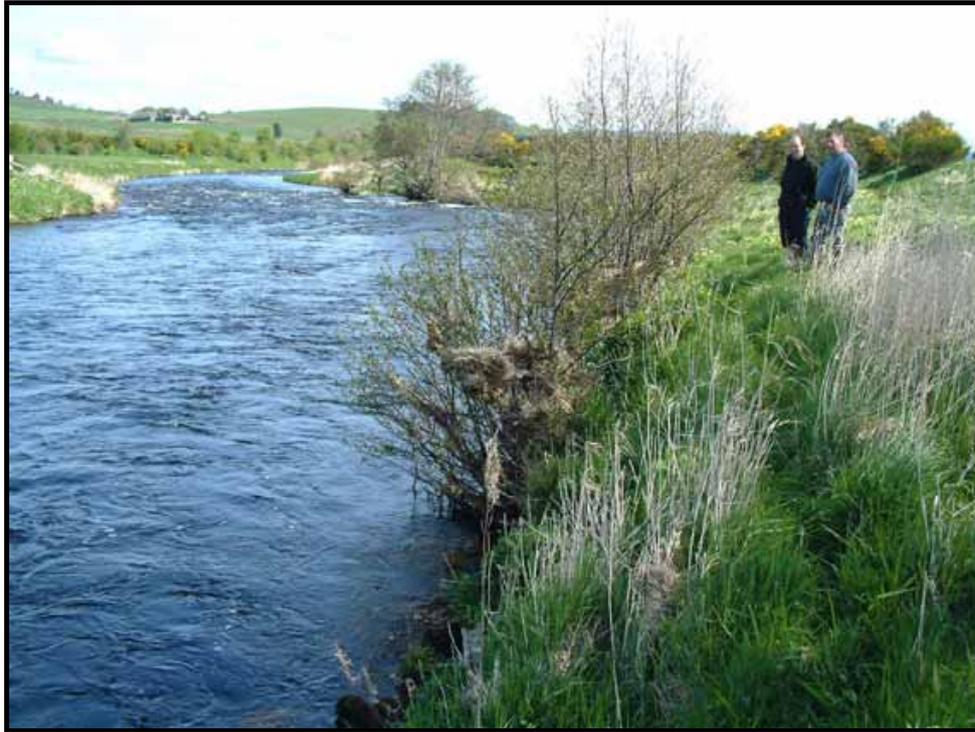
As well as the marginal grasses and other plants, there were occasional bushes, some showing signs of past pruning, probably more as an aid to salmon angling from the banks at times of higher discharge than with trout shelter in mind. The scarcity of overhanging bushes or trees may be due to previous heavy grazing pressure. It could be worth considering planting small clumps of alder and perhaps willow along the more open areas of bank. However, the greatly reduced level of grazing pressure along the right bank should allow more bushes to become established as a natural process. Where possible, these should be encouraged as they will provide additional overhead cover and root refuges for larger trout, acting as sanctuaries from predators and as shelters from heavy flows.

Plate 4: Occasional bankside bushes provide extra shelter

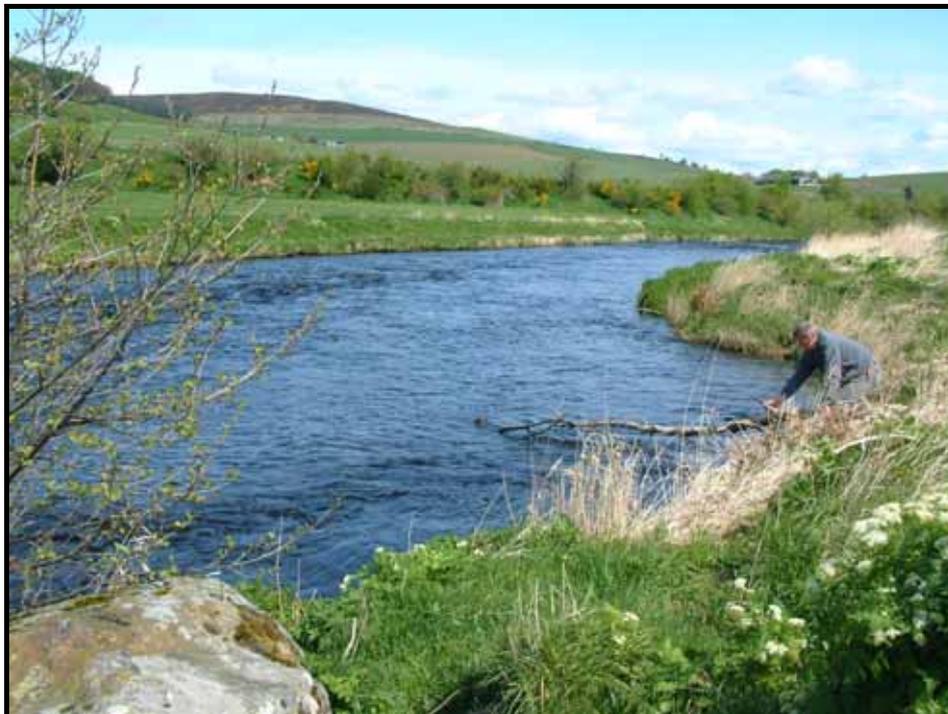
Plate 5: Only very limited bank erosion

- Ample instream cover is provided by existing structure and varying water depths, so there is no need to consider river engineering. The banks are stable and there is very little evidence of erosion.

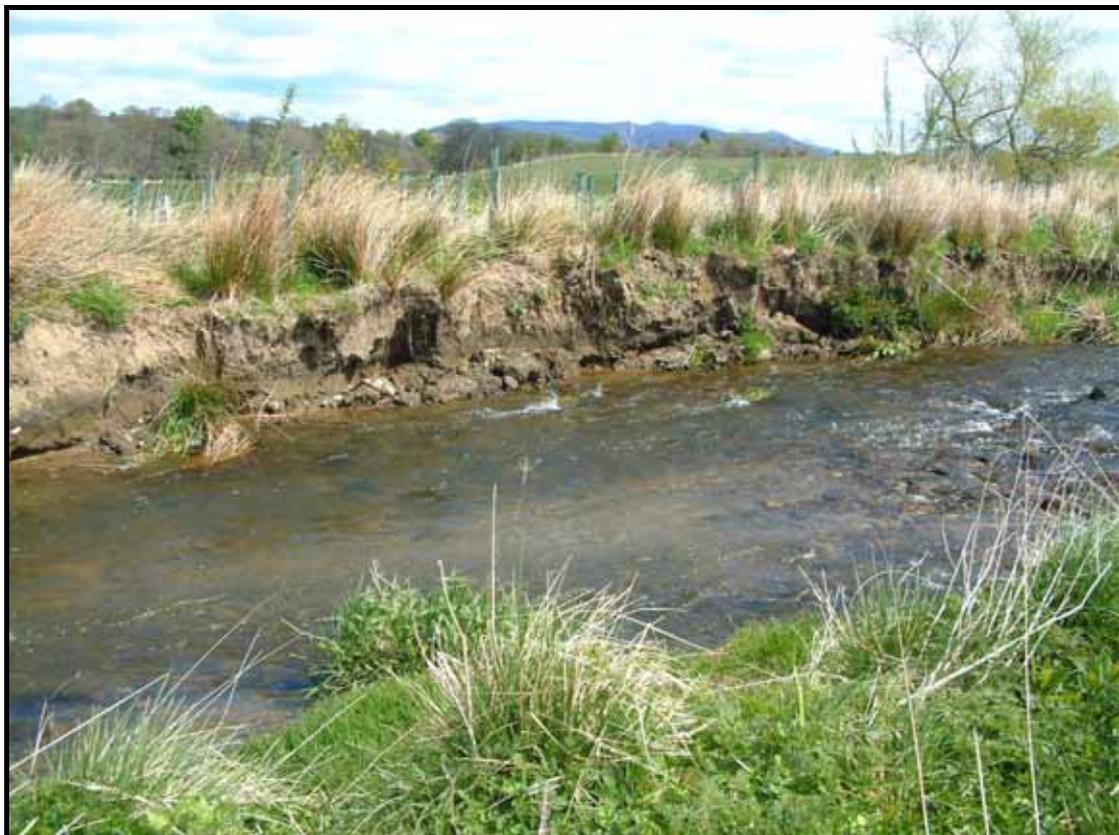
In its lower reaches before it enters the Don, the channel of the Leochel Burn is very unstable, which is normal when rivers meander through flatter, more erodible, terrain. After a recent unusually severe spate, the channel has dug a new line to the west of the former one. This is still a highly dynamic area with raw, collapsing banks. Further large changes in course appear to be imminent which may result in the loss of ground with some recently planted trees. Presumably, in anticipation of continuing erosion, they can be lifted for replanting elsewhere. It appears to be impractical to carry out sheathing work to protect the new bank section in view of the scale of the damage that has already occurred, the speed of flow and the porous nature of the substrate. It would be better to allow the stream to find its own line.

Plate 7: A heavily-eroding lower section of the Leochel Burn means the probable loss of some newly-planted hardwoods

- The unstable banks of the new channel of the lower Leochel Burn do not appear to be worth attempting to stabilise until the new course is clearer. Even then, the course is liable to wander and any sheathing work may end up isolated from the water.

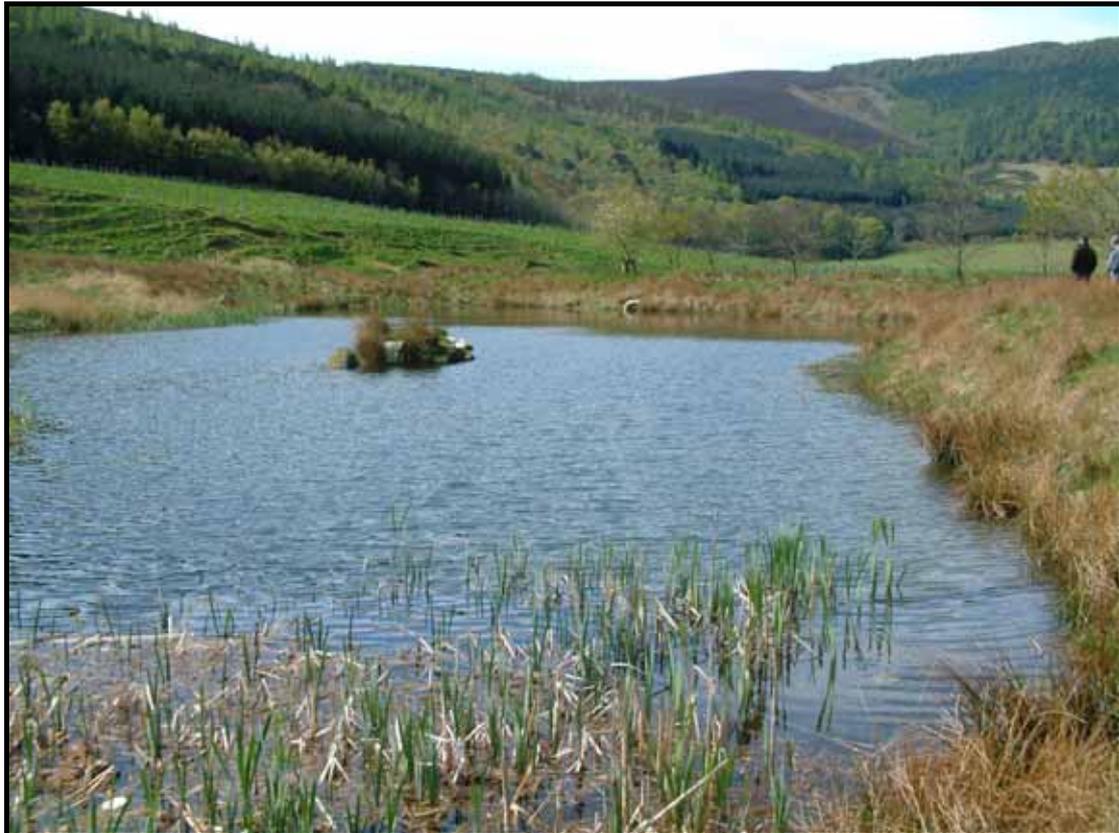
The Estate is interested in the potential to construct a 1.5 acre shallow pond in an area of boggy ground to the west of the present channel of the Leochel Burn. This would provide additional wetland habitat for aquatic biota, visiting birds etc and be an interesting and aesthetic feature. A pond for wildlife has already been installed successfully higher up the beat.

Plate 8: Existing wildlife pond at Breda

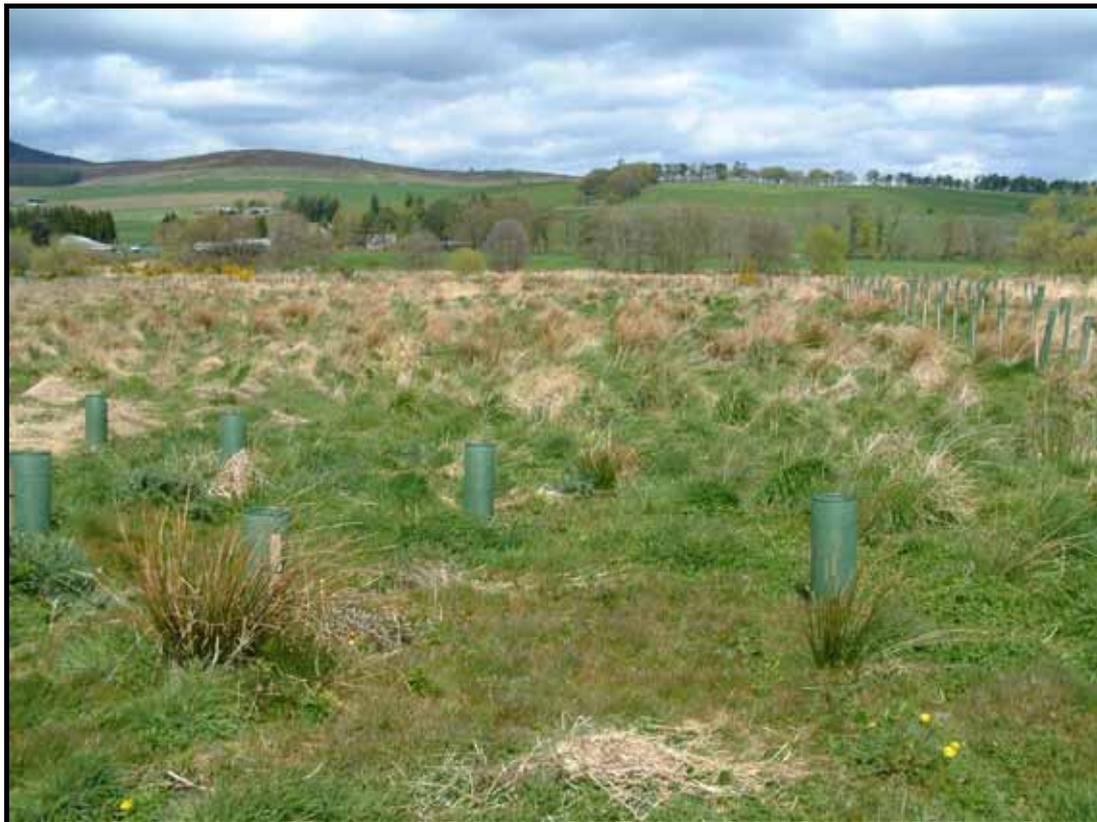
Mr McLean also wondered whether the proposed new pond beside the Leochel Burn could have additional nursery potential for brown and sea trout parr. Water would be piped from the burn. It would be possible to excavate a pond base and use the dug out material to bund the site, although it would be prone to flooding in times of spate. Ideally, the pond should be a maximum depth of about 2.0 metres and be made drainable for better management of aquatic plant build-up and removal of the fish. Excavation below this level would soon hit the water table and so the pond could be made deeper. However, this would require a long outflow pipe to get sufficient fall in level for full drainage. That might be difficult because of the relatively flat terrain to the river. The problem with growing migratory fish in ponds is that many of them are reluctant to leave them until the water is almost all drained away. Then they come out in a rush.

Plate 9: Site of proposed pond beside the Leochel Burn

The pond would require planning consent. Also, the River Don District Salmon Fishery Board should be consulted at an early stage to find out their requirements for screening of the intake and outlets against ingress of salmon and sea trout juveniles and particularly smolts during their spring migration period. The Board might take the view that screening would be unnecessary if one of the main purposes of the pond was to create additional nursery habitat for parr and smolt production and they are happy with the flushing arrangements. However, the additional productive capacity of the pond may be small in relation to the Leochel Burn as a whole. The Fishery Board has embarked on a three-year habitat survey of the Don catchment, including the Leochel Burn, that will assist in targeting obstructions to fish movements, sources of pollution etc (pers.comm. J. Kerr).

- A marshy area to the west of the burn may be suitable for a simple, shallow pond which would enhance the wetland habitat for diverse biota and could add to the nursery production capacity for Don trout, providing the pond is made drainable and is regularly flushed out.

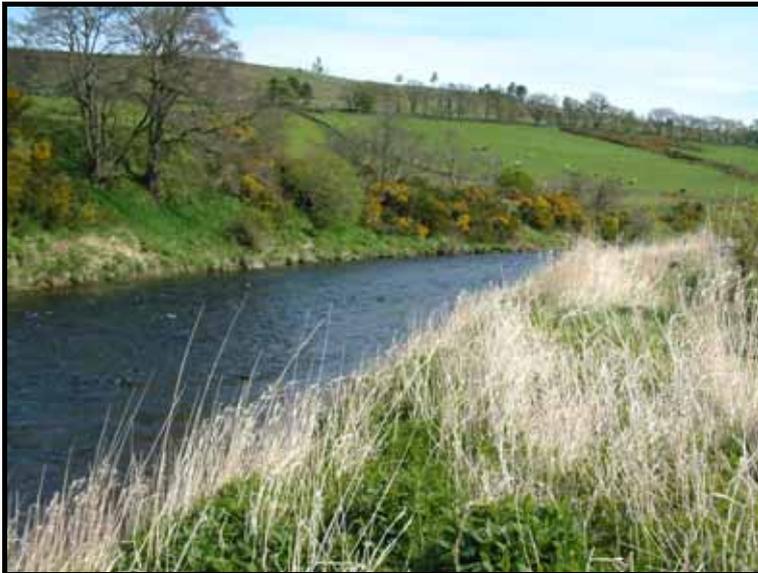
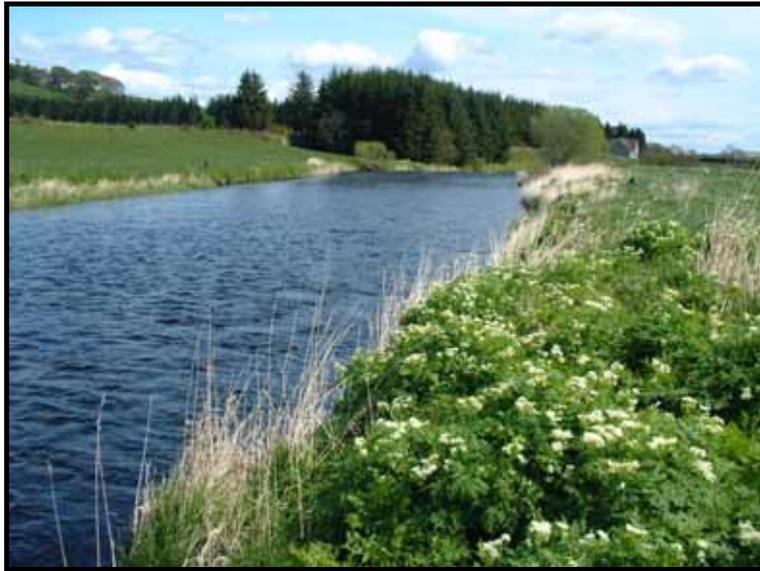
The Estate is also keen to provide wheelchair and track access for disabled anglers. These would be situated in two pools where the banks may be capable of supporting platforms with guard rails. This is a very commendable idea. A number of stocked rainbow trout fisheries provide facilities for the disabled angler e.g. Glen of Rothes Fishery by Aberlour. However, there are few places in Scotland where disabled anglers can fish safely in a river in natural countryside with a reasonable chance of catching wild trout, or salmon. The fishing platforms will need to withstand heavy spates and the banks may require extra shoring to protect against erosion. Enquiries about the provision of angling facilities for the disabled may be made with the Scottish Anglers National Association/ Salmon and Trout Association Administrator, Alastair Wallace, National Game Angling Centre, The Pier, Loch Leven, Kinross KY13 8UF (admin@sana.org.uk). Grampian Social Services should also be able to advise on possible funding assistance. It would also be advisable to enquire about consequent matters of liability.

Plates 8; 9: Pools and runs where disabled angling access may be created

- The provision of stable platforming and access suitable for disabled anglers is a novel and very commendable idea which needs specialist attention.
- The Breda Estate fishings may soon be used as a showcase for wild trout and holistic river habitat conservation.
