Habitat Advisory visit to the River  
Swift, Warwickshire, sponsored by  
Orvis and undertaken on behalf of  
Warwickshire Flyfishers by Vaughan  
Lewis, Windrush AEC Ltd  
March 2005

## 1.0 Introduction

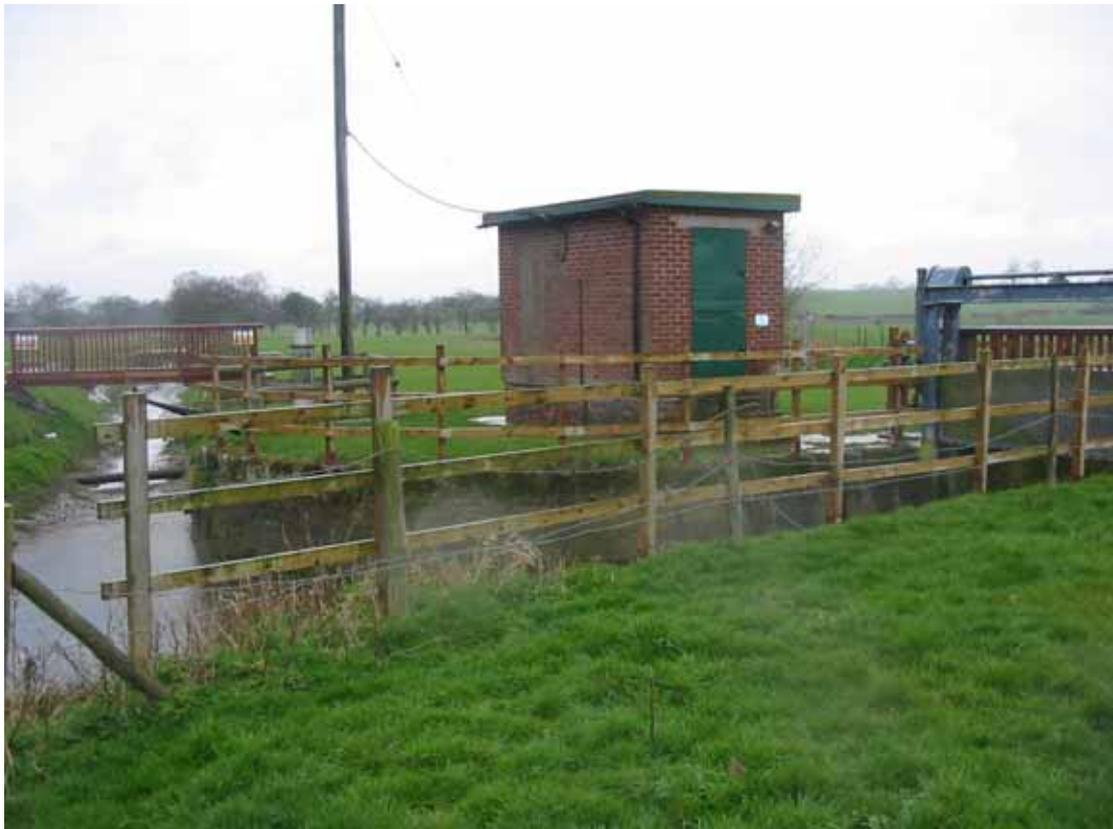
The downstream limit of the fishery was near to the village of Churchover, with the A5 at Bransford Bridge, the upper limit. A large automated sluice gate was present at the downstream end of the fishery. The gate's function was to divert and prioritise water along a LB channel that fed the Oxford Canal during times of lower flow, allowing the navigation to continue to operate.

**Automated sluice at downstream fishery limit. Note canal feeder to the left of the picture**

- At present, British Waterways is allowed to abstract an unconstrained volume of water for navigation purposes. However, the provisions of the recently adopted Water Act, 2004, will ultimately place a volumetric limit on the abstraction. No action need be taken by the club, but the situation with respect to abstraction for the Oxford Canal should be restricted in the future.

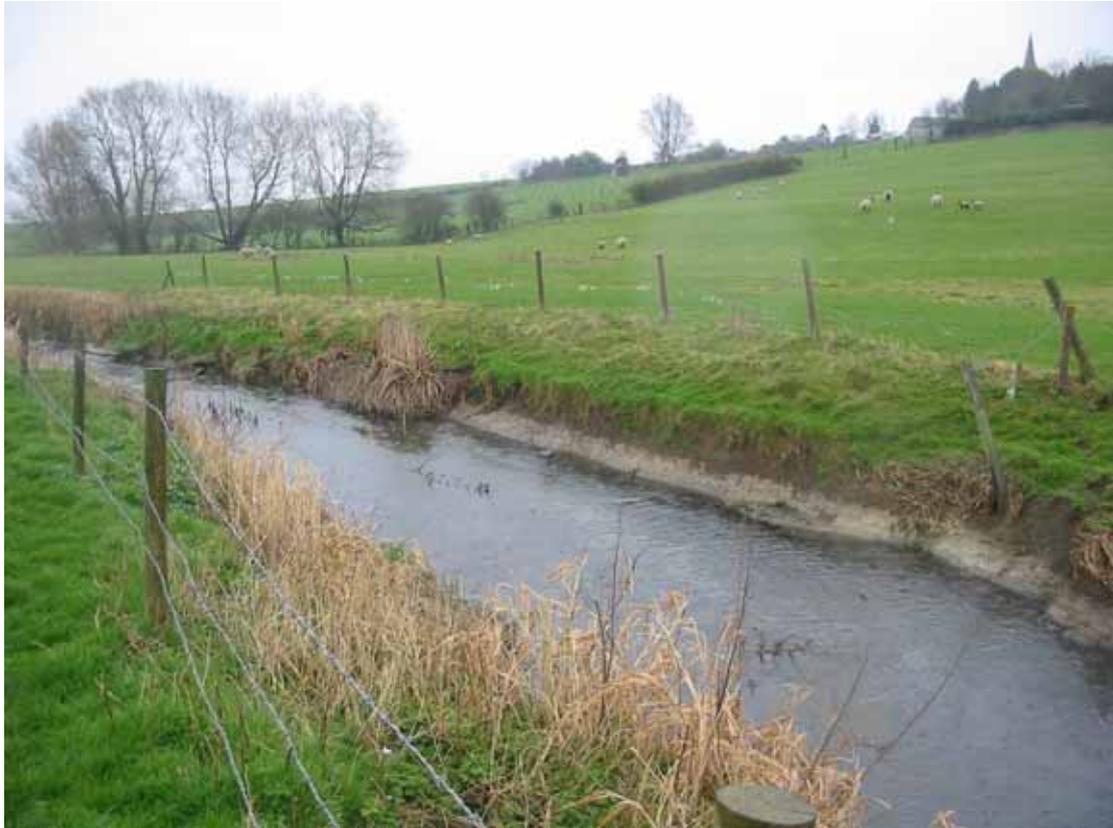
Immediately downstream of the sluice was an Environment Agency (EA) gauge weir that effectively prevented upstream migration of fish. On the day of the site visit, the sluice was fully open. In combination with low winter rainfall, this had resulted in a drop in upstream water level of some 30cm.

**River Swift upstream of sluice. Note the exposed margin of the river, as a result of draw-down from the raised sluice and lack of rainfall during winter 2004/05**

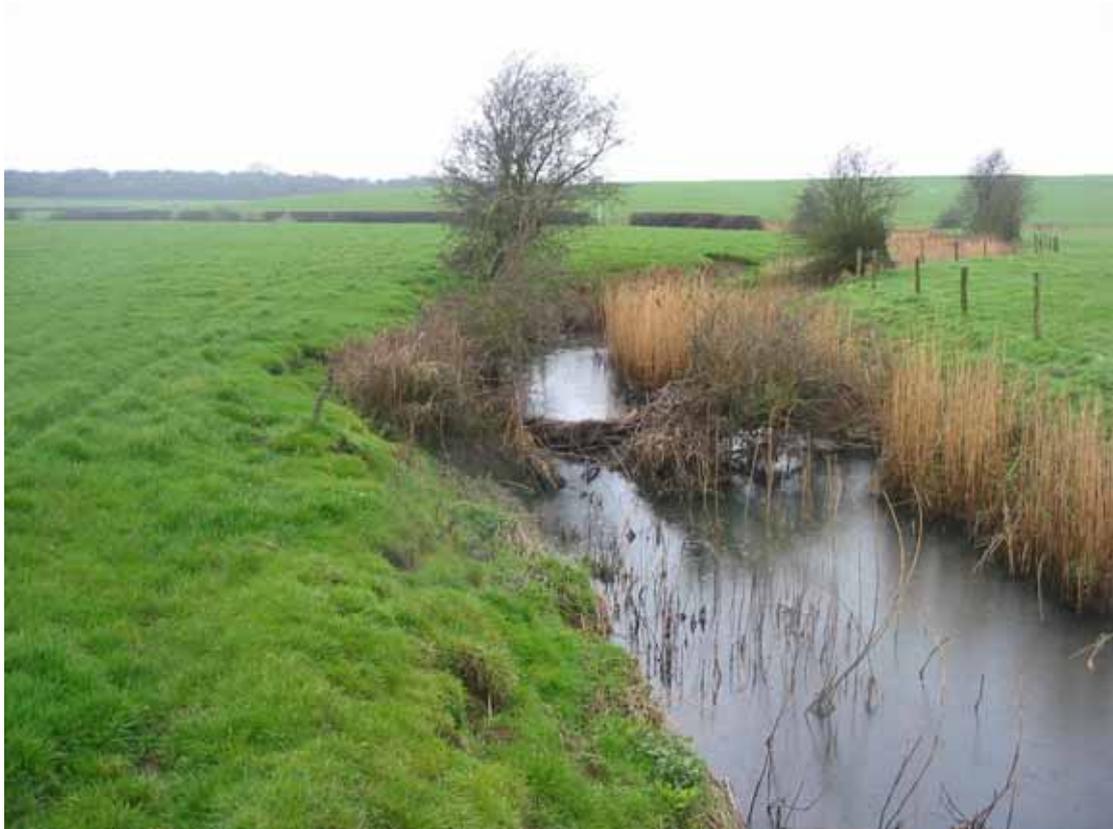
There were few trees or shrubs on the banks, with the result that both channel shade and Large Woody Debris (LWD) were limited. Instream cover was mainly provided by the extensive beds of emergent vegetation and the presence of large numbers of deeper pools.

**Typical section of lower reach of the fishery, showing emergent vegetation and LWD**

The report also provides recommendations for the management of LWD, the most important of which is “although there are certain situations that may require wood removal to eliminate stream blockage, the wisest management is no management”. Building on this simple truism, it is recommended that before any future work to remove LWD from river channels is undertaken, the wider implications of the proposal on the whole river system are considered, rather than just the potential (in many cases unproven) benefits to salmonid populations. In addition, the impact of planned riparian tree work on the supply of LWD to the river should be considered. In some circumstances, it may be beneficial to allow trees to fall into the channel, provided the risk of increased flooding is acceptable.

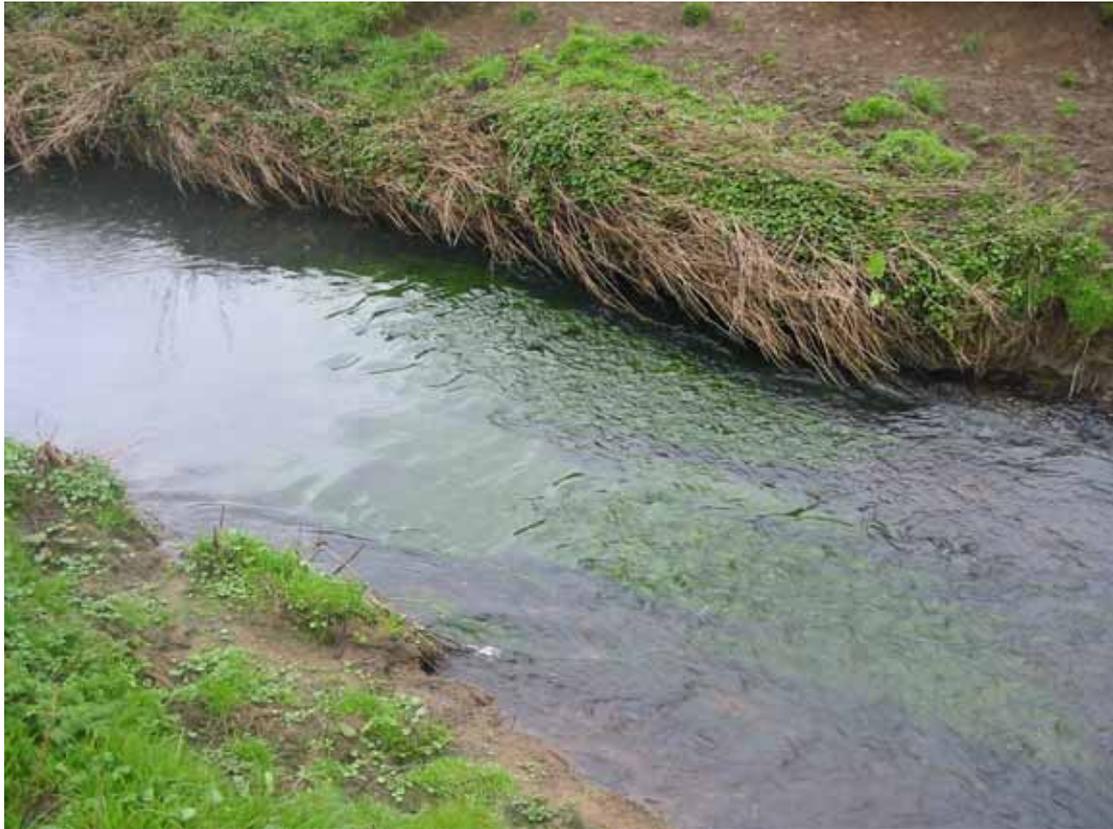
In the middle reaches of the river, stands of Water crowfoot *Ranunculus* spp were present, despite the paucity of gravel substrate.

### **Stand of water crowfoot in the middle reach of the river**
