**HABITAT ADVISORY VISIT
RIVER EBBLE, WILTSHIRE
UNDERTAKEN BY VAUGHAN
LEWIS, WINDRUSH AEC ON
BEHALF OF LONGFORD ESTATE.
MAY 2006**

This report is the output of a Wild Trout Trust Advisory visit undertaken by Vaughan Lewis, Windrush AEC to the River Ebble, Bodenham Wiltshire on 1st June 2006. The visit is part of the Trust's Cinderella Chalkstreams Project, jointly funded by English Nature and the Environment Agency.

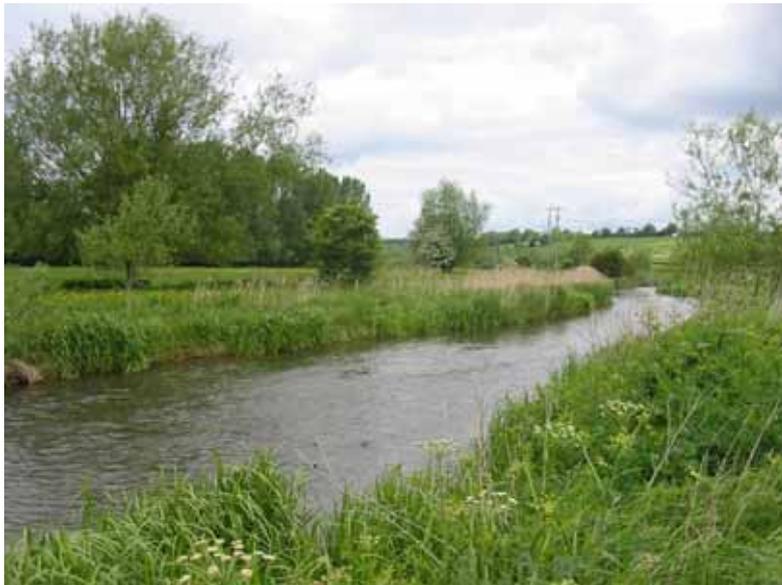
Lower section of the river u/s of the A338 roadbridge showing shallow riffle

Instream habitat quality was generally good, with sections of deep glide, shallow glide and riffle present. Gravel quality on the riffle sections was however only moderate, with significant volumes of entrained fine sediment present amongst the poorly sorted substrate. There was abundant submerged weed in this downstream section, particularly starwort *Callitriche* Spp. and water crowfoot *Ranunculus* spp. The growth of these plants was much reduced in the more heavily shaded areas.

- A short section of the downstream reach was slightly overshadowed, reducing the growth of instream plants. A careful regime of selective coppicing/pollarding could be used to partially open up the channel, and reduce shading locally. Care should be taken only to coppice/pollard small sections of the bankside trees, with more cutting undertaken in successive years. In addition to reducing shading, this will create a mosaic of uneven aged trees on the bank and dappled shade across the channel.

- Timber generated from the felling could be utilised to increase scouring and sorting of the riffle areas. Sections of trunk and larger branches could be pinned in place to form either upstream facing groyne or paired upstream facing 'v' groyne. Both designs speed up flow velocity locally, encouraging scouring of the bed and the creation of deeper water areas and better quality, well sorted spawning gravel. Note that in all cases, it is vital to 'key' the structures into the banks carefully to avoid erosion at this interface.

- A regime of cleaning spawning gravels each September could be established. This can be achieved by either manual raking, or by the use of high-pressure water

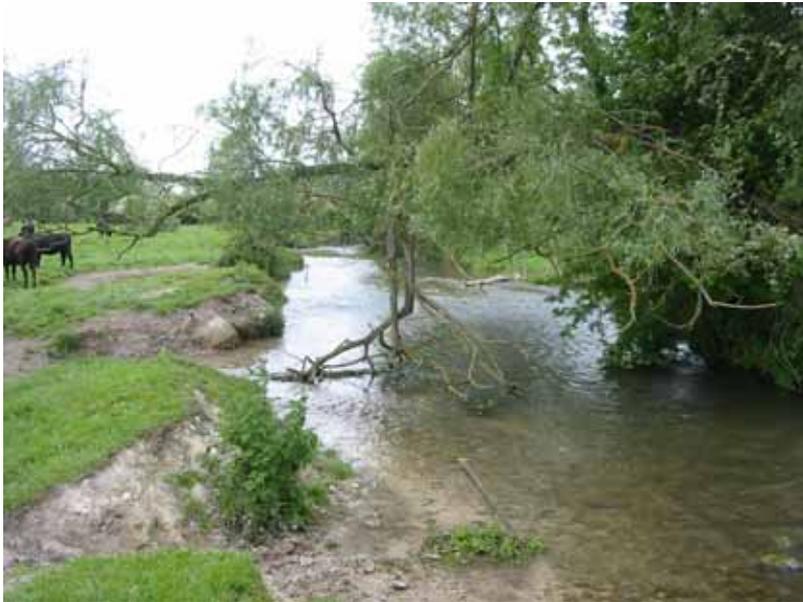
There was considerable grazing pressure on the banks of the whole reach of the river from agricultural stock grazing. Up to 400 dairy cows were kept in floodplain fields

at various times. Fencing along the river was intermittent in nature, with some of the fence lines erected very close to the bank top, reducing the benefits to vegetation growth from the exclusion of stock.

Overgrazed section of river bank

- There was significant overgrazing of much of the fishery by cattle. Where fencing had been erected it was often too close to the bank top and in many cases, had partially collapsed. In order to prevent further damage and allow regeneration of riparian vegetation, it is imperative that the banks throughout the grazed sections of the fishery are protected by the erection of fencing. Ideally, a buffer strip in excess of 3m should be created alongside the river, in order to allow vegetation growth and also to promote detention of fine sediment. Fencing of the channel would also promote the narrowing of the river, with a reduction in width of more than 1m predicted. This would increase flow velocity and encourage the sorting of the substrate, with consequent reduction in the siltation of spawning gravel. The benefits of fencing can clearly be seen at Homington Meadows, with the contrast between fenced and unfenced sections dramatic.

- The arisings from the tree trimming could also be used to create faggots, roughly 2m long with a diameter of approximately 300mm. Once manufactured, the faggots could be used to reform a new edge to the river in the overwide, cattle eroded sections of the river, once adequate fencing from stock has been erected. The channel could be narrowed locally by up to 2m using the faggots. They should be pinned in place using wooden stakes and backfilled with secured brushings, overtopped with cut sods of sedge *Carex* spp., reed canary grass *Phalaris arundinacea* or yellow flag *Iris pseudacorus* obtained locally. These will help to promote rapid development of a protective marginal vegetation fringe. The top of the faggots should be set at approximately 100-150mm above mean summer water level.

- Where the banks were overgrazed, there was a total absence of riparian trees. Following erection of fencing, it is recommended that small clumps of trees are planted strategically along the fishery. Suitable species include ash *Fraxinus excelsior*, hawthorn *Crateagus monogyna* and goat willow *Salix caprea*.

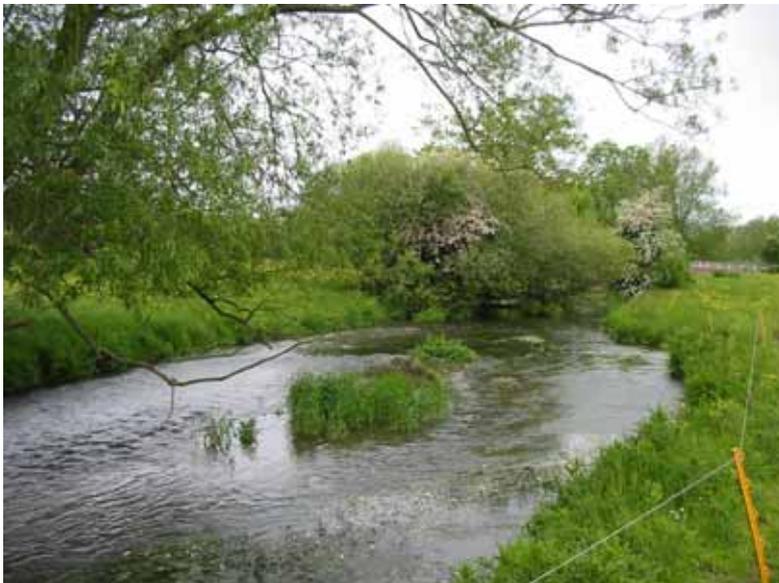
Some small islands had formed within the channel. These were splitting flow in the channel, creating a variety of instream habitat. Careful use could be made of faggot bundles to recreate this feature elsewhere in the river.

Midstream island

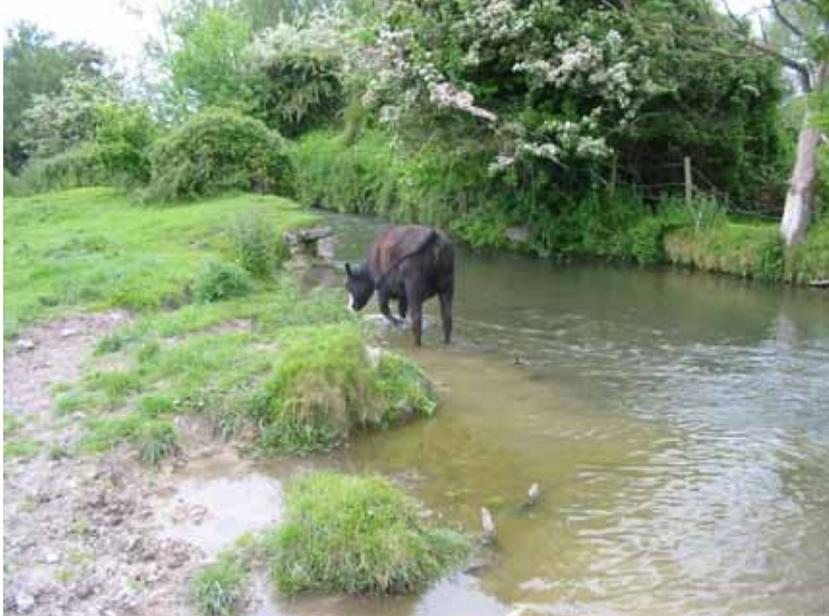
The upper section of the fishery, Homington Meadows, was again heavily stocked with cattle, leading to overgrazing, with sections of exposed chalk present and an over-wide channel.

Unfenced

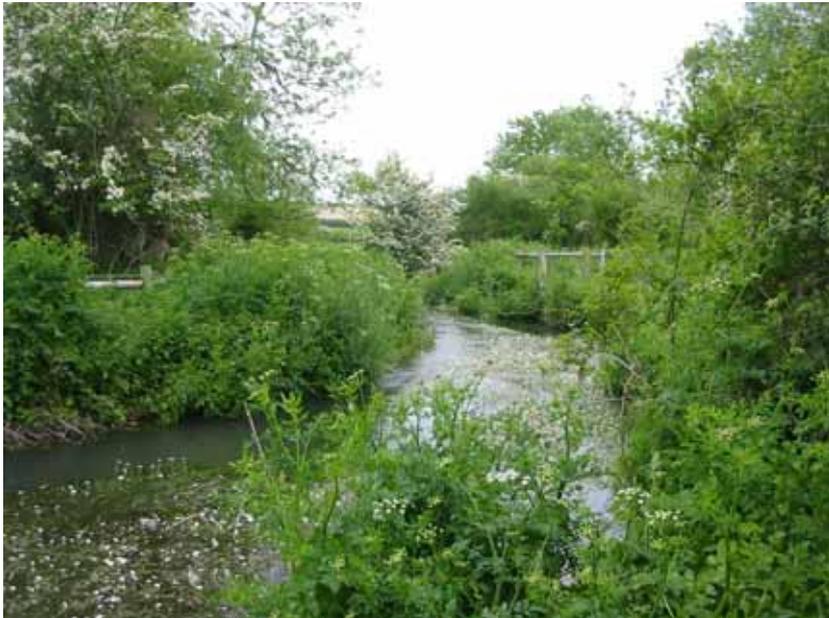
In response to this damage, much of the reach had been fenced. Unfortunately, the fencing had been erected very close to the water edge. As a consequence, access for

The fenced sections had a well-developed and diverse marginal flora, providing valuable erosion protection for the banks and cover for young trout.

And fenced section of Homington Meadows

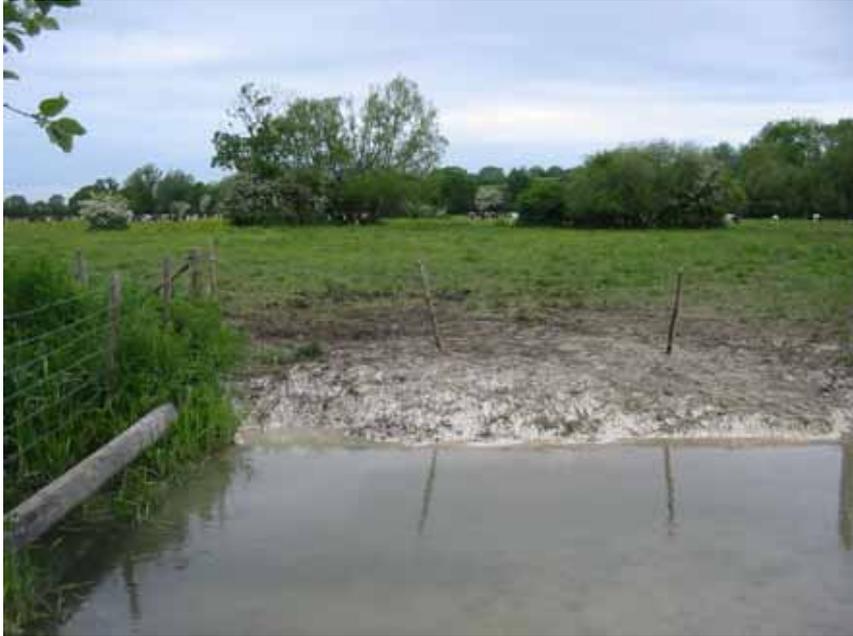
- One very obvious source of turbidity was the unfenced and chalk lined cattle crossing near to the Memorial Garden. Discolouration from the crossing was affecting water clarity downstream adversely for at least 1km. This issue should be addressed as a matter of urgency, with a fenced, stone lined crossing constructed across the river.

Unlined chalk bedded cattle crossing

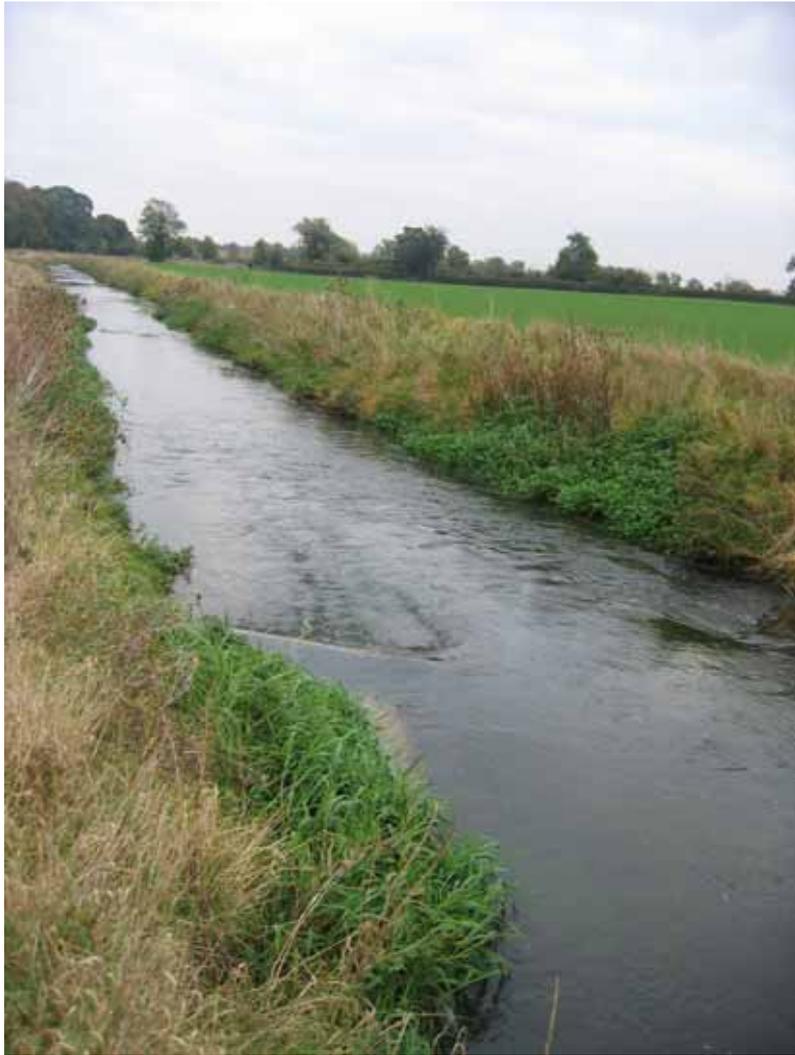
Upstream facing 'v' groynes
