River Alham – Albion's Vale

An advisory visit carried out by the Wild Trout Trust – December 2009

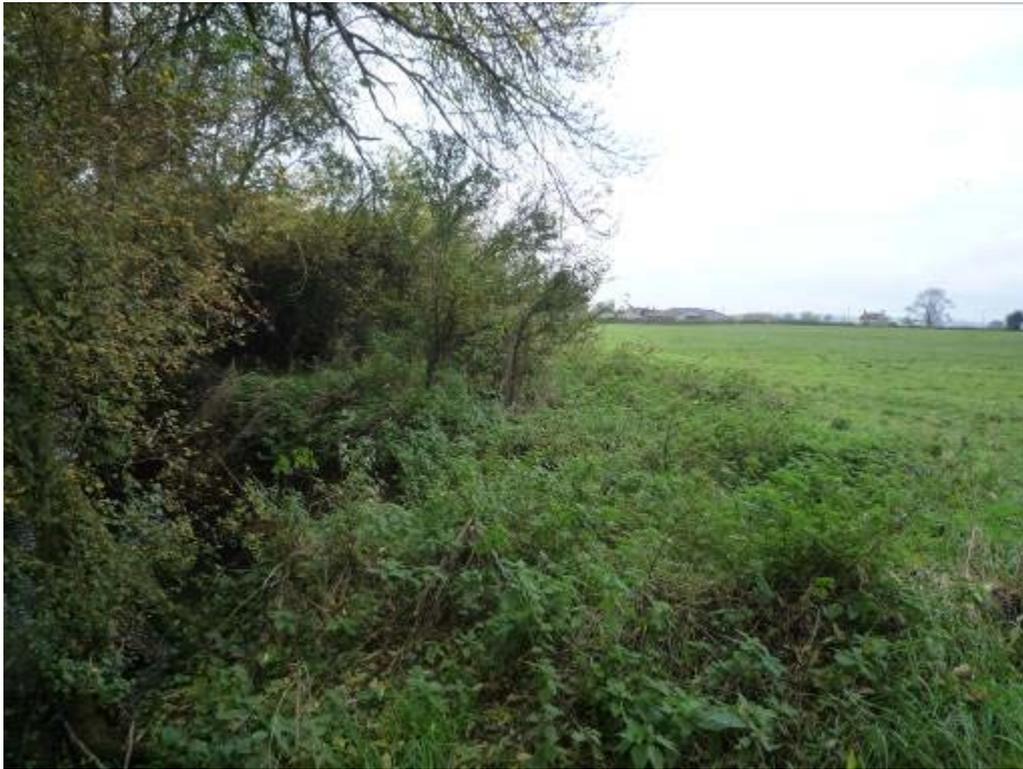
A nice thick buffer zone keeping livestock well away from the river margin

Some measures to protect the river from grazing livestock are already in place on the top meadow. These actions are particularly beneficial to spawning and nursery areas near the top of the fishery. Some consideration should be given to extending the protection through permanent or temporary fencing on the lower

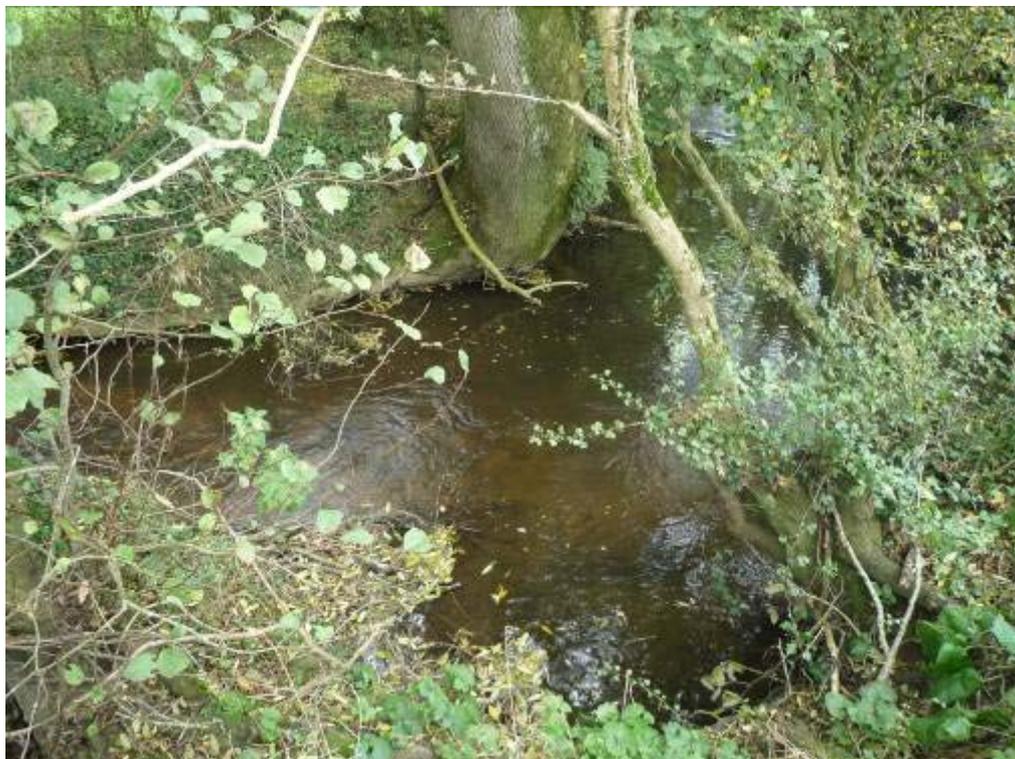
Typical small pool below the root system of a marginal ash tree – good holding water for adult trout.

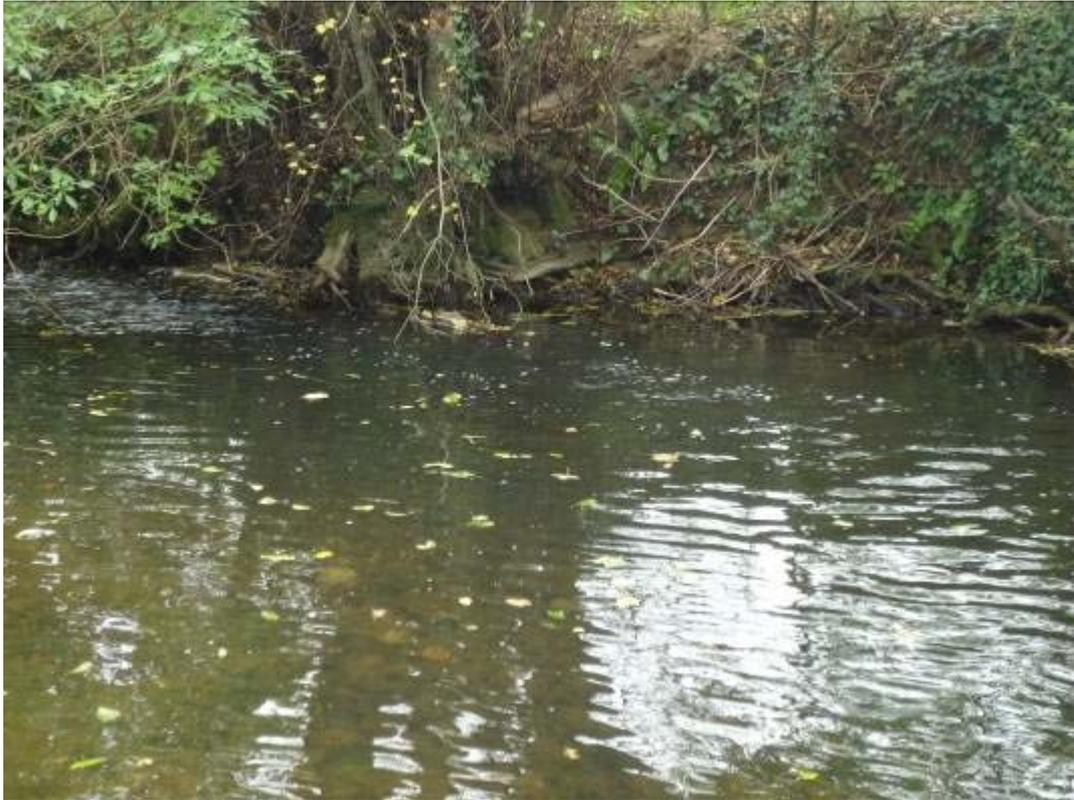
Another great holding pool near the top boundary

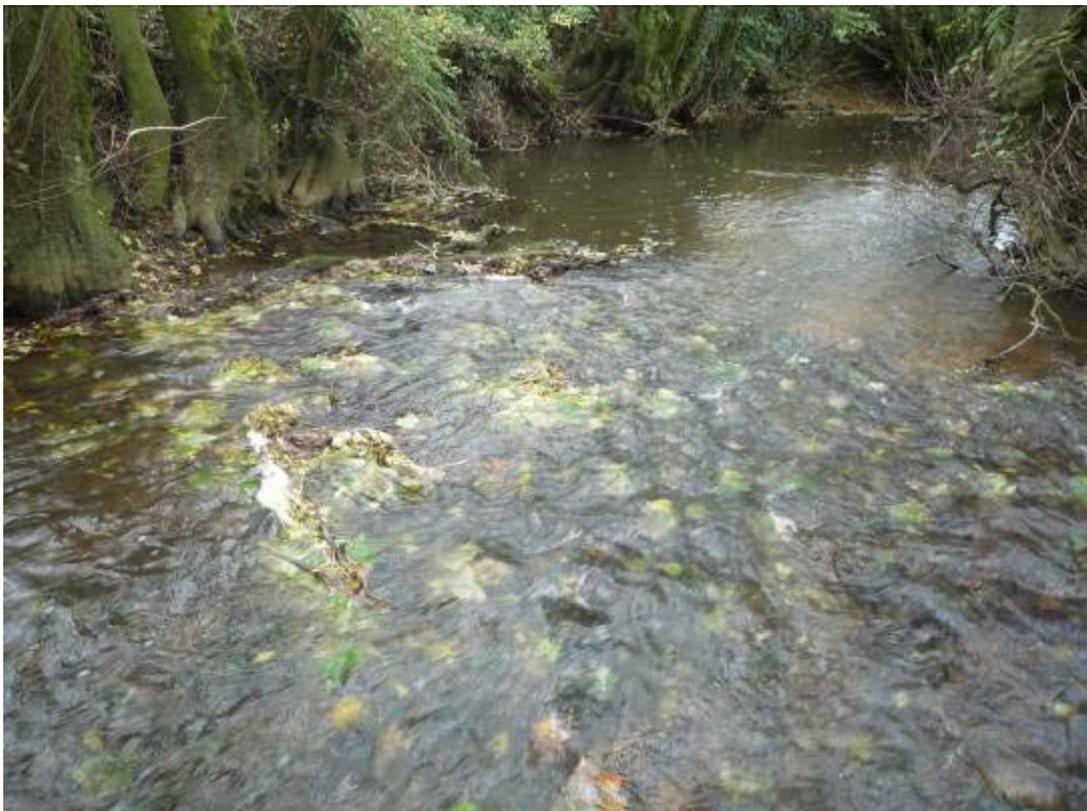
A shallow riffle supporting good juvenile trout habitat

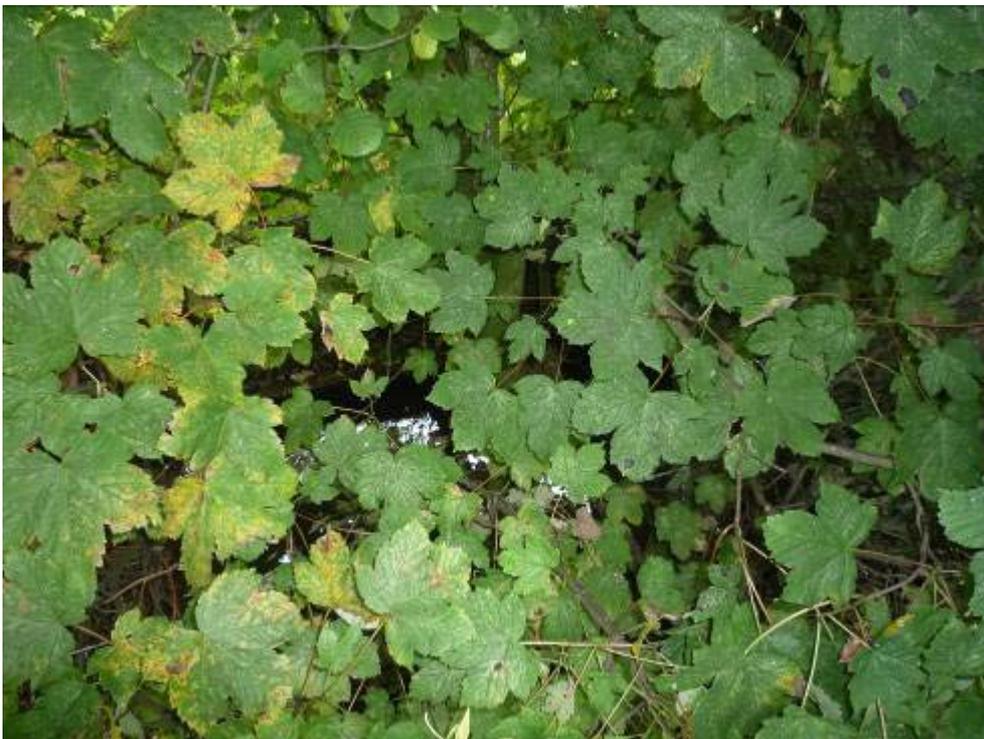
Channel shading on this top section is quite heavy. The ideal situation on a small stream is to have approximately 60% shade to 40% light, creating a dappled mosaic effect. This has to be taken in context with the section of stream as a whole. Some of the reaches further down were much less shaded so overall the level of canopy cover was not excessive. Some thinning of sycamore saplings on this top stretch would allow valuable shafts of light to penetrate to the river bed and could help to boost in-channel invertebrate densities.

[Some light thinning of marginal sycamore saplings may help to boost productivity](#)

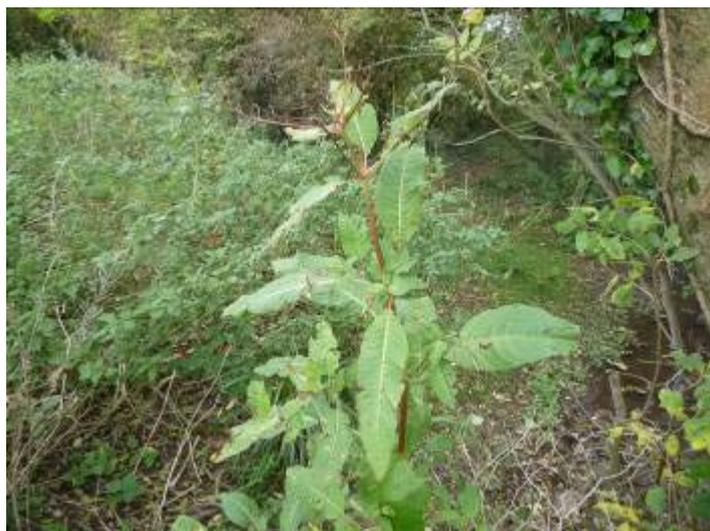
At one or two locations there was evidence of the non-native plant Himalayan balsam (*Impatiens glandulifera*). This plant is undesirable because its

suppression of other vegetation, coupled with its winter die back, combine to leave extensive areas of bare bank, contributing to excessive erosion.

Himalayan balsam is an undesirable non native plant

The control of Himalayan balsam can be achieved by physical or chemical means:

The main method of control, and usually the most appropriate, is pulling or cutting plants before they flower and set seed (usually in June or July). Working parties are the best means of doing this.

Limited grazing access appears to be controlling balsam in some sections of the fishery. This could be continued, but needs to be carefully controlled and balanced with preventing overgrazing of desirable species, damage to coppice re-growth or damage to river banks. Access in late spring or early summer before the balsam has flowered would be ideal. In areas inaccessible to livestock, physical or chemical control is recommended.

Himalayan balsam can be controlled with a weedkiller based on glyphosate, such as Roundup. Glyphosate is a non-selective, systemic weedkiller that is applied to the foliage. It is inactivated on contact with the soil, so there is no risk of damage to the roots of nearby plants, but care must be taken that the spray doesn't drift onto their foliage. Glyphosate is most effective when weed growth is vigorous. This usually occurs at flowering stage but before die-back begins; with most weeds, this is not earlier than mid-summer.

Tackling the Himalayan balsam is well worth the effort. Some help with volunteer resources to pull the plant may be available via the Somerset Wildlife Trust or possibly the West Country Rivers Trust.

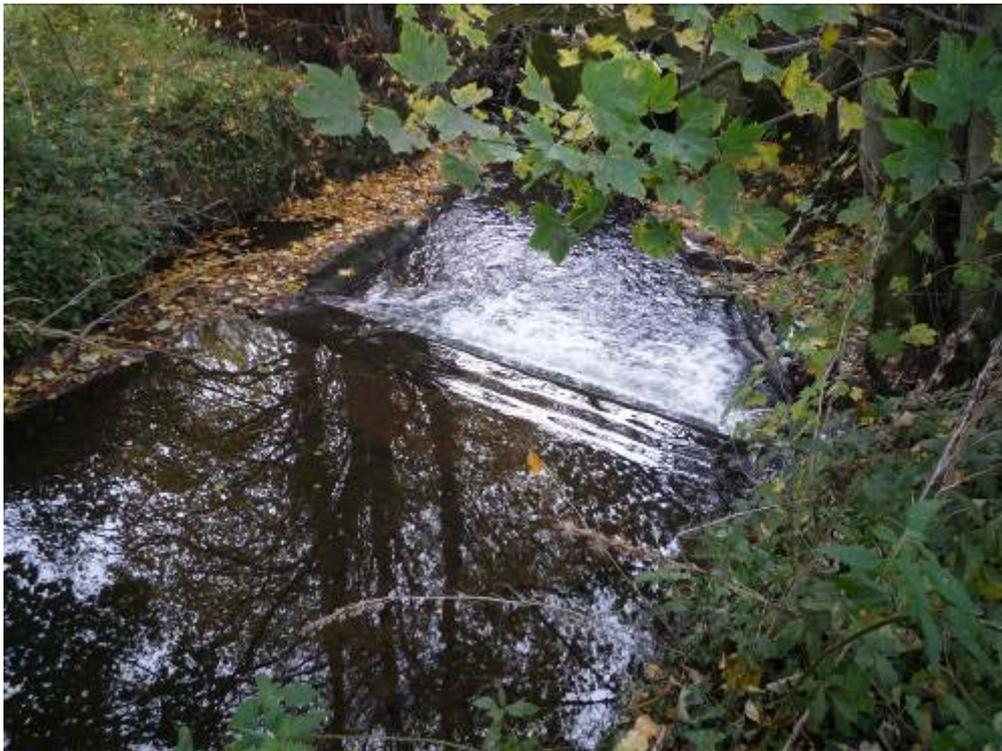
Towards the lower end of the top reach was a low block stone weir. It is unlikely that this weir fragments trout populations, as under high flow conditions adult trout should be able to negotiate the structure. The weir could, however, limit the upstream movement of juvenile trout and of important species such as the bullhead (*Cottus gobio*). A very simple enhancement would be to remove one or two of the central blocks to reduce the head loss and create a solid flume of water through the centre of the structure. This will also have the effect of increasing the upstream water velocities which will benefit trout habitat.

Small weir which could be improved by notching out the central section.

- Consider removing one or two central blocks from the small weir located in the top meadow.
- Control the invasive Himalayan balsam through pulling or spraying.
- Continue the sympathetic management practice of leaving fallen timber in the stream wherever possible.
- Thin out some clumps of sycamore saplings to promote a little more light for the channel.
- Explore the options for improving fish passage through the two large impoundments on the lower section of the fishery. A consultation with the EA is strongly recommended.
- Consider signing up for some training in undertaking simple surveys as part of the Anglers Monitoring Initiative. This is an excellent initiative and will give you a much better understanding about the productivity of your stream and some indication of long term water quality performance.

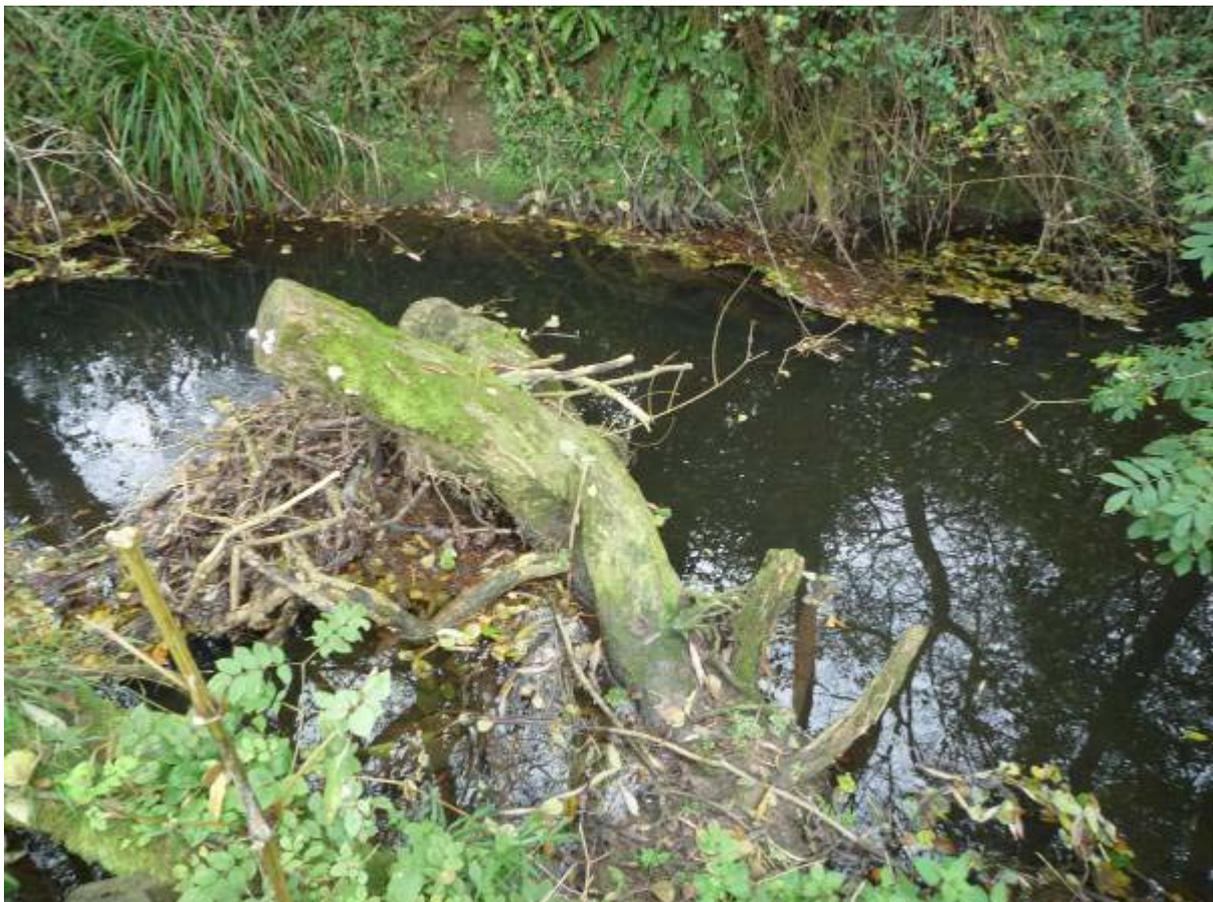
Throughout the whole reach there were good examples of habitat created by large woody debris (LWD). This type of habitat is absolutely crucial in streams such as the Alham. The presence of LWD has been shown to be extremely important in several respects:

A good example of some LWD on the Alham providing cover and promoting pool habitat immediately below.

increased flood risk at vulnerable sites downstream. However, if the material is stable and fixed to the bank it should always be left *in situ*.

Taking out the odd branch or tree limb to facilitate a cast here and there and encouraging further debris dams to form in areas of shallow glide will provide enough habitats to sustain a good trout population and facilitate just enough access for some occasional fishing.

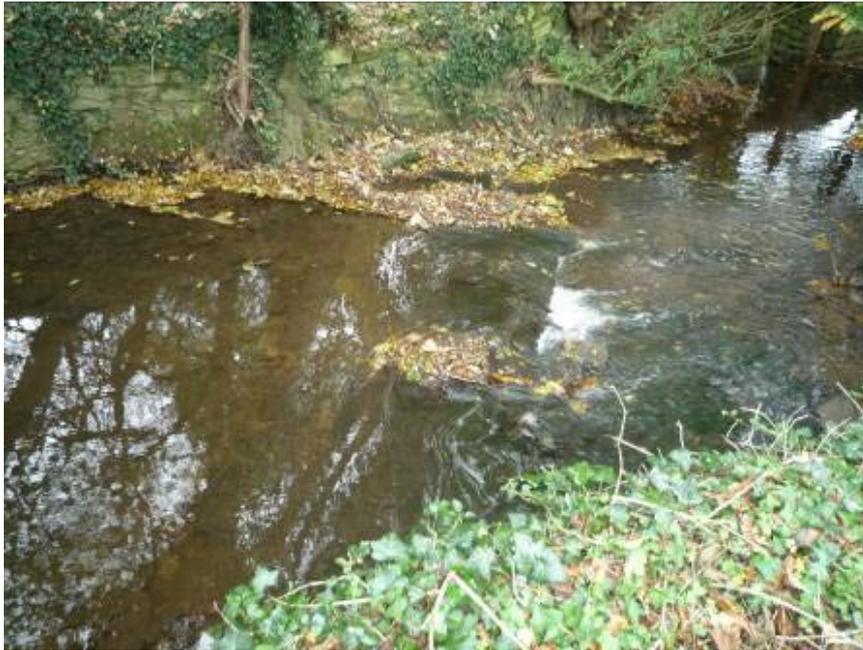
In the meadow below Milton Bridge the river forms a long slow glide. This is due to the impounding influence of a structure a short distance upstream of the main milling impoundment, which is adjacent to the old silk mill. The purpose of this upstream structure is unclear, but the angled stone blocks may be there to protect an old pipe or culvert running under the stream bed. With any such structure, care must be taken to understand exactly what purpose it serves and what, if anything lies beneath.

Angled impoundment a short distance upstream of the main silk Mill.

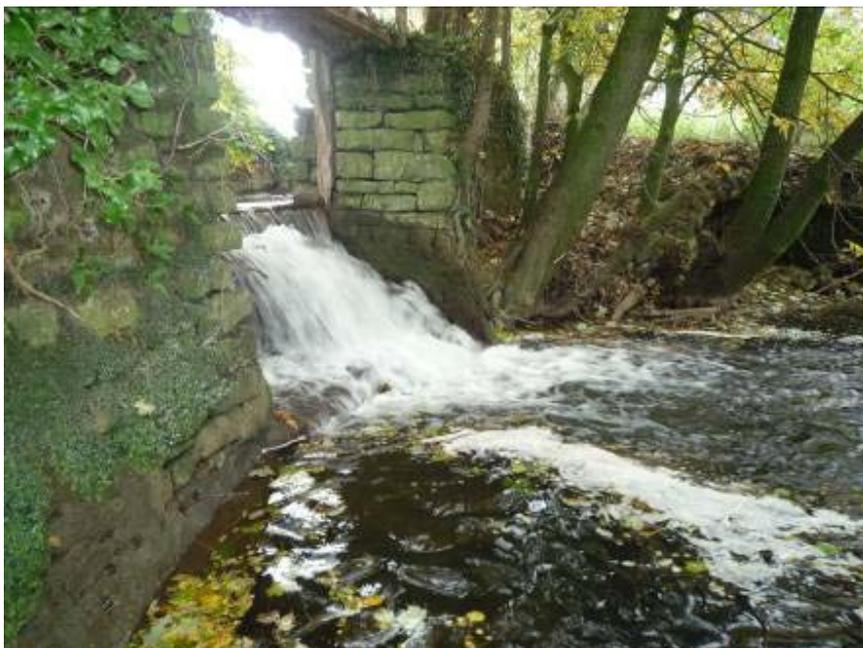
The main Silk Mill impoundment. This structure will fragment fish populations

The main silk Mill impoundment is a very old structure with significant industrial archaeological significance. Unfortunately the structure will be restricting upstream migration for all but the fittest and determined trout. On many rivers and streams where such structures exist, the Environment Agency has identified a list of prioritised actions to enable fish to freely migrate through the system. Unfortunately, constructing easements or fish passes on structures is extremely costly and very often resources are only allocated to those rivers with a known, or potential run of migratory salmonids. To my knowledge, this would not apply to the Alham. Creating a bypass channel or reducing the head loss by installing a pre barrage might be options worth exploring with the EA, but work of this nature is specialised and will require detailed planning and significant resources.

The large impounding structures on the lower half of the stretch have a severe impact on habitat quality and will be restricting access for upstream spawning migrations. Flagging up these sites with the EA as possible future sites requiring attention is recommended. If resource were to be made available a scoping study to explore options, feasibility and possible costs would be the first step.
