## River Avon – Yeo Farm, Loddiswell

An advisory visit carried out by the Wild Trout Trust – April 2009

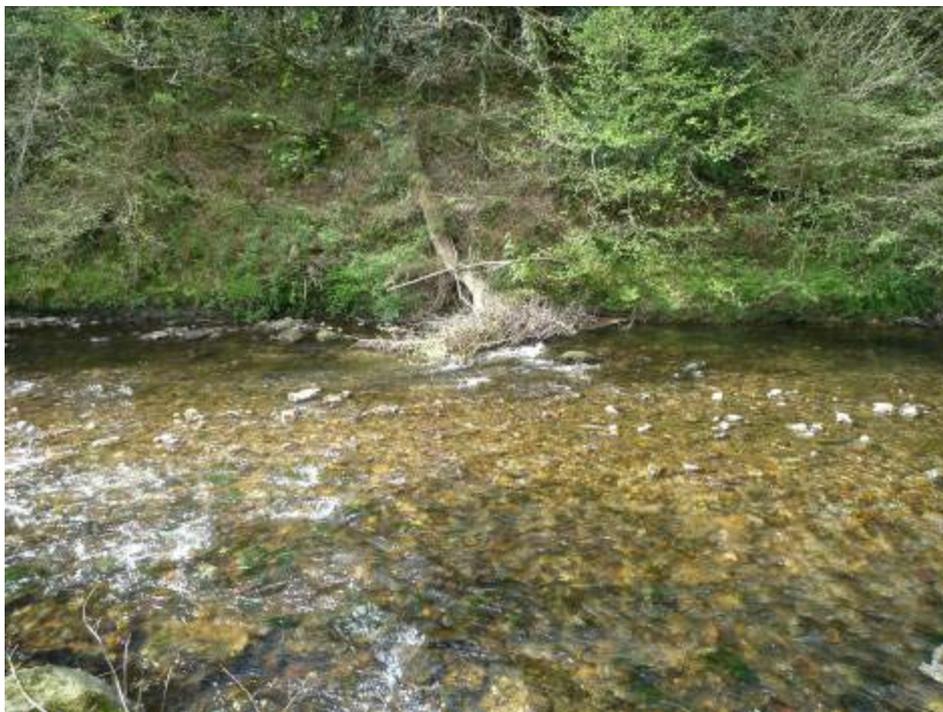
[A good example of some LWD providing excellent marginal cover](#)

Before discussing options for creating better quality habitats using LWD it will be important to ensure that existing pieces that are currently in the channel are not removed. Keeping LWD secure in a spate river can be a challenge. It is however surprising how some pieces that are attached to the bank by old root systems can remain quite stable for many years. The wood often acts as a flow deflector and has the ability to scour pools and develop runs (for fish improved holding), and also blow out fresh gravels into bars (ideal for spawning). Fallen trees and wood are therefore a vital component of in-channel habitat as well as for the riparian zones.

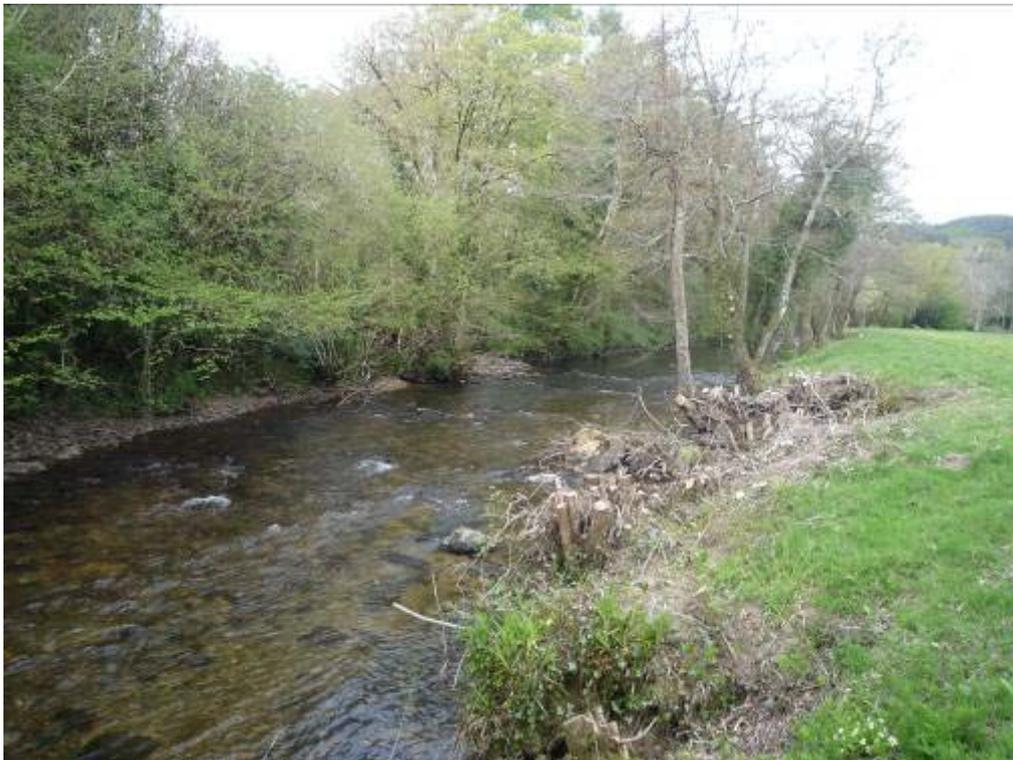
An area near the bottom of the beat where some coppicing has been carried out. It may be possible to "hinge" some trees into the channel to create secure flow deflectors on the heavily shaded upstream beat

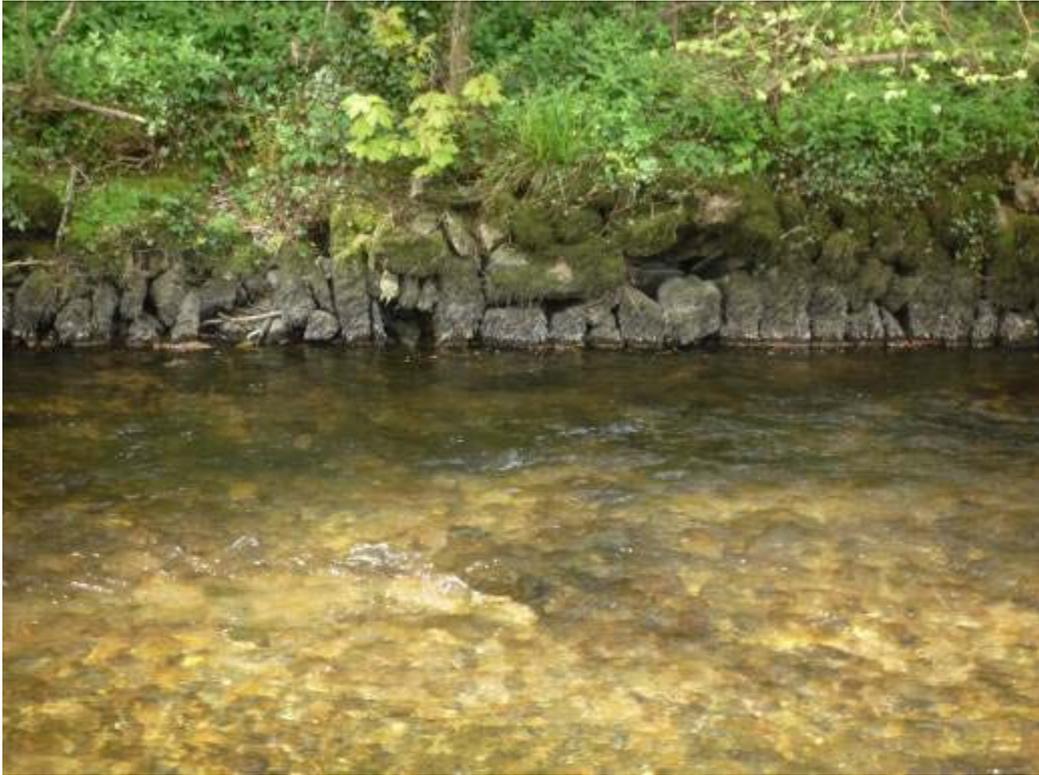
Large stones used to protect the RB from excessive erosion. Some low scrubby cover provided by a small goat willow would soften its appearance and enhance its fish holding capability

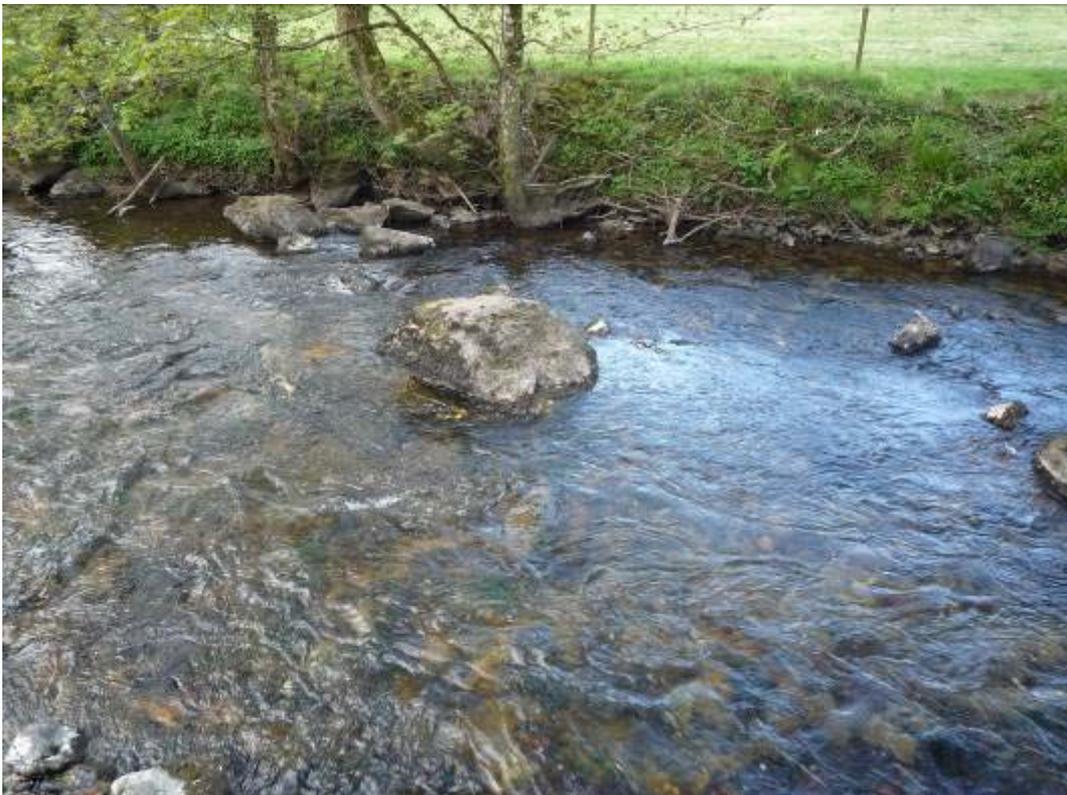
Large stones on a shallow riffle can provide a good holding spot for adults.

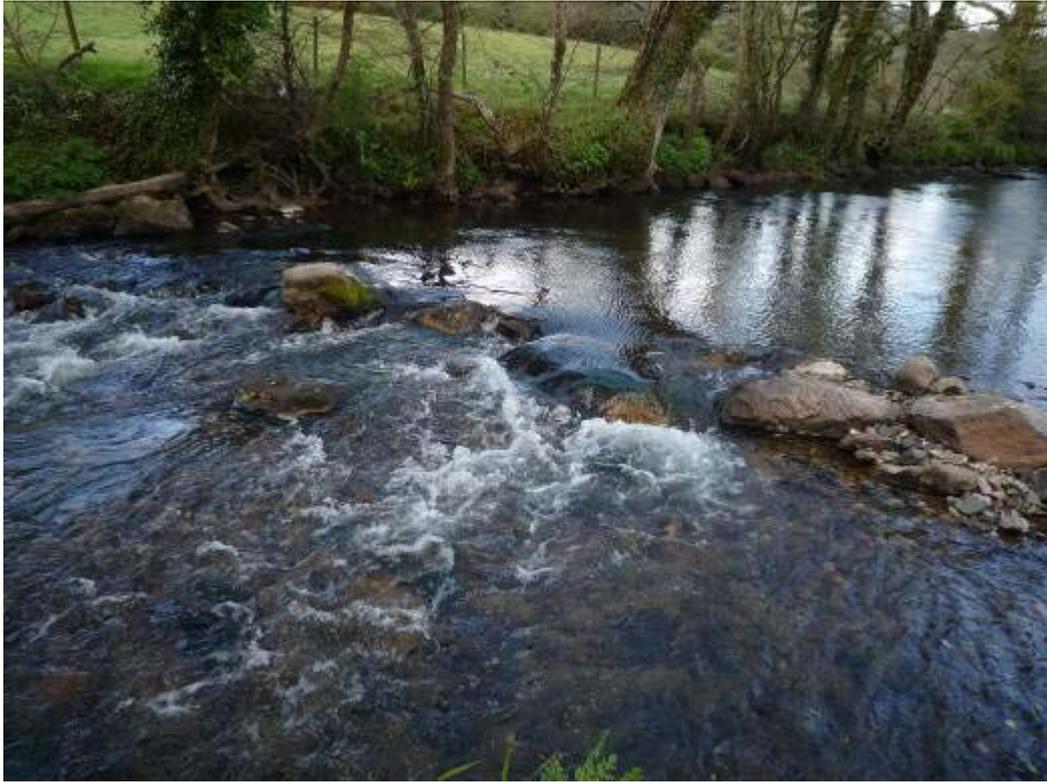
Large stones configured to create a weir and impound water. Not a barrier to fish migration but no great benefit in habitat quality

Better quality pool habitats are usually created by promoting downward river bed scour rather than holding the water back with any form of impoundment. Pools that form naturally are often kick started by a fallen tree where the flow hits the underside of the trunk and is forced downwards. Even after the tree has disappeared pools can remain very stable for many years. Raising the water level through impoundments can often result in sterile laminar flows upstream of the impoundment: much poorer habitat for adult salmonid fish than a naturally scoured pool. Promoting improved holding water with large fallen trees may well help to promote better quality pool habitats, particularly on the upper reaches of the beat. Where more than one tree has fallen into the channel it should be remembered that pool habitats rarely form too close to one another. As a general guiding principle, a decent pool will only form at a distance of approximately 5 to 7 multiplied by the average channel width. So if your average channel width is say 10m, then you would not generally expect a pool to develop within approximately 60m..

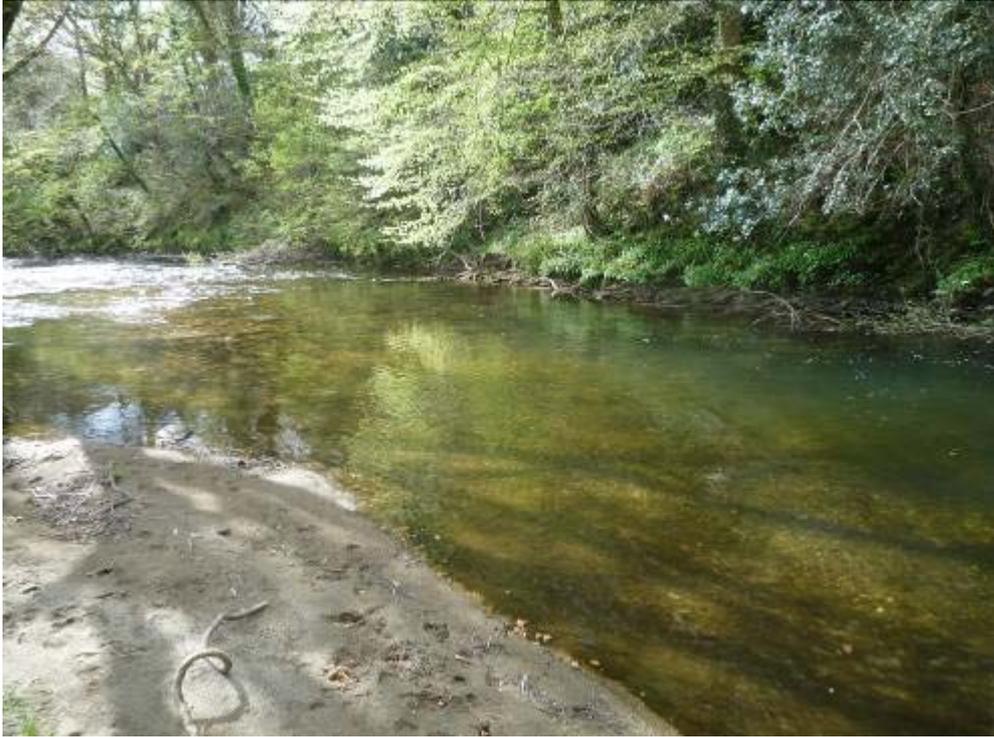
The tail of a superb naturally formed pool. A great lying up spot for sea trout and salmon. Some overhanging shade is an essential component of good quality pool habitat.

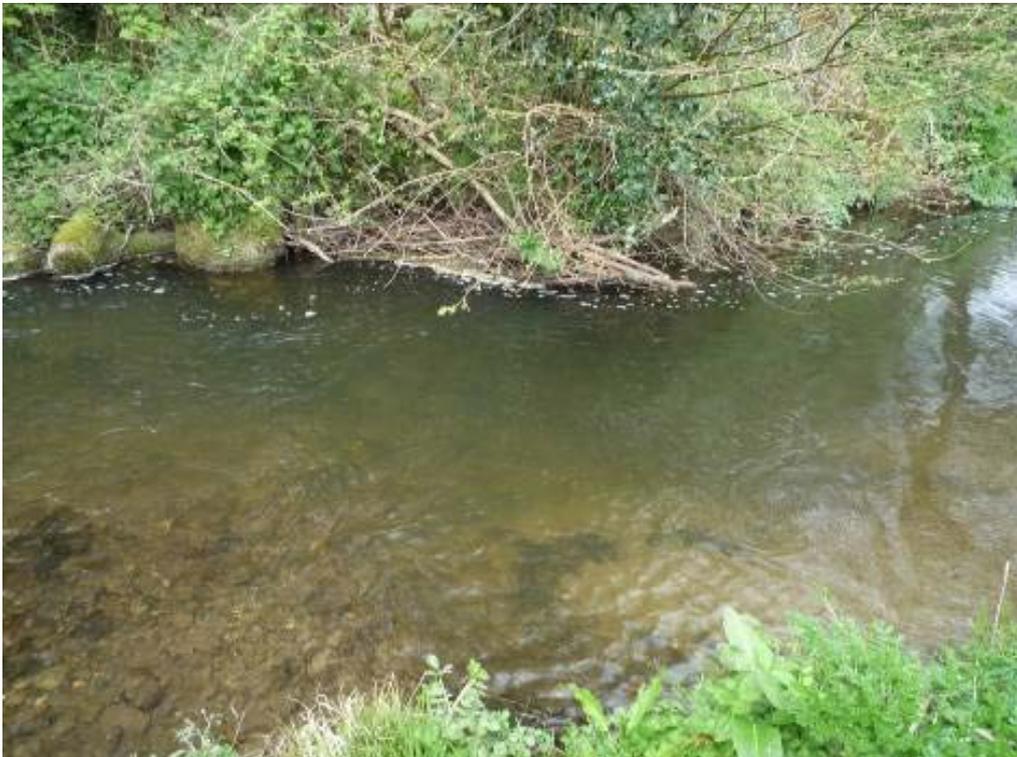
A good example of a small West country river where an old fallen tree has created a great pool.

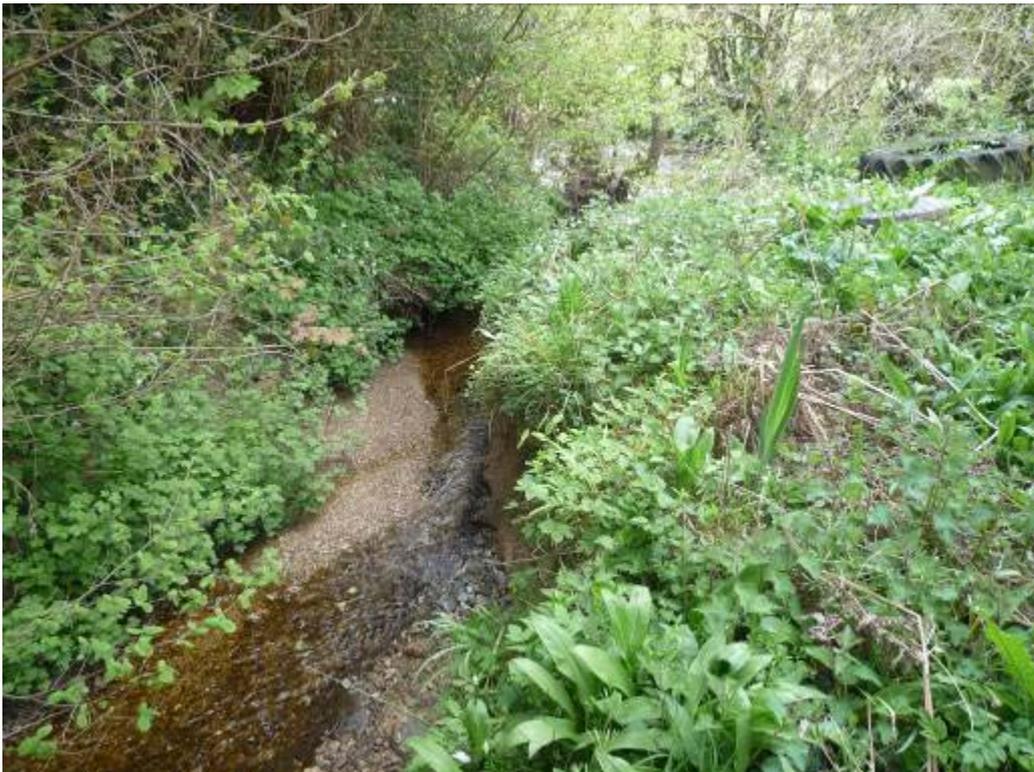
Near to the bottom boundary a small stream joins the main river on the LB. These small side streams are usually critically important spawning and nursery habitats on spate river systems and care should be taken to ensure that water and habitat quality is protected. These streams require good amounts of both LWD to help sort spawning gravels and CWD (Coarse Woody Debris) to provide overhead protection from predators. If debris dams build up they should not be removed unless they are considered to be a blockage to upstream migration. This is unusual as there are normally small undercuts and gaps where fish can find a way through.

Small stream entering the river just above Topsham bridge. Potentially a critically important habitat for spawning and juvenile trout.

Care must be taken when carrying out any maintenance on the small side stream. LWD should be left within the channel and if necessary woody brushings placed over the shallow riffle areas to protect fry from predation. If debris dams form they should be regularly checked, particularly from October through to January to ensure that migrating adult fish can still make progress upstream. The banks and marginal zones should be left scruffy and do not tempted to tidy up the channel or trim the margins.

- Keep a close eye on the side stream in the autumn to ensure that fish can gain access to spawning areas. Do not maintain the stream as an open drainage channel but allow woody debris to form and a scrubby margin to develop.
