## River Beane – Beane Valley Fishery

An advisory visit carried out by the Wild Trout Trust – December 2009

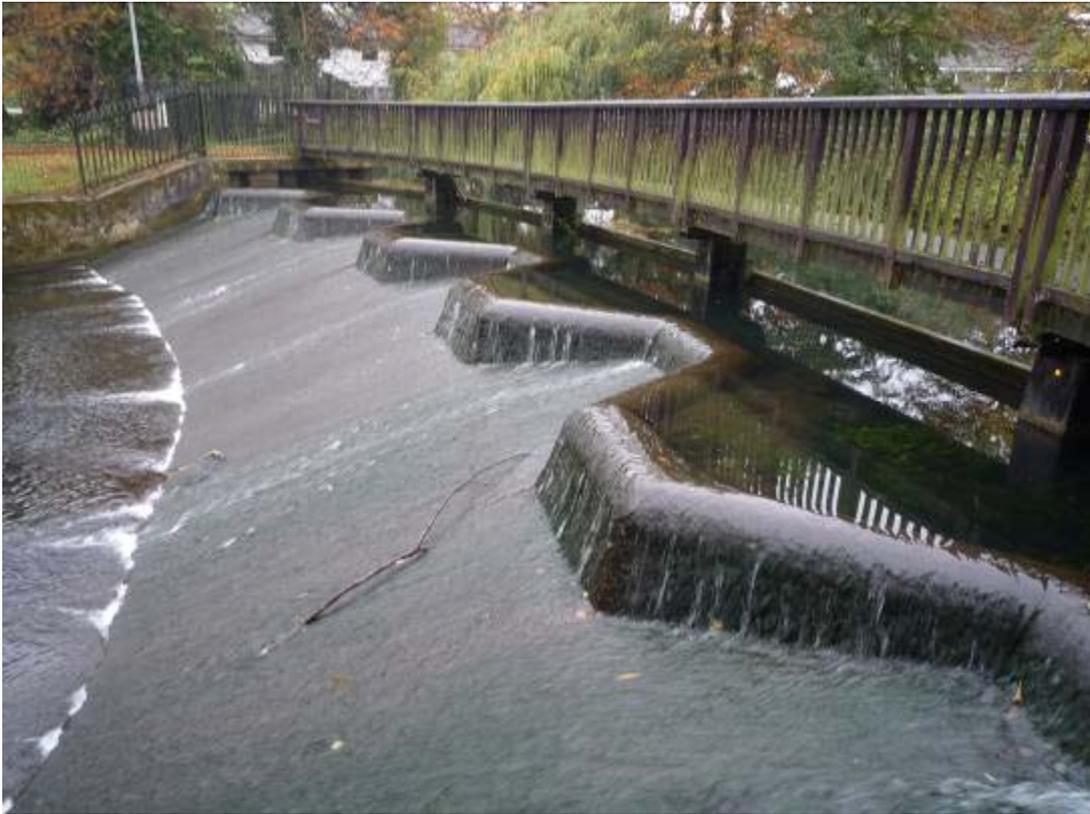
The huge fixed crest labyrinth weir downstream of the bottom boundary.

This weir is a very large and heavily engineered structure that is fragmenting species movement within the Beane system and severely restricting the formation of any natural morphology in the river upstream of the weir. The River Beane is defined as a heavily modified water body under the Water Framework Directive, as evidenced by structures such as this weir. Removal of this and similar structures is required if the river is to achieve the Directive's target of 'good ecological condition'. This will require substantial investment and political will and may be deemed uneconomic. No specific mention of removal of this weir is mentioned in the draft Thames River Basin Management plan ([www.environment-agency.gov.uk/research/planning/33106.aspx](http://www.environment-agency.gov.uk/research/planning/33106.aspx))

It is understood that the weir was designed to provide a head of water for Sele Mill. Sele Mill lies on a parallel channel and was the first paper mill in this country. The site has now been redeveloped as a residential property. The owners of Beane Valley Fishery have recently been consulted over a request to use part of their land as a flood storage area to compensate for a reduction in channel capacity at the Sele Mill Syphon. This would appear to be a positive move from an ecological point of view.

An even more positive move would be to reduce the height of the weir, and so reduce the 'drowning' effect of the impoundment. This would encourage better quality habitats to develop further upstream. A combination of reducing the head loss of the weir and raising the height of the bed upstream could reconnect the river with the flood plain and would seem to be the ideal solution for improving the river ecology as well as reducing local flood risk.

- Lobby the EA over plans for dealing with the impounding structure downstream. There are potentially huge environmental benefits associated with removing or lowering this impoundment. This work coupled with some reduction in water depth by raising the bed could reconnect the river with the flood plain and create habitat for flow loving plants and fish.

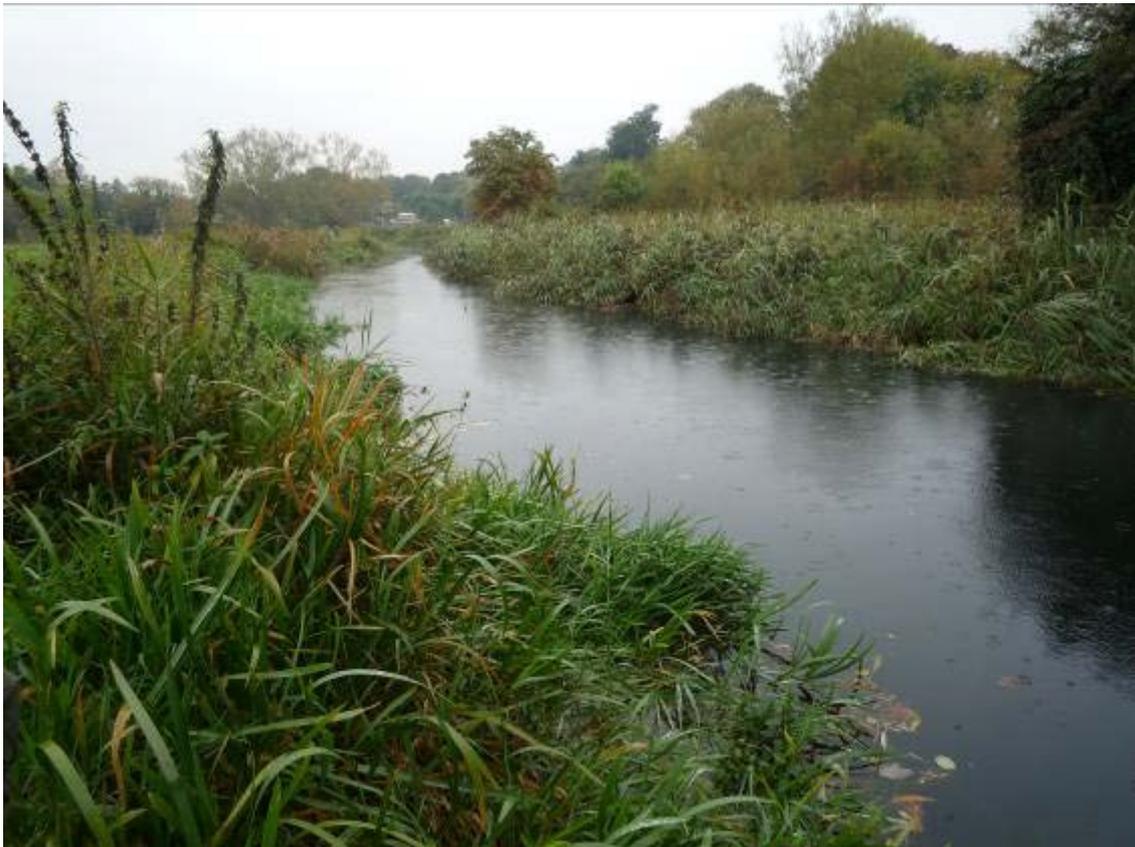
A typical section of the Beane Valley Fishery. A deep, wide channel with slow laminar flows

On some sections there were a few overhanging willow trees but most of the available cover was from the marginal beds of emergent plants. It was not possible to get an accurate assessment of the nature of the river bed material but it is understood that some decent gravels are present. The significant width and depth of the channel and low water velocity is not conducive to encouraging classic chalkstream plants such as water crowfoot (*Ranunculus spp*) to develop. As a consequence, classic lies for adult trout are scarce and only exist where there is either some over-head cover, or on the few sections where some tree trunk flow deflectors have been installed. The lack of any shallow, fast flowing sections over clean, loose gravel means that there is currently no scope for wild trout spawning or nursery habitat. Some wild fish will inevitably drop down from

shallow habitats upstream and providing better quality lies for these and introduced fish will be a priority. If, at any future date, the weir is lowered, then there might be scope to harness the increased water velocity to develop some local spawning habitats.

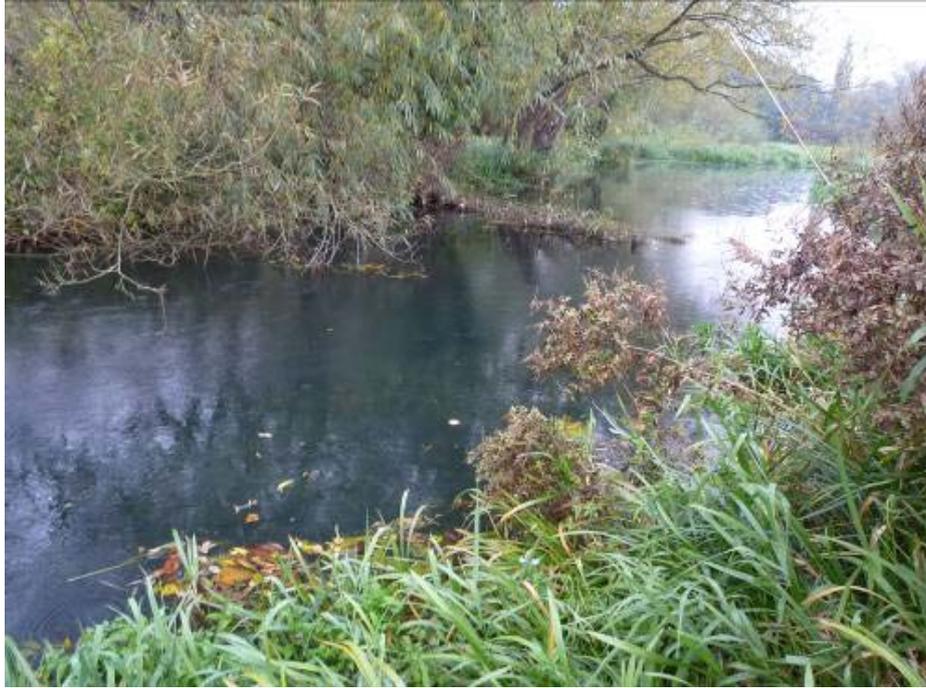
Some low, water level willow will provide some “holding” lies for adult trout

Where low, scrubby willow (sallows) exist, these should be managed to maintain overhead cover for trout by retaining low level branches trailing into the river. Planting of some additional sallows, particularly on the LB towards the bottom of the fishery, would enhance the available cover for adult trout and give some protection from predators.

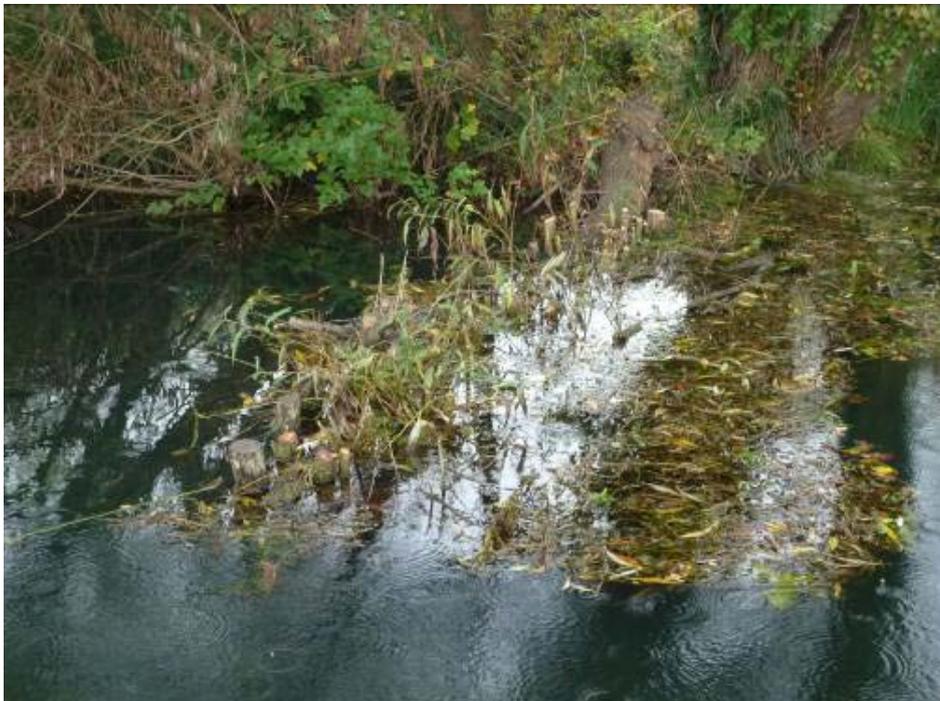
A willow log pegged into the channel providing some local cover and some slightly elevated water velocities

This technique can also be used with cut LWD material, which can be pegged into the channel and will promote local bed scour and cover for fish. LWD

material must be securely fixed as there is a risk that it can break away in high flow conditions and cause an obstruction further downstream.

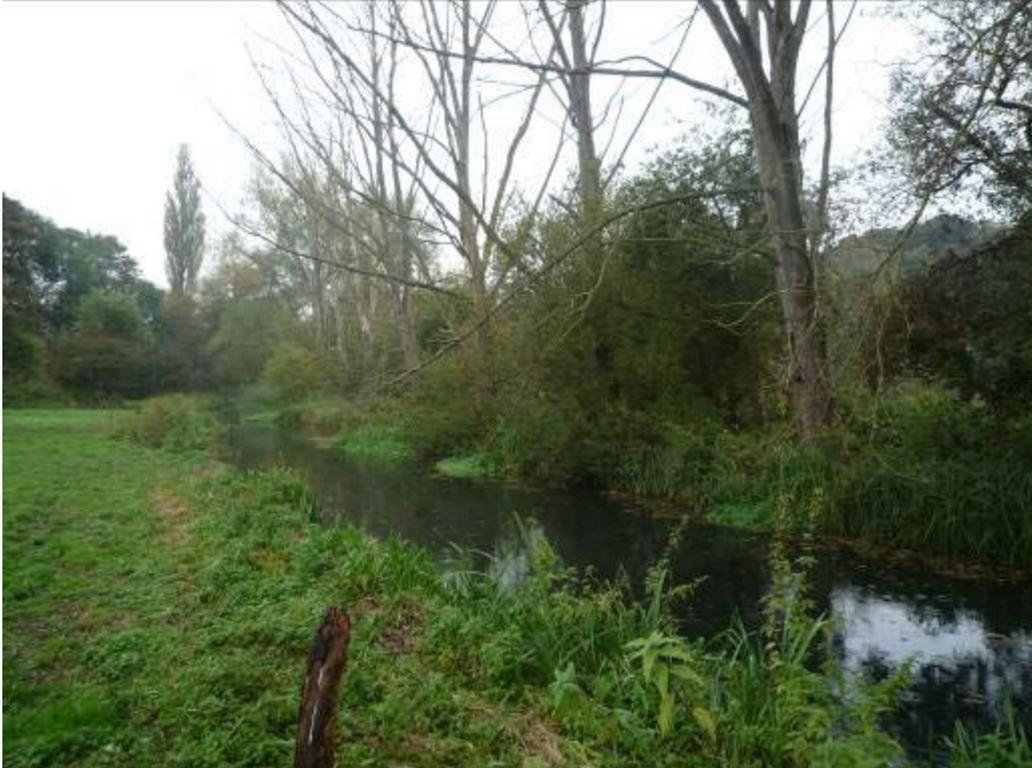
Some of the mature poplars on LB could be topped and hinged into the channel

Further upstream the fishery reverts to single bank (RB). On the opposite LB there is a line of mature cricket bat willows. A potential enhancement could be achieved by hinging and securing two or three of these trees into the channel to help kick the flows around and provide some much needed in-channel structure.

In the interim, a comparatively cheap and simple way of improving the holding capacity of the fishery is via the use of large woody debris flow (LWD) deflectors. Some log flow deflectors have already been installed but perhaps the best results could be achieved through "whole tree" hinging. This technique is possible on mature marginal trees, particularly willow, where the trunk can be sliced down at the rear and the tree winched over into position. The trunk and any large branches can then be secured to the river bed using stakes and wire or they can be bored out using a wood auger and secured using sections of steel reinforcing bar. Provided the tree is still attached to its root system it will remain alive and secure. A complex structure like this will collect substantial amounts of sediment and provide excellent refuge from fish eating predators, particularly cormorants.
