River Coln – The Bull Water at Fairford

An advisory visit carried out by the Wild Trout Trust – November 2008

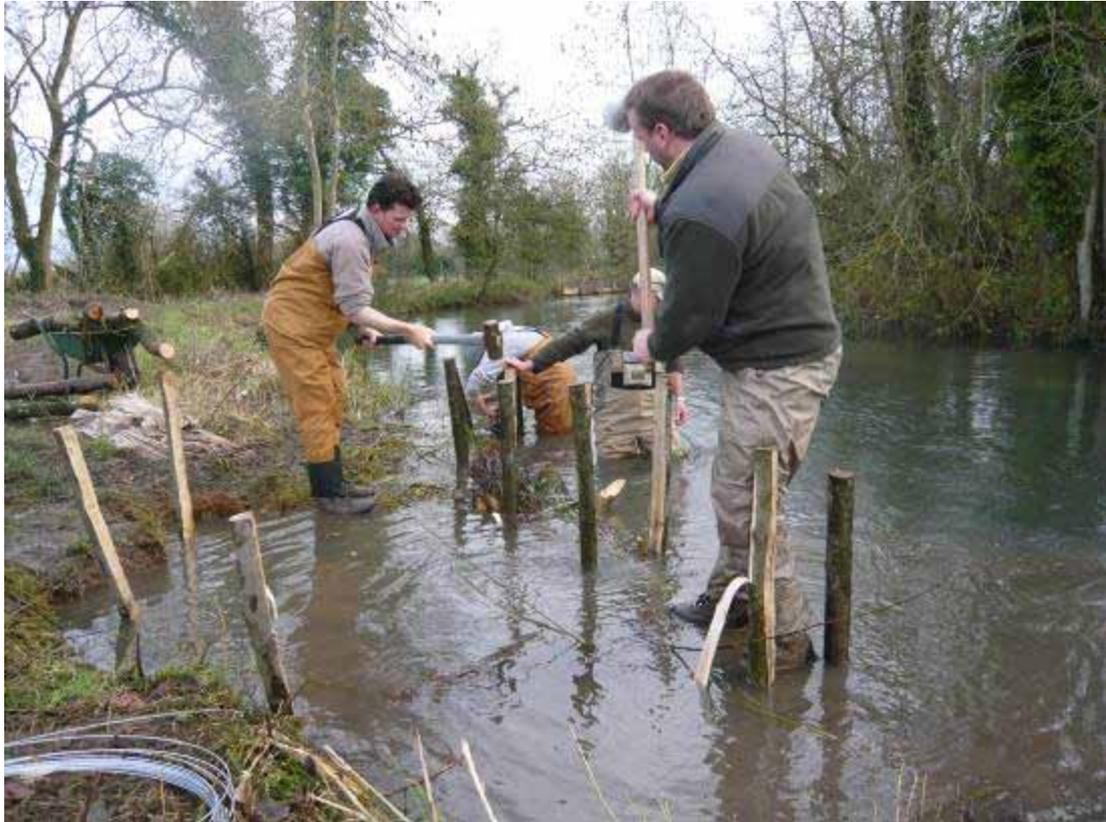
Members of the Bull fishing group get to work combating marginal erosion during the WTT Practical Visit in November 2008

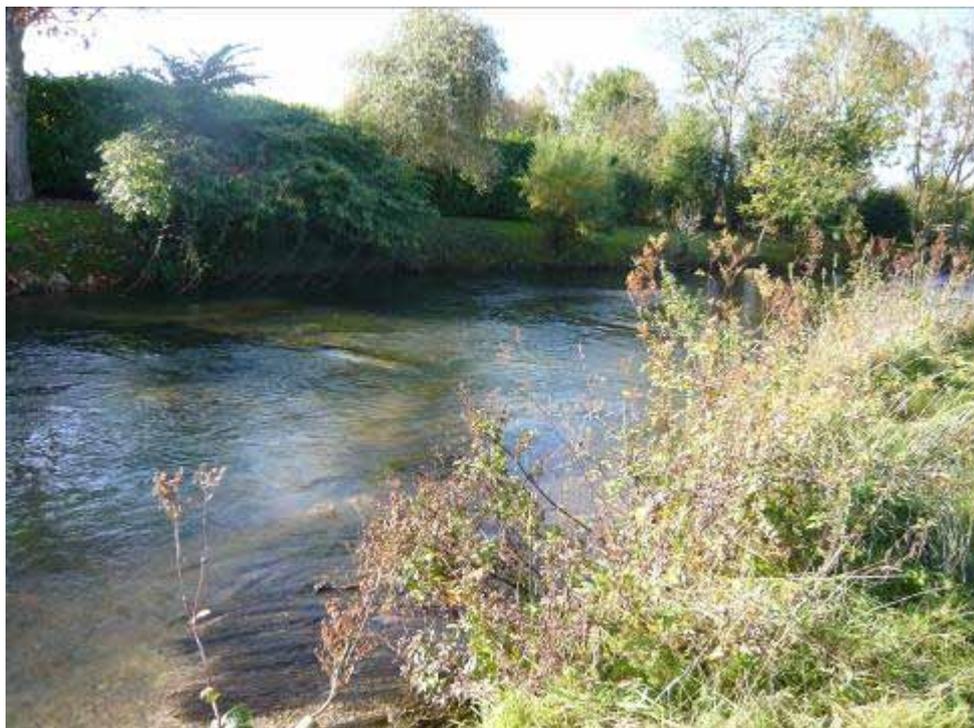
The Bull's Waters comprise approximately 2 km of single LB fishing running downstream from the village of Fairford. The top 500m of the water backs onto formal gardens located on both LB and RB and in some sections maintenance regimes from gardens have spilled over to be extended into some marginal sections of river bank. A public footpath runs throughout the length of the fishery and is extensively used.

Raised bank and formal gardens near the top of the fishery

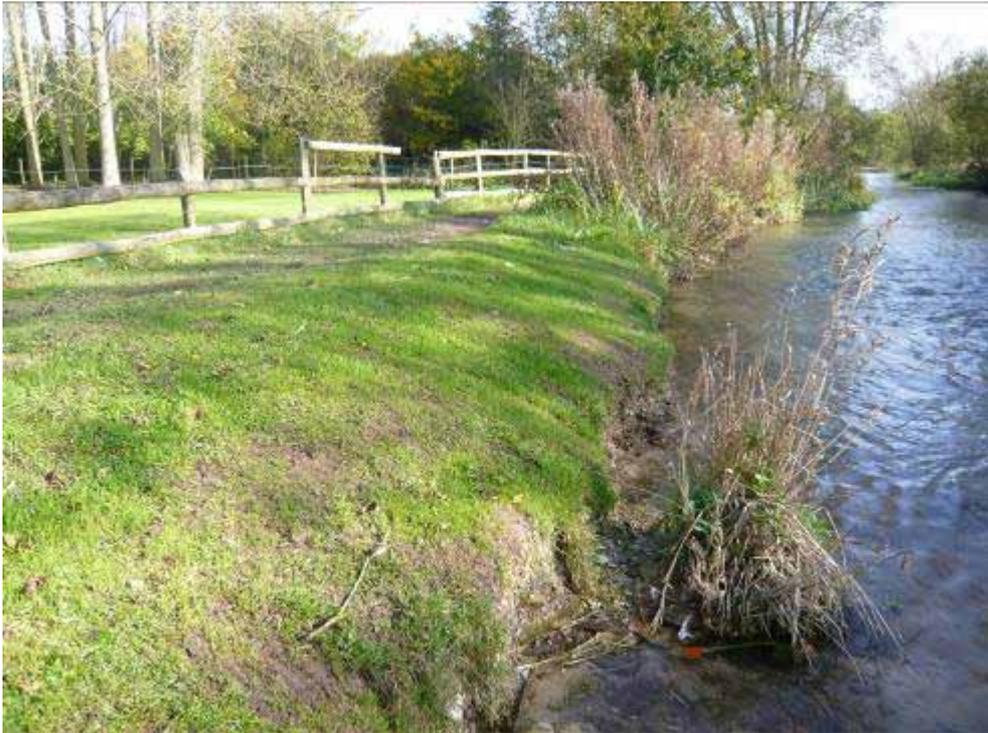
Part of the LB where riparian gardening has resulted in the loss of a natural fringe of aquatic plants and marginal herbs.

A dialogue should be maintained with local neighbours on riverside maintenance regimes. It may be pertinent to offer to take over the responsibility of managing certain marginal areas to ensure that good habitat can be preserved.

- Open up a positive dialogue with the Parish Council and local environment groups.
- Provide other riparian owners with properties backing onto your water with information on "best practice" for bank side management and maintenance.

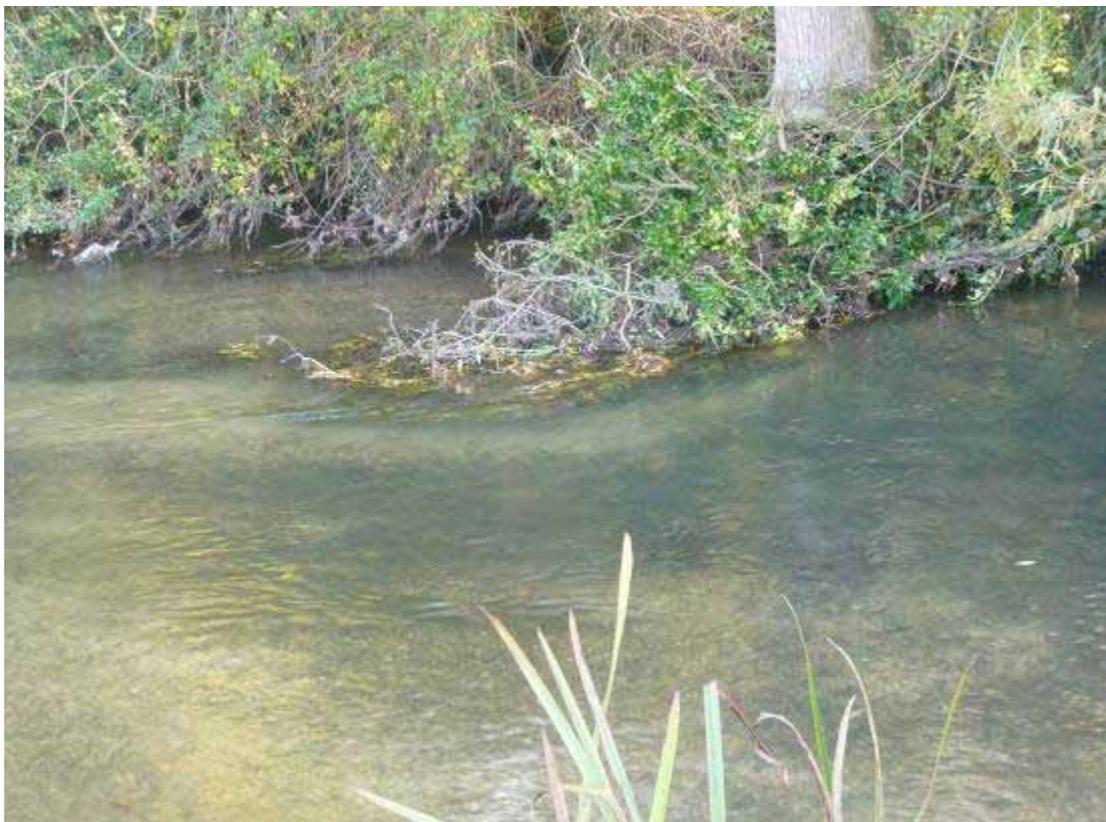
Near the lower end of the fishery, the river became less managed and there were numerous examples of fallen trees and submerged large woody debris (LWD). Many of these were acting as flow deflectors and enhancing spawning potential as well as providing cover for adult fish. Much of the river bed substrate on the Coln is comparatively poor for trout spawning, either being large chips of limestone or gravels concreted together. The river did, however, have lots of variety in depths and flow patterns, probably induced by the presence of LWD at certain times which has sculpted habitats for all life stages of brown trout. The presence of LWD has been shown to be extremely important in several respects:

A good example of a "natural" groyne which is promoting good habitat diversity.

Retaining as much LWD within the channel as possible to maintain the heterogeneous nature of the river bed is seen as a priority.

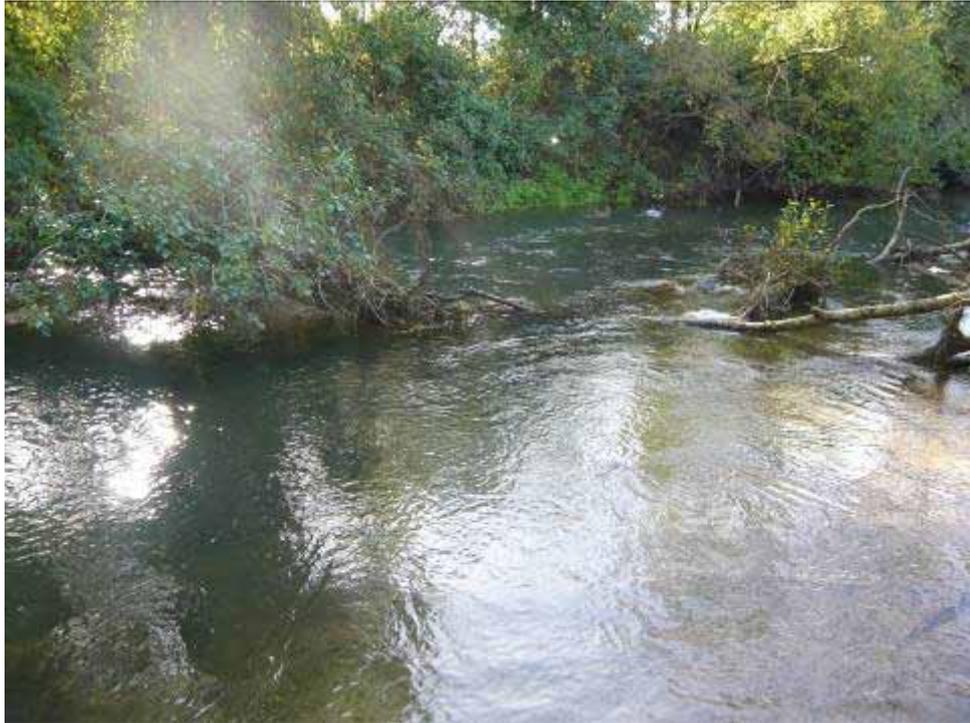
If LWD is potentially blocking the channel as in this case, it can usually be moved and secured to provide good quality habitat.

- Retain as much LWD within the channel as possible. The West Country Rivers Trust provides a useful guide to the management of natural LWD:
1. Is the debris fixed, if yes then continue to 2, if not continue to 5.
 2. Is the debris causing excess erosion by redirecting the current into a vulnerable bank? If yes then go to 5 if not then go to 3.
 3. Would fish be able to migrate past it (take into account high river flows). If yes go to 4, if no go to 5.
 4. **Retain the woody debris in the river.**
 5. **Re-position or extract the debris.**

Note: If the debris dam needs to be removed but there is still a significant amount of the root system attached to the bank then it is recommended that the stump be retained for its wildlife habitat value and its stabilising effect on the bank.

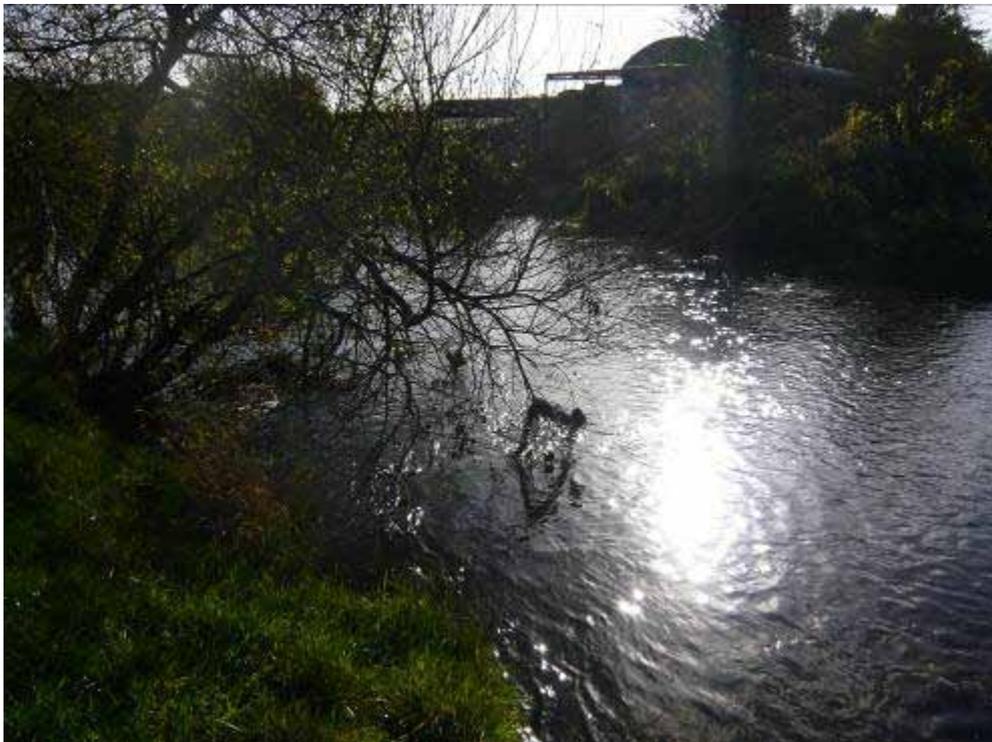
Low scrubby cover provided by marginal trees such as goat willow provides essential cover from predators, particularly in the winter period when weed growth is poor

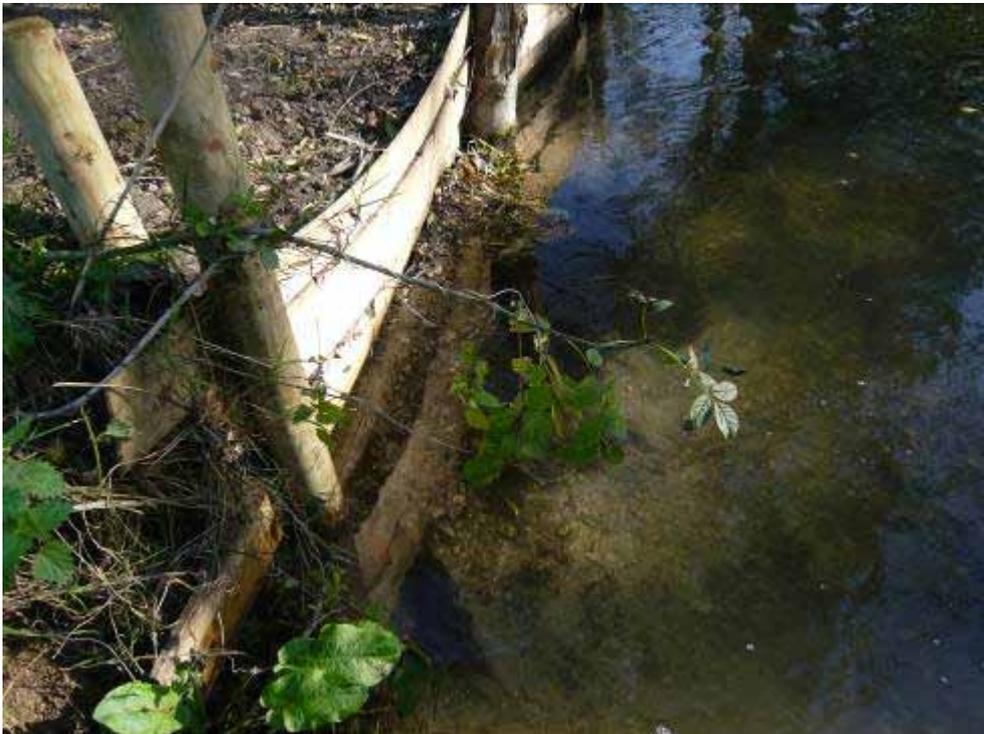
Near the bottom end of the fishery some attempts had been made to arrest erosion on the outside of a bend quite close to an adjoining side stream. Any excessive movement of the river could potentially threaten the footpath which runs between the two channels for some distance before they eventually join. The plywood revetment with soil backfilling will not provide a long term solution to this problem and is not fit for purpose.

Revetting a bank with planks of timber, or with sheets of plywood as in this case is doomed to fail.

In areas where protection of the bank is of paramount importance, it is still possible to create valuable habitat as well as give lasting protection to the banks. A strategically placed tree trunk at a 50 to 70 degree upstream angle to the bank can deflect the erosive forces of the river towards the centre of the channel and away from the bank. Creating a softer, squishy toe to the bank and planting up with marginal emergent plants can also tie the soils together and absorb some the rivers energy.

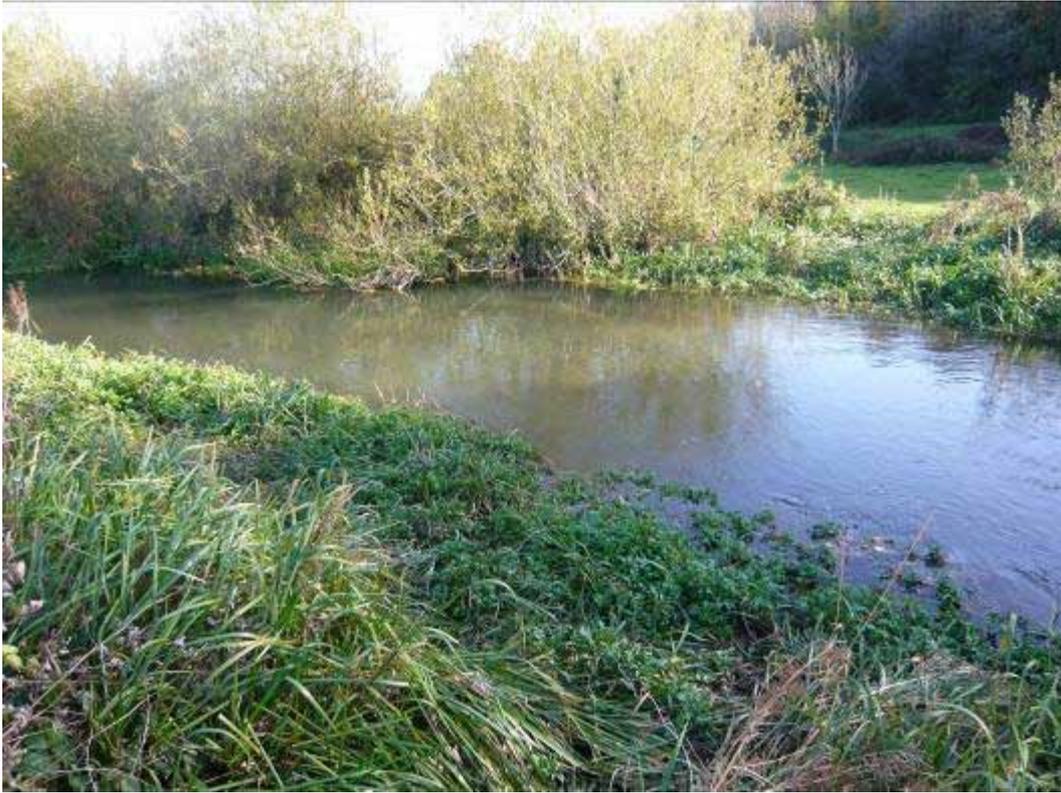
A good low, soft margin to both banks with the addition cover provided by the scrubby goat willow.
First class habitat.

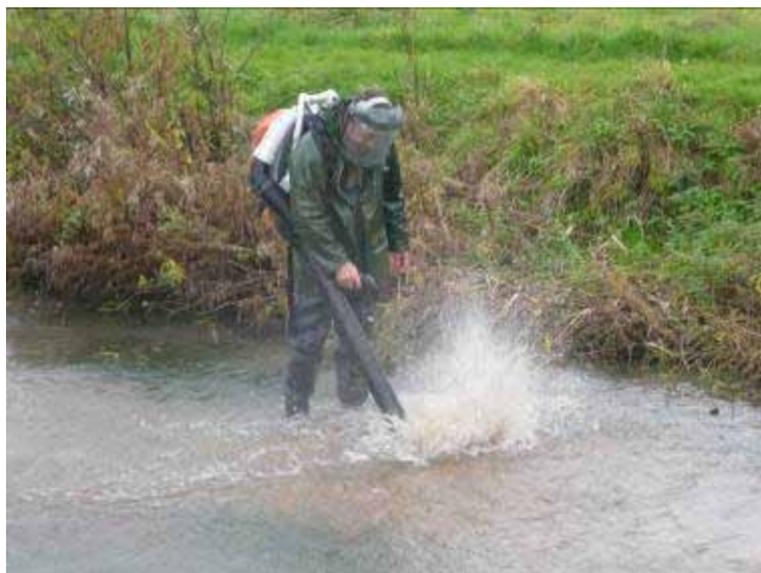
Gravel cleaning using a backpack leaf blower

Attempts should be made to enhance spawning potential both through cleaning existing spawning habitat and by potentially introducing new gravels. There are several techniques used for gravel cleaning and further advice can be found in the Chalkstream Habitat Manual.

- Retain refuge areas where fish can hold up without being disturbed by anglers.
- Instigate an autumn programme of spawning enhancements. Identify the main areas of spawning activity and during October give those areas a thorough clean using high pressure pumps or a leaf blower.
