Devils Brook - Burlesdon

An advisory visit carried out by the Wild Trout Trust – November 2010

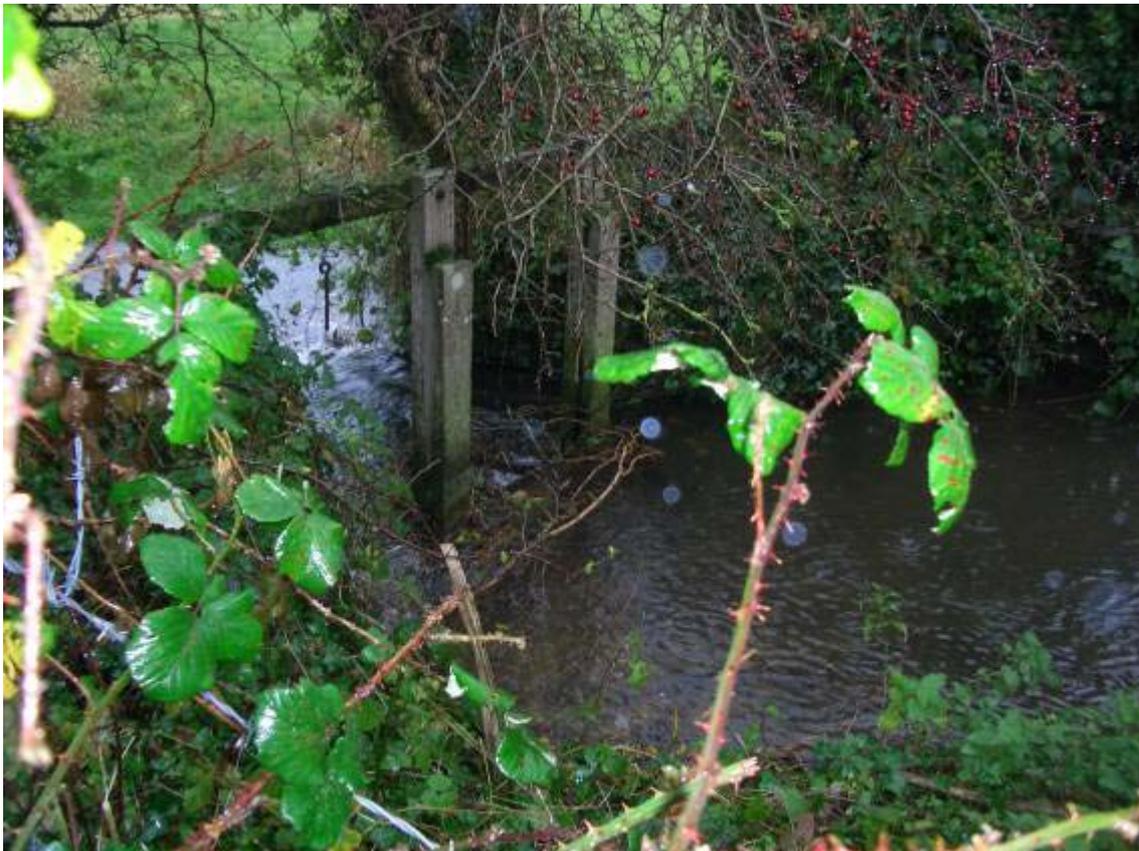
One of the numerous structures to be found on the Devils Brook

- The numerous hatches and weirs dotted throughout the length of the Devils Brook fragment habitats and fish populations. Identifying the purpose and function of each structure will help in developing an overall plan that could protect and improve both riparian and in-channel habitat through a more sensitive programme of hatch control.

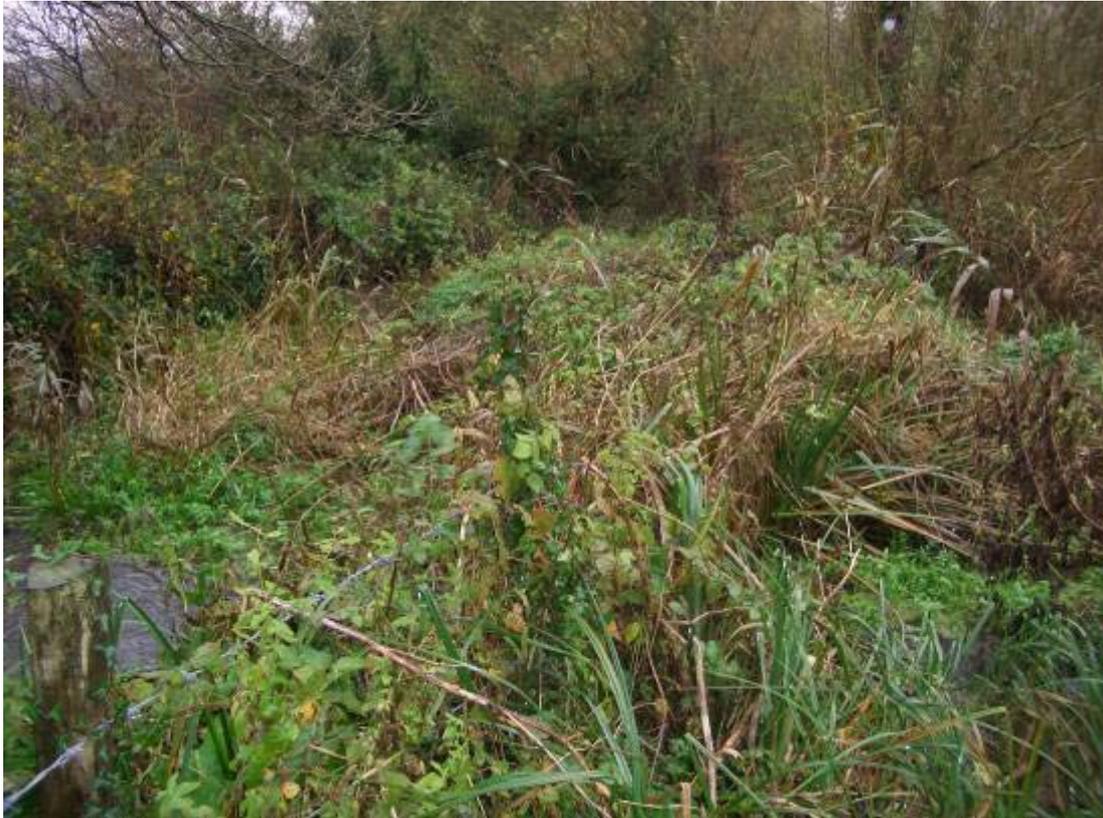
Stock fencing which excludes cattle from this lower section has enabled a variety of marginal plants and shrubs to develop

Where fencing has excluded cattle the channel is naturally pinched by the encroaching marginal plants. Although not possible to confirm on the day, it is highly likely that the increased water velocities promoted by the “pinched” channel will have enabled the stream to be self cleansing, promoting runs of fast flowing water over a silt-free, clean gravel bed. This type of habitat is favoured by both adult and juvenile trout.

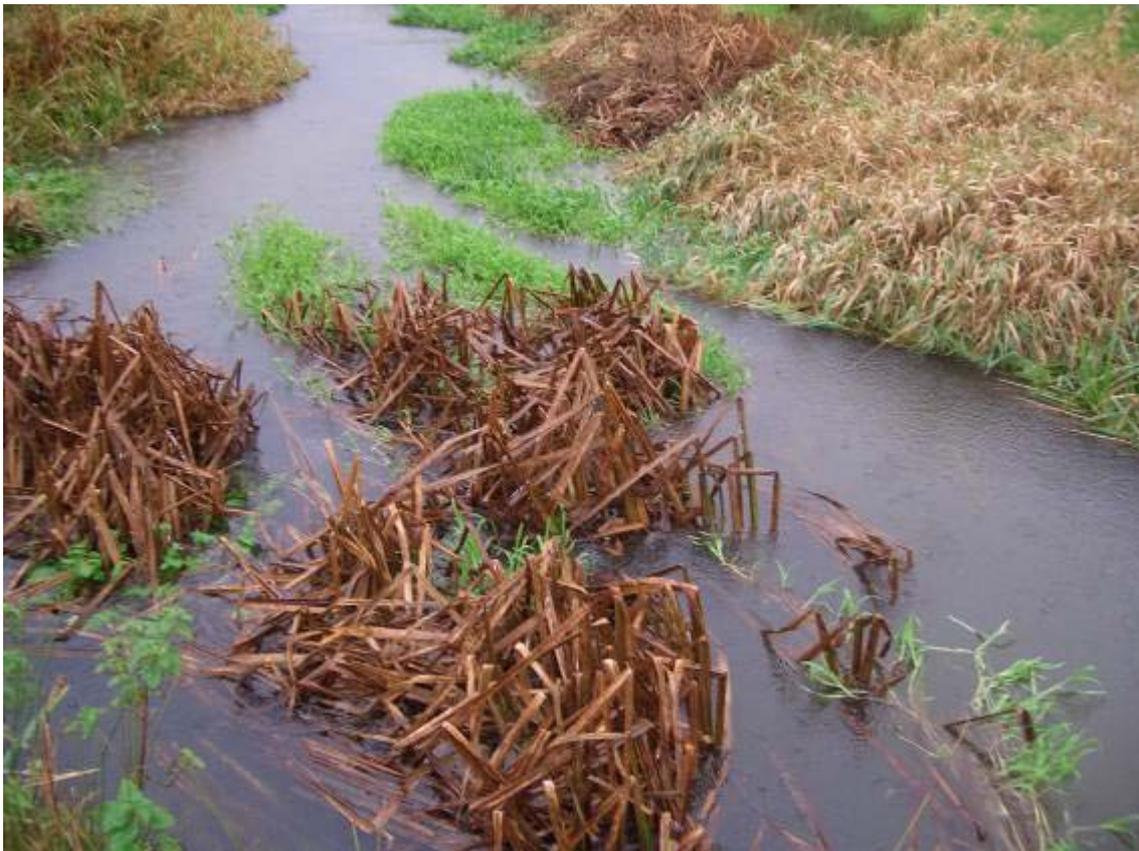
[Burr reed growing in central channel locations.](#)

It is thought that some past land drainage work has exacerbated the amount of sediment that now accumulates in this section. Unfortunately the impounding nature of the sluices will also be responsible for the lack of any sediment transport through the lower section. Some ideas for getting the river channel back into a more sustainable regime are discussed in the conclusions and recommendations section of this report.

Particular concern was expressed about the rapid colonisation of burr reed in the channel, particularly in the reach running adjacent to the farm. Beds of emergent reed growing in the marginal areas are to be encouraged. Under these conditions the plants naturally pinch the channel, promoting better quality habitat in central channel locations by helping to quicken the flow. The plants also provide an important habitat for adult life stages of key invertebrates which are a vital component of trout diet. Unfortunately they are not so desirable when large beds grow right across the channel as these will further impound the stream and may accelerate local siltation. The solution is to leave marginal plants in place but grub out beds that grow in central channel locations. This can be hard work and sometimes requires some bespoke tools.

An alternative method is to treat offending plants with an approved herbicide. This should be applied by a qualified operative following a consultation with the Environment Agency. To keep some of the plants in check, it might also be worth considering the introduction of tree trunk flow deflectors to scour away at the plants and also to provide some shade by planting the odd tree. The more open sections of channel would definitely benefit from a programme of tree planting. It is understood that tall trees are undesirable on sites favoured by wading birds. Low scrubby willows will not provide favoured perches for corvids but will help to promote cooling shade as well as providing improved winter cover and a comfortable lie for trout. Low scrubby trees are particularly valuable on the outside of bends, or overhanging pool habitat.

- On the more open sections where beds of emergent plants are colonising central channel locations, undertake a programme of selective control. This should include long term plans to avoid recolonisation through the provision of shade via some local tree planting with suitable species (goat willow and thorn) and the installation of LWD flow deflectors to pinch the channel and elevate water local water velocities.

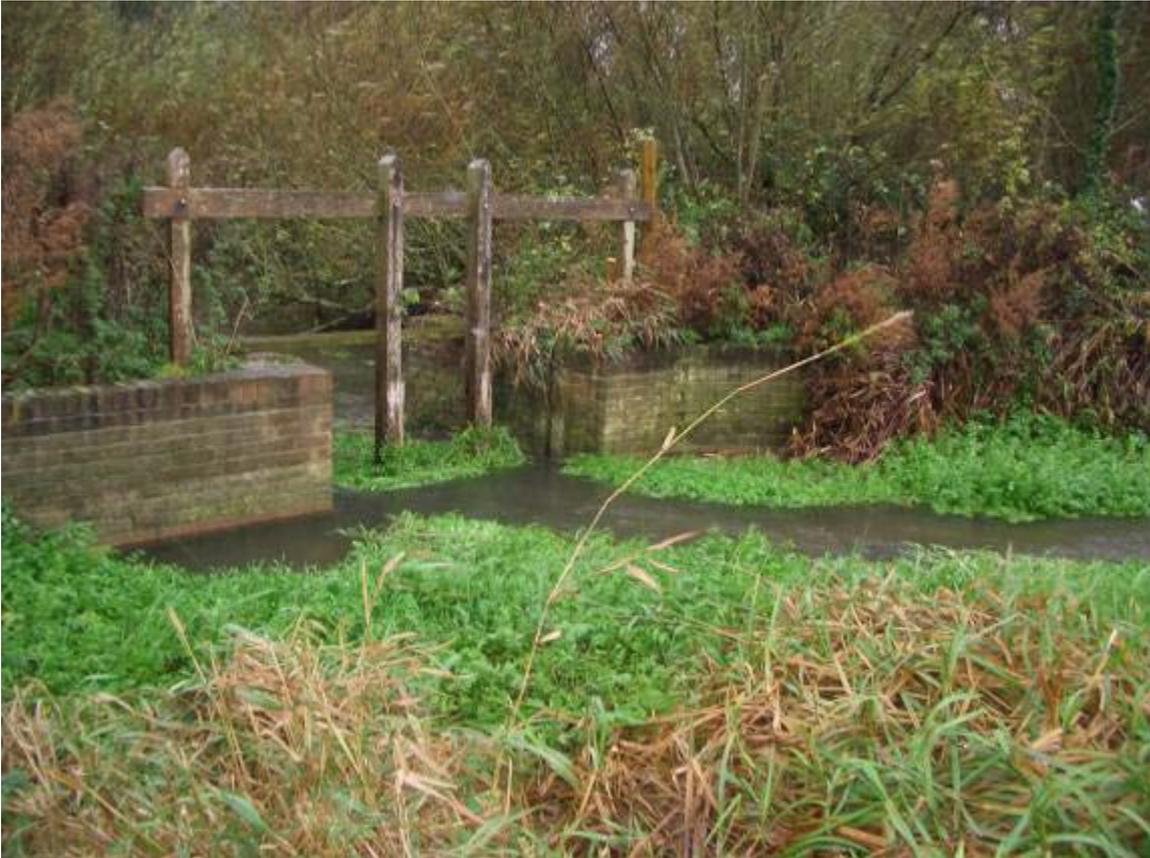
The section of channel that runs across the meadow and below the main house is devoid of marginal cover. The section is heavily impounded and the channel primarily dominated by thick stands of burreed.

Structure responsible for impounding the reach that runs in front of the main farmhouse

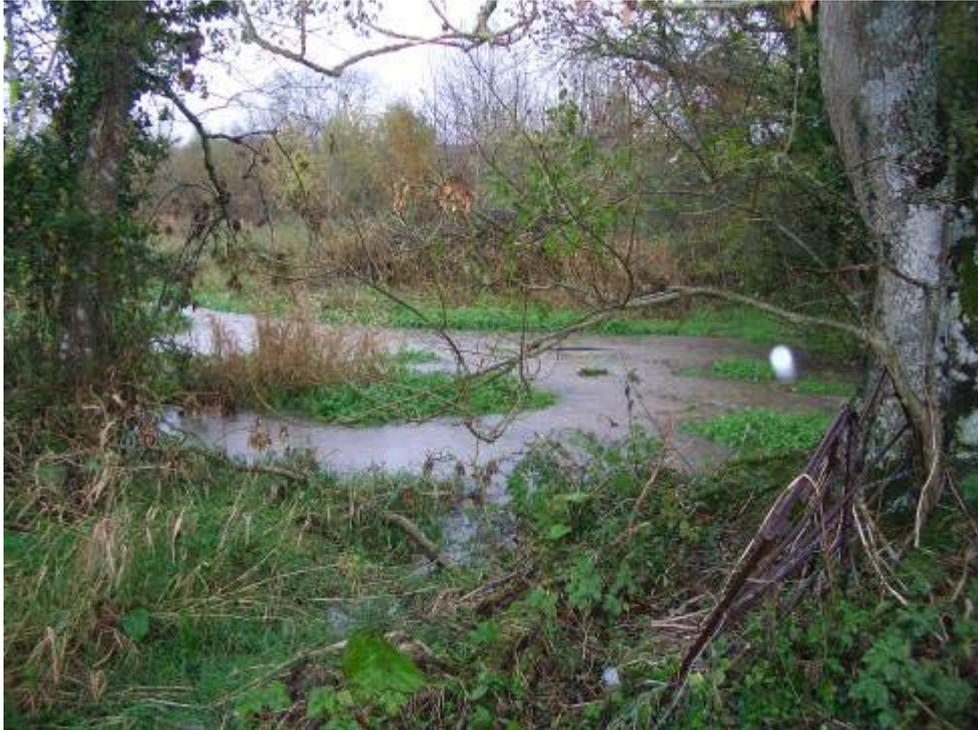
A long shallow riffle above the adjacent lake. The provision of some marginal brushing or coarse woody debris would make this an ideal habitat for juvenile trout.

Further improvements could be made with the addition of some large woody debris flow deflectors to help promote small pools and pools in the shallow sections. This will help to promote some decent lies for adult trout, either pre-spawning or during the summer and also create some ramps of loose gravel ideal for trout spawning.

- On open shallow riffle sections peg in the occasional piece of LWD to help sort gravels and promote better spawning opportunities.

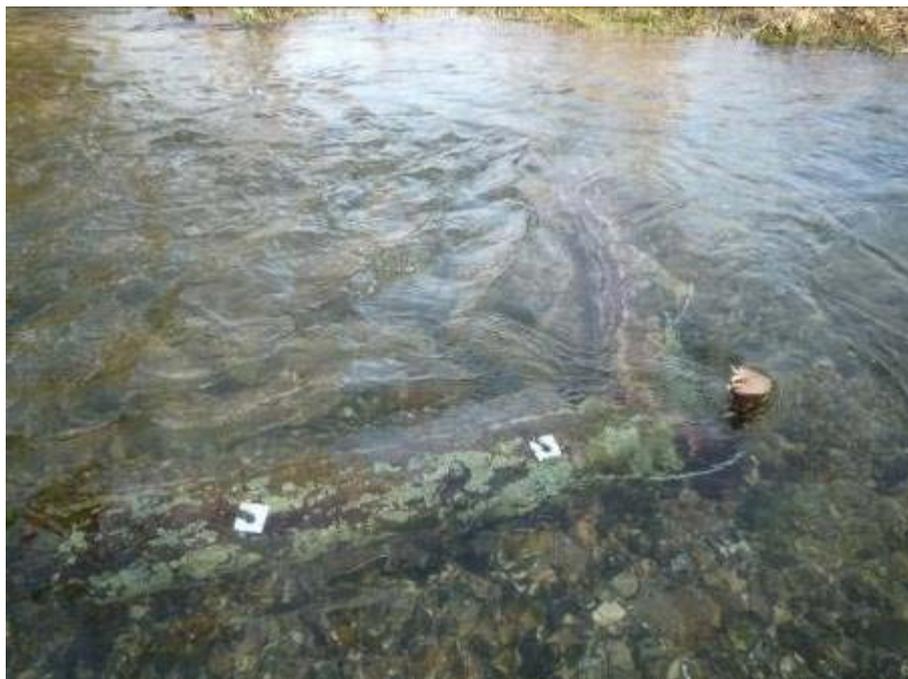
Two pieces of LWD configured to form an upstream "V". Structures like this scour local pots in the shallow bed and promote a clean, loose ramp of gravel downstream.

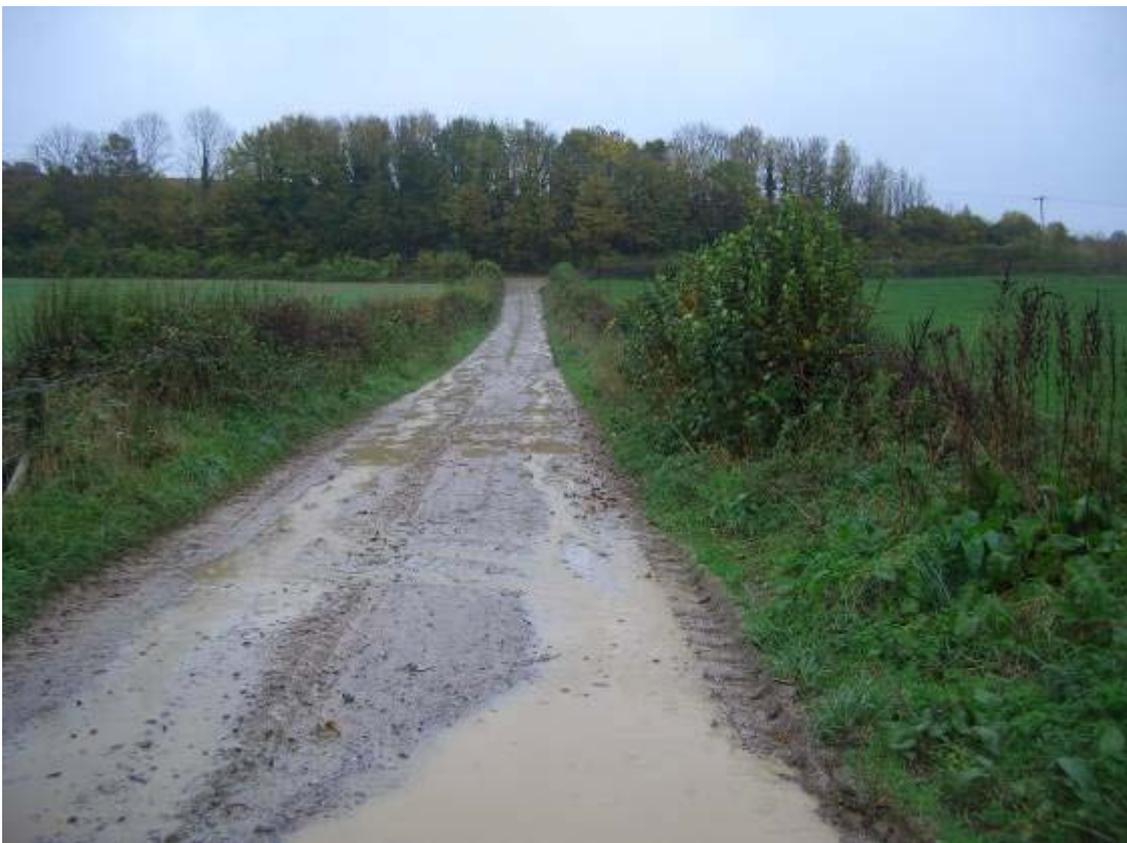
The last section of channel inspected was above the main road and consisted of an artificially straight channel running through a fairly steep sided valley. The stream had obviously been re-aligned and slightly perched above the valley floor, again to provide a head of water for irrigation. On the day of the visit it was noticeable how much sediment was running down the access road. The road was acting as an arterial drain, bringing in sediment rich water from the arable fields at the top of the valley sides. Intercepting some of this run-off through the construction of some road grips or humps to push the water into adjacent soak-away areas would protect the river from nutrient-rich sediment loads which are not conducive to high quality trout streams.

Track leading down to the Devils Brook acting as an arterial route for sediments running off the arable fields up behind the tree line.

Any measures taken to reduce the amount of nutrient rich sediment entering the river are to be welcomed. The access road crossing the river upstream of the dual carriageway appears to be a conduit for introducing sediments from the arable meadows that run along to tops of the valley. Exploring options for diverting surface water into large soakaway areas is recommended. Advice might be available from your local Catchment Sensitive Farming officer via the Environment Agency.

- Continue with efforts to eradicate non native plants such as Himalyan balsam (*Impatiens glandulifera*).
- Consider installing a drainage system to intercept sediment laden water running down the access road.
- Explore options for a radical in-channel enhancement of the long straight channel near the bottom boundary.

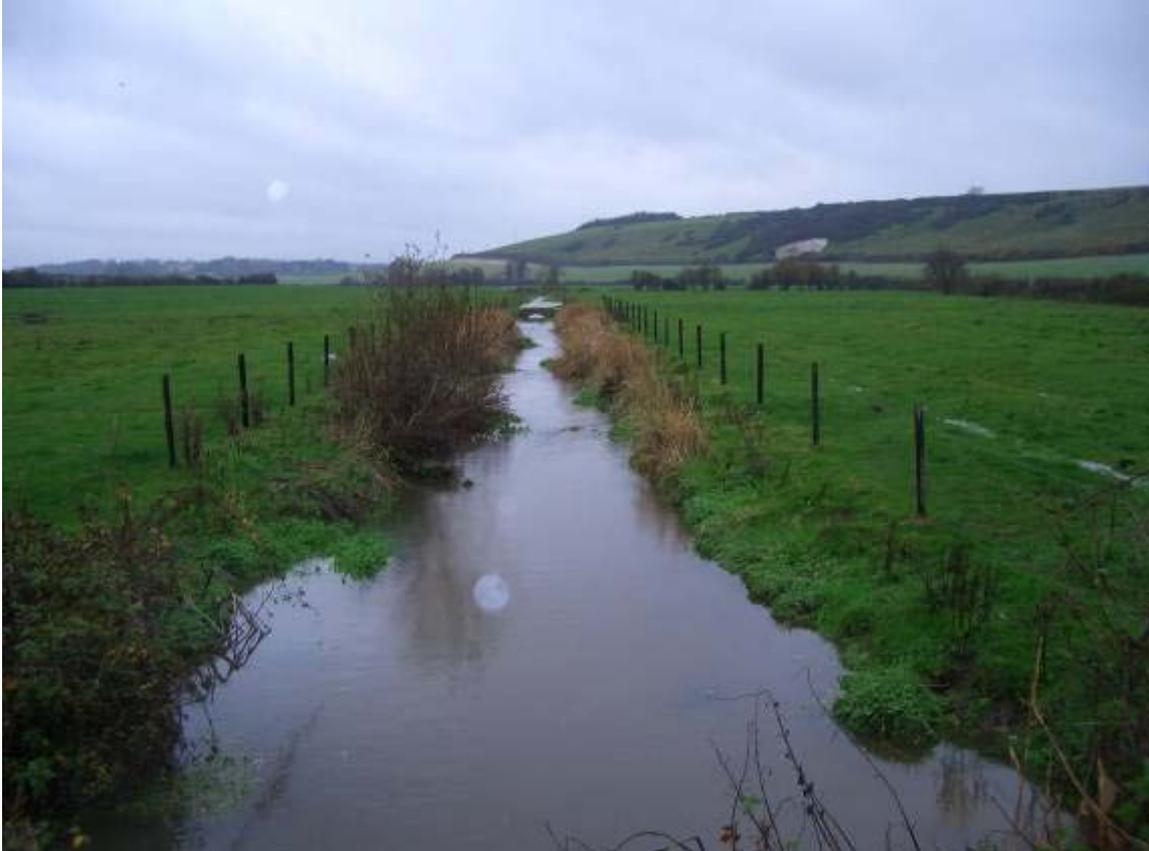
The stream either side of the access road was very straight. Although not observed directly on the day, straight channels also tend to be very uniform in depth and velocity and are unlikely to provide the mix of habitats that are vital to supporting a wild trout population. This reach had been fenced as part of the GCT (now GWCT) study looking into the impacts of stock fencing on trout populations. It was quite surprising how little scrub had developed given that the fencing was carried out over ten years ago. This may be because the buffer zone was fairly narrow and determined grazers could reach – or break – in to graze

the margins. First impressions of this reach suggest that it is ripe for wholesale restoration. Redesigning a meandering channel route that sits in the valley floor would create a much enhanced environment for trout and a wide range of other river and flood plain related species.

The top section of the Devils Brook has been realigned as a “drowning” carrier. The channel is crying out for a more natural channel morphology.

The very top section of river inspected looks ripe for a restoration scheme. The river is straight for a long stretch and looked to be comparatively uniform in depth profile. Reprofilng the planform of the stream by creating some kinks and bends as well as promoting some depth diversity will greatly improve its conservation value and provide a much wider variety of habitat niches. There are various methods that could be employed dependant on budget and design constraints. Exploring options for restoring this reach to a much more natural looking and ecologically valuable stream is well worth while. A well designed restoration project might attract some funding from government agencies via a partnership approach, or from other sources. The WTT can advise further on potential project options.

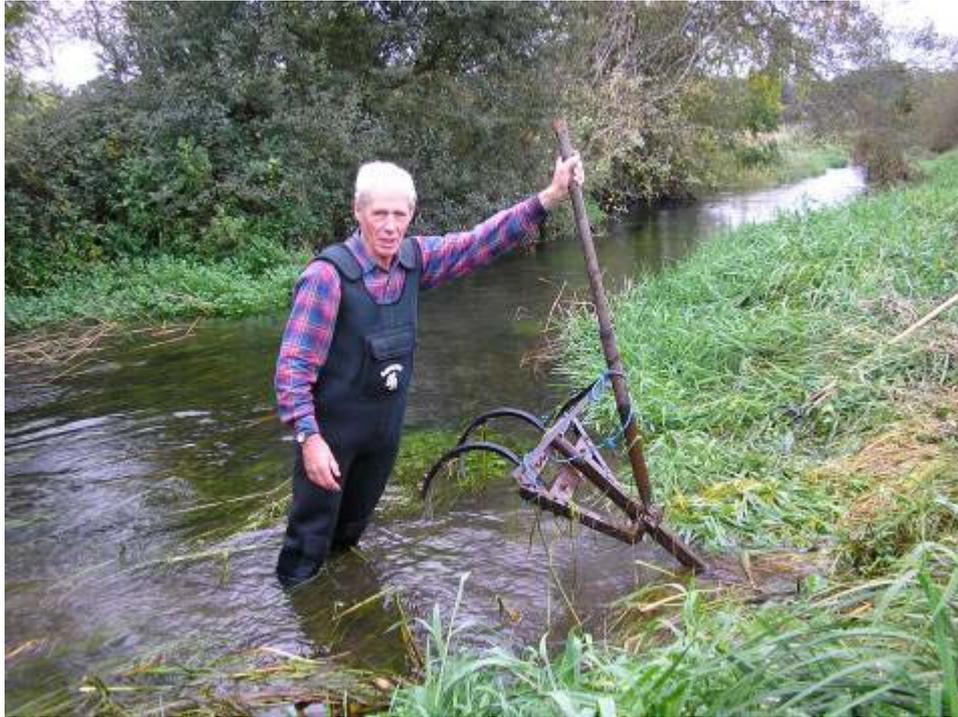
"The ripper" a simple plough designed to be used with a bank-side winch to grub out undesirable plants.

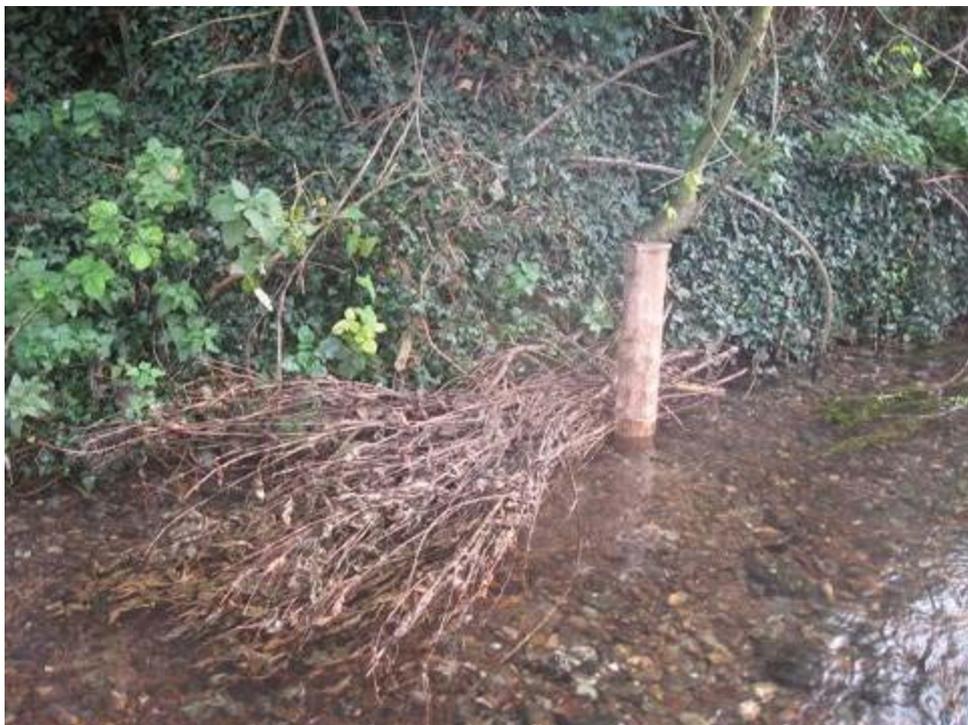
Brushings pegged into a bare shallow margin providing a refuge for juvenile trout

It was also noted that some of the shallow riffles were lacking in marginal cover. Bank-side dead and dying annual plants often lean over into shallow margins and provide important winter cover for juvenile trout. In sections where weed growth is poor and a low scrubby margin non-existent it will pay to introduce a few brush bundles or dropping the odd sapling to create a matrix of branches. This will help to deter avian predators and encourage the trout to take up residence rather than flee downstream.

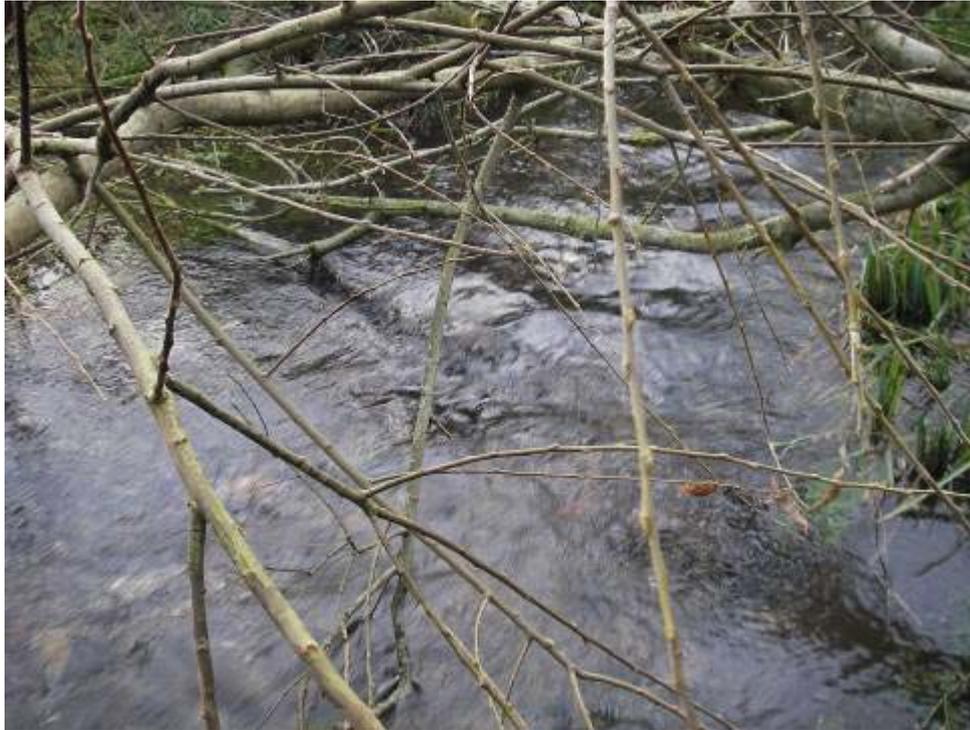
A tangled matrix of coarse woody debris pegged over the top of an important spawning site

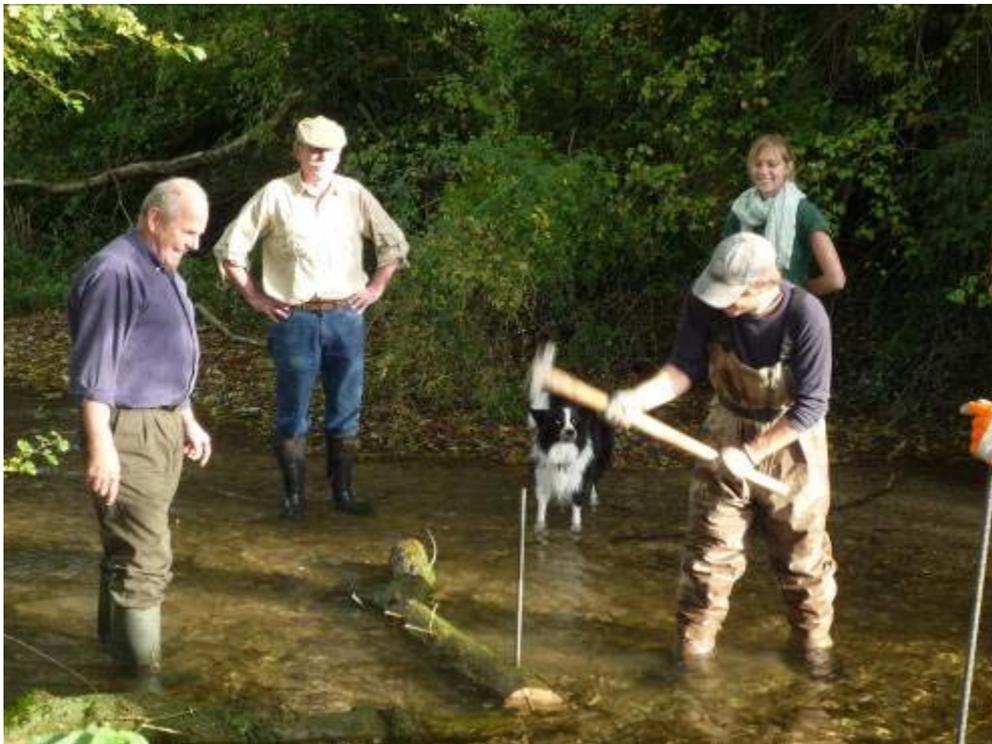
Pegging in a piece of LWD onto a shallow riffle on the Ebbles to promote improved spawning habitat

On the sites where shallow glide and riffle habitat existed, further enhancements can be made by pegging in some large woody debris (LWD) flow deflectors to help scour small holding pots and to throw up ramps of clean loose gravel. Spawning success on many Wessex chalkstreams is compromised due to the impacted nature of the gravels. Flat, silt laden gravels can be difficult for trout to dig redds and often the trout egg to fry survival rates are poor. Putting in a little effort to help sort and clean gravel with simple LWD deflectors can give
