**ADVISORY VISIT TO THE NORBURY FISHERY  
RIVER DOVE, STAFFORDSHIRE,  
UNDERTAKEN BY VAUGHAN LEWIS,  
WINDRUSH AEC LTD, ON BEHALF OF  
NORBURY FLY FISHING CLUB  
JUNE 2008**

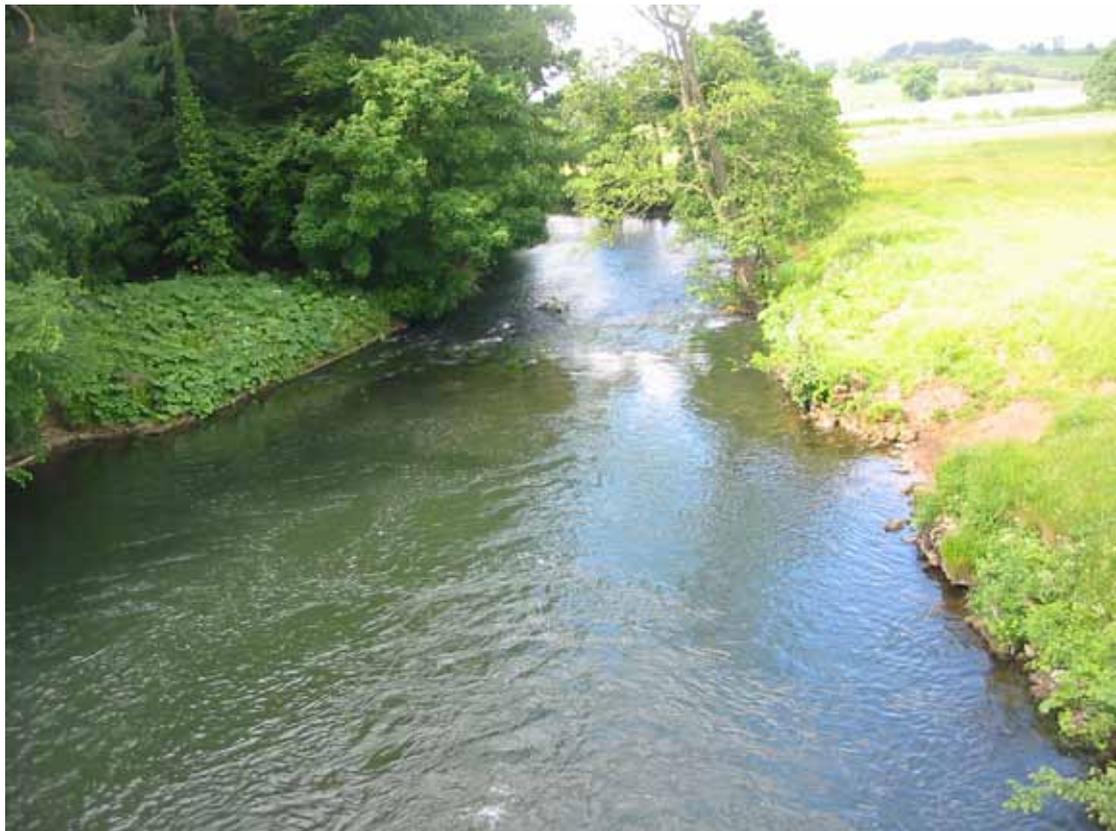
The RB of the river was grazed by agricultural stock (no fences were present), with some localised bank erosion visible. The LB was densely tree lined, with consequent light/moderate shading of the channel. There were extensive stands of water crowfoot *Ranunculus* Spp., particularly on the extensive gravel shallows. These provided

abundant spawning and juvenile habitat for brown trout *Salmo trutta*, grayling *Thymallus thymallus* and increasingly Atlantic salmon *Salmo salar*.

The banks of this reach of the river were partially reveted in the past using local stone, presumably as part of the operation of the downstream mills. Much of the revetment has fallen into disrepair and been eroded away. However, some sections remain in place. Instream habitat along the reveted sections of the river was dominated by a mix of shallow and deep glides with moderate flow velocity. These areas provided abundant habitat for adult fish.

- In sections where increased pressure from agricultural stock has cause excessive bank erosion, stock proof fencing should be erected. Ideally, an ungrazed buffer of 10m should be created between the new fence line and the existing bank. This will both allow the development of coarse grasses and emergent vegetation that will slow down the rate of erosion, and will optimise detention of fine sediment from surface run-off. If it is not possible to create a 10m buffer strip, then the maximum practical width should be protected.

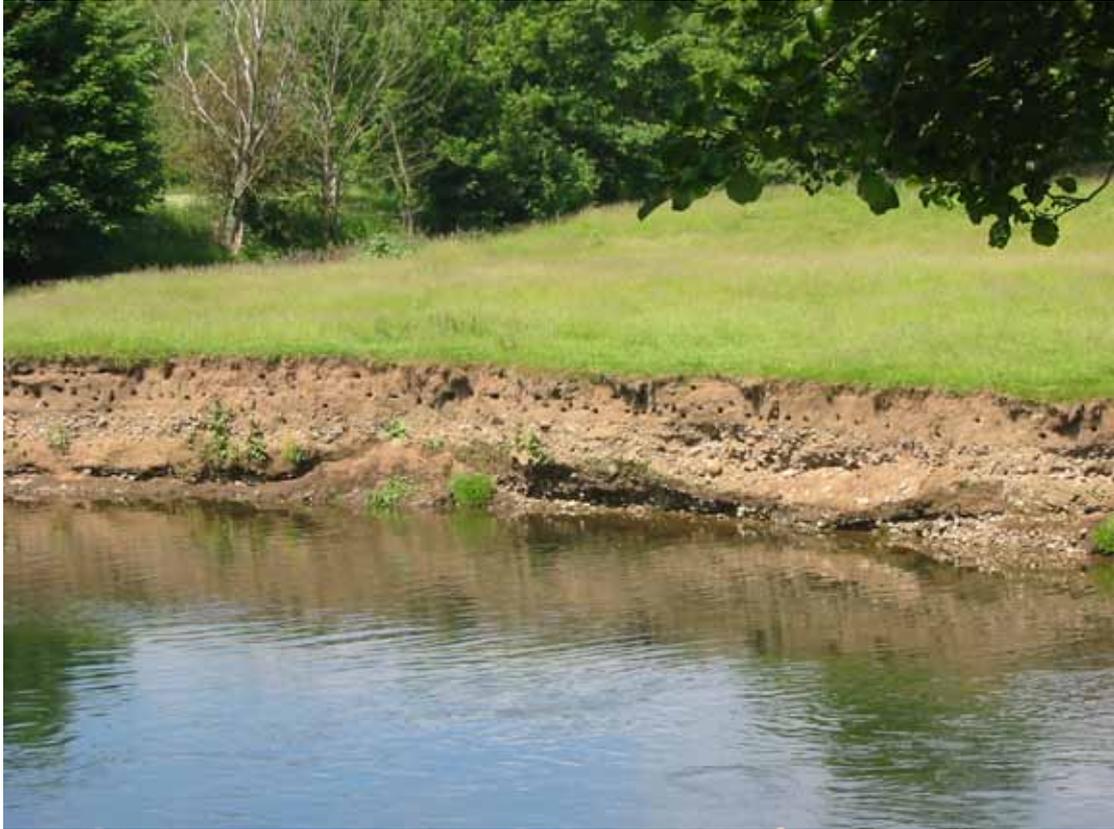
Further downstream on the main channel, there was an abundance of water crowfoot. There were significant areas of eroding bank, with the erosion exacerbated by grazing pressure from agricultural stock. In at least two locations, the eroding banks were being used by breeding sand martins.

### **Sand martin breeding colony in a section of eroded bank**

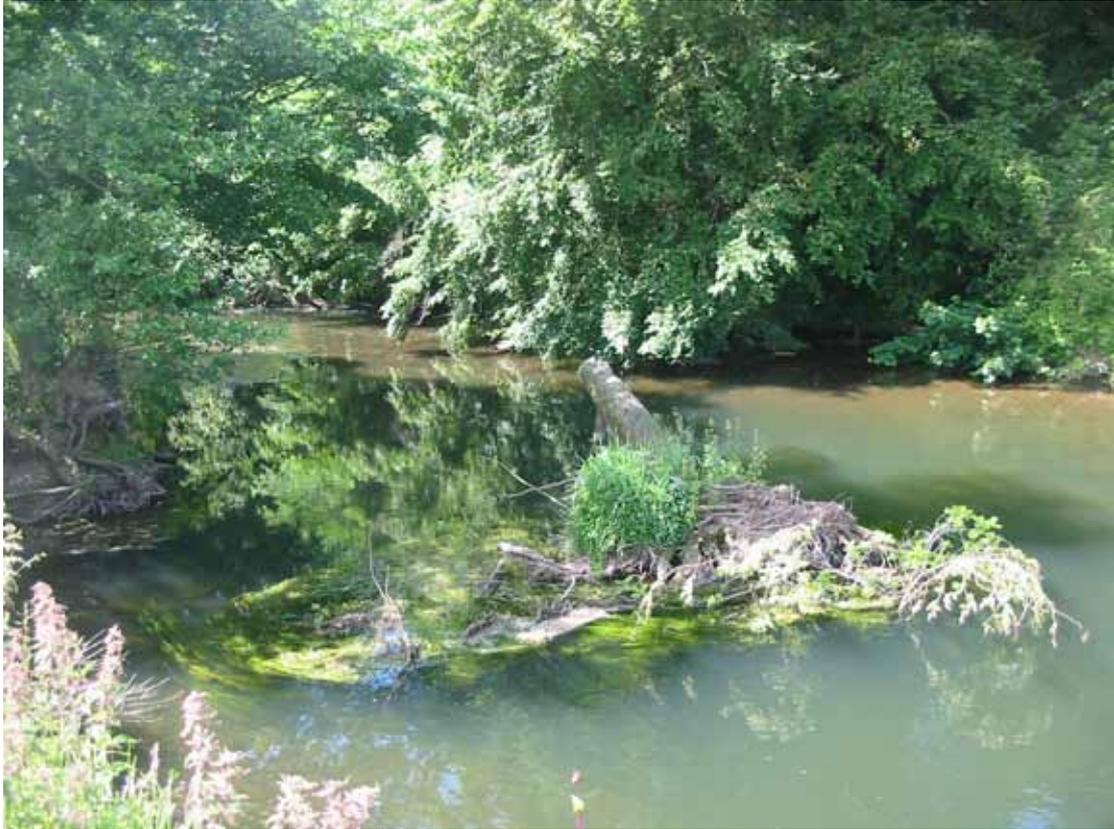
There were some significant pieces of LWD present throughout the middle/lower fishery. These had been retained by the club and were providing not only excellent areas of cover for fish and invertebrates but were also acting to scour the substrate, thus increasing habitat diversity.

**LWD in the Dove. Note the milky hue to the water.**

- There was a moderate amount of LWD in the river. Retention of as much timber that falls into the river as possible is a good policy. In addition, deliberately felling individual trees and anchoring them into the channel would further increase the amount of LWD present in the channel. Particular benefit would be obtained by felling trees onto the relatively uniform sections of shallow gravel riffles, where the

Fixing of timber in the channel can be achieved in a number of ways. The simplest involves wiring felled trees to the remaining stump on the bank, and stabilising the outer limbs of the trees in the water using wooden/metal stakes driven into the bed. Where appropriate, trunks can be drilled through and high tensile wire passed through in order to create a firm fixing. Similarly, lengths of 20mm-25mm diameter reinforcing bar can be driven through pre-drilled holes into the riverbed in order to hold trunks in place. Where possible, trees to be felled should be only cut through for 75% of their diameter and then 'hinged' into the river. This 'laying' technique maintains a firm fixing to the tree stump and in many cases, allows the tree to continue growing. The dying alder trees will provide an abundant supply of 'donor' LWD.

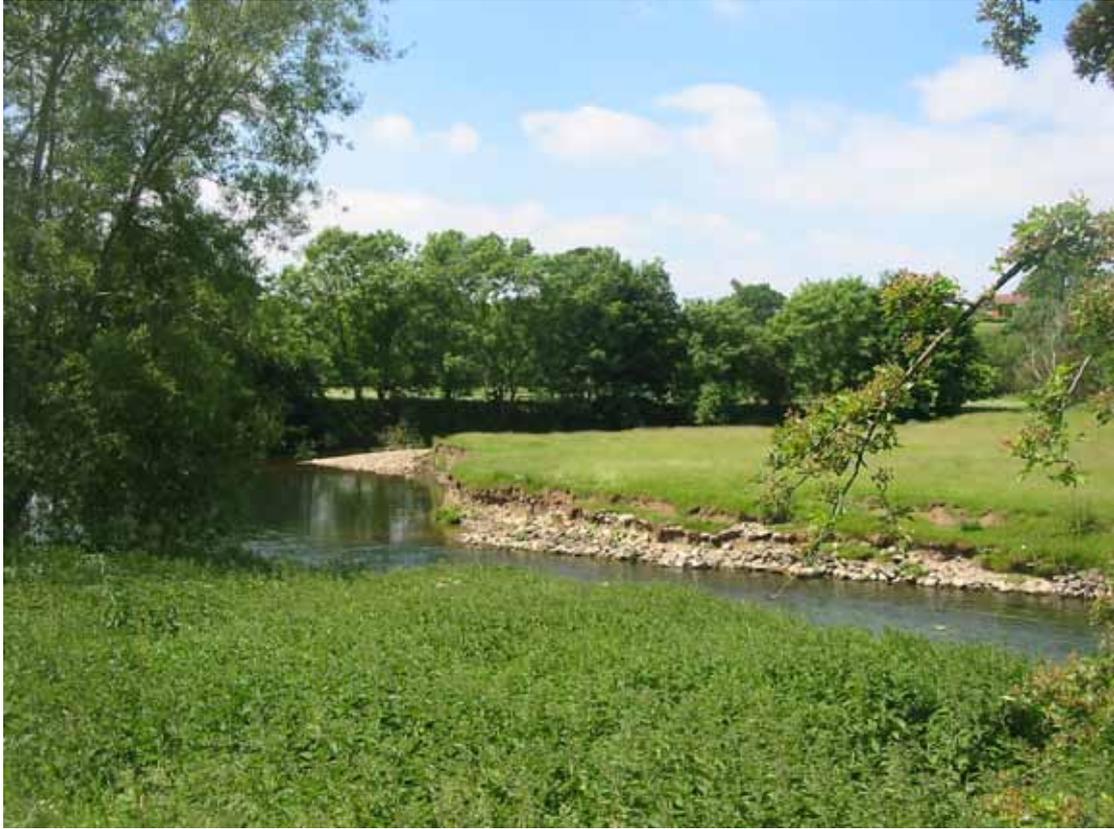
The middle/lower reaches of the fishery had been particularly badly affected by sheep grazing. As grazing has weakened the sward and damaged the banks, increased amounts of erosion have taken place, resulting in significant loss of land. On one bend for instance, up to 8m of bank have been lost over the past 10 years.

### **Significant area of erosion of the inside of a bend**
