River Ebble – Homington

An advisory visit carried out by the Wild Trout Trust – March 2009

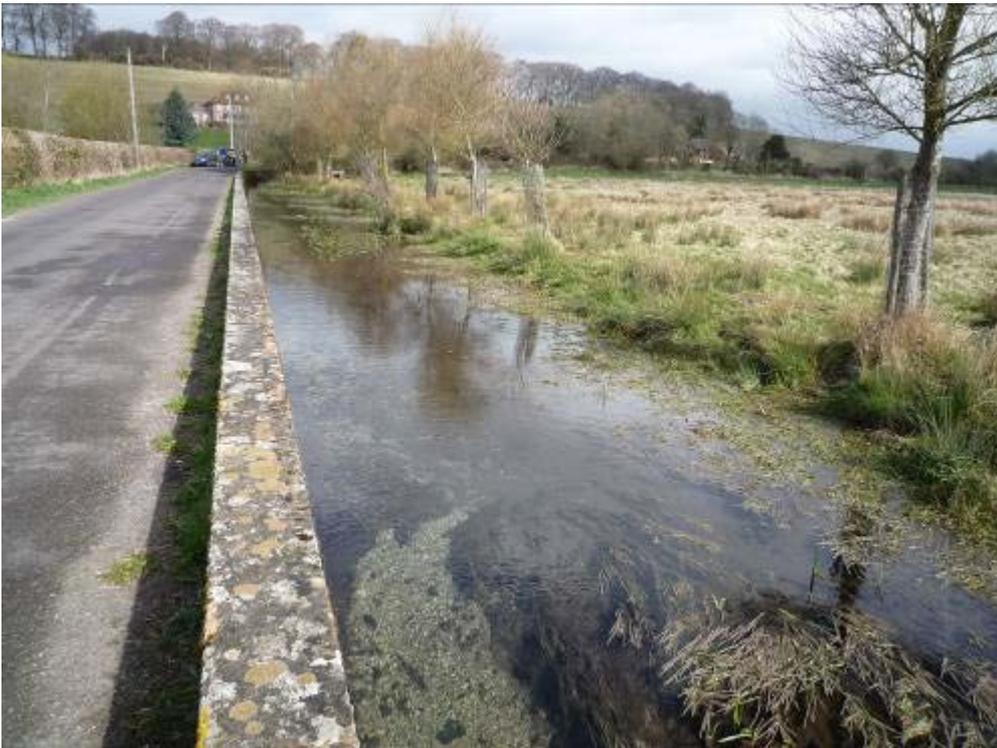
Bottom end of the side stream joining the main river at the head of the fishery

The side stream running parallel with the road is currently too wide and flat in terms of gradient to provide much in the way of suitable spawning habitat. Where cress beds were starting to establish and naturally pinch the channel some thin layers of gravel were observed but the bed predominantly consisted of sand and silt. The channel was dominated by emergent vegetation including water cress (*Rorippa nasturtium-aquaticum*) and reed sweet grass (*Glyceria maxima*).

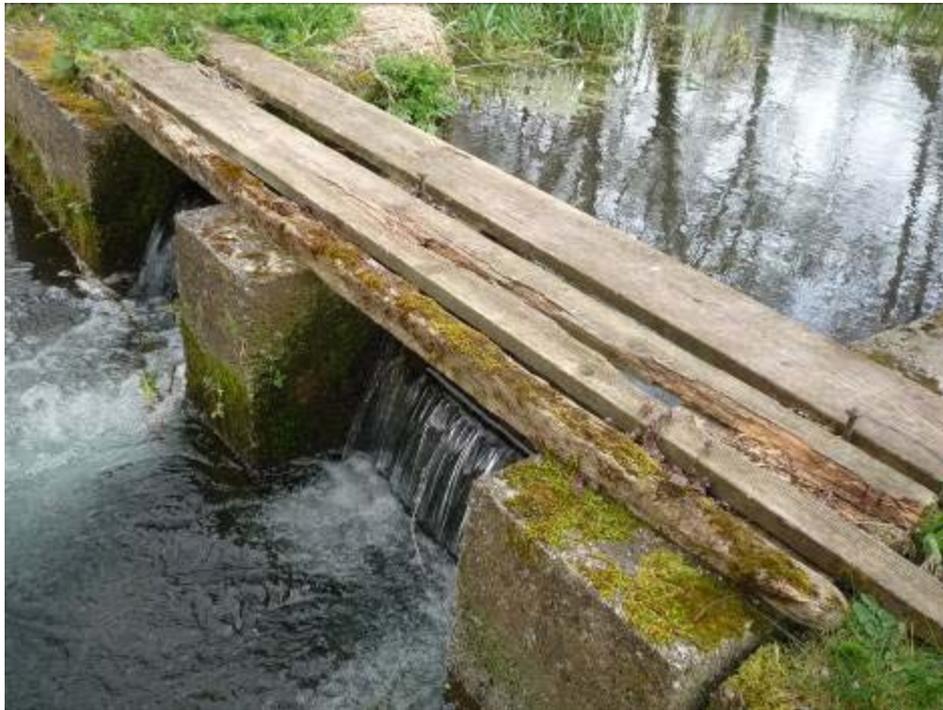
[Water level control structure installed to create a head of water to feed an adjacent lake](#)

During heavy autumn flows it is possible that fish undertaking upstream spawning migrations may be able to swim over this structure. The height of the impoundment appeared to be in excess of 300mm which could deter small brood fish from being able to negotiate the weir in a low flow autumn. Consolidating the flow by notching one of the boards to create a solid plume of water will help to ease access for adults swimming upstream and provide an obvious escape route for juveniles as they descend (See recommendations).

This small stream may also have better quality spawning areas further up the valley and modifying the boards in the weir adjacent to the off-line lake may help with autumn spawning migrations. Cutting a small vertical slot or notch in the centre of the board to promote a narrow flume of water over the structure will allow fish to move up and utilise habitats further upstream.

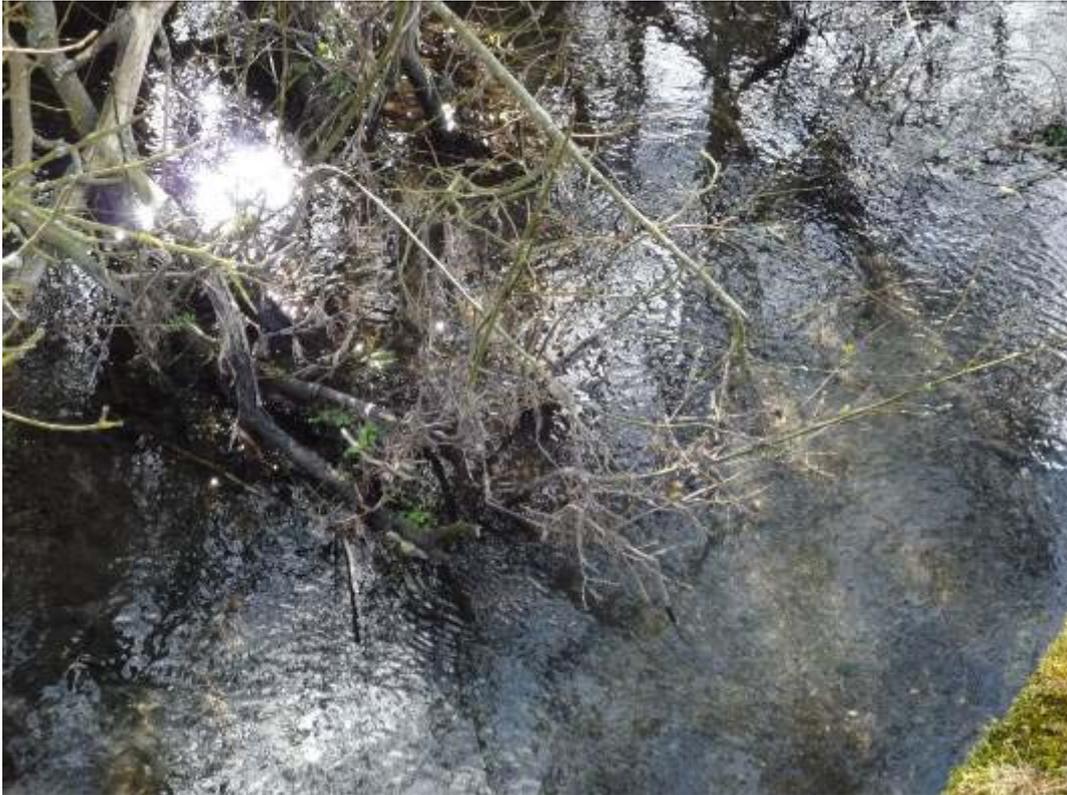
A short section of the side stream where a scrubby margin of willow is providing winter cover for trout

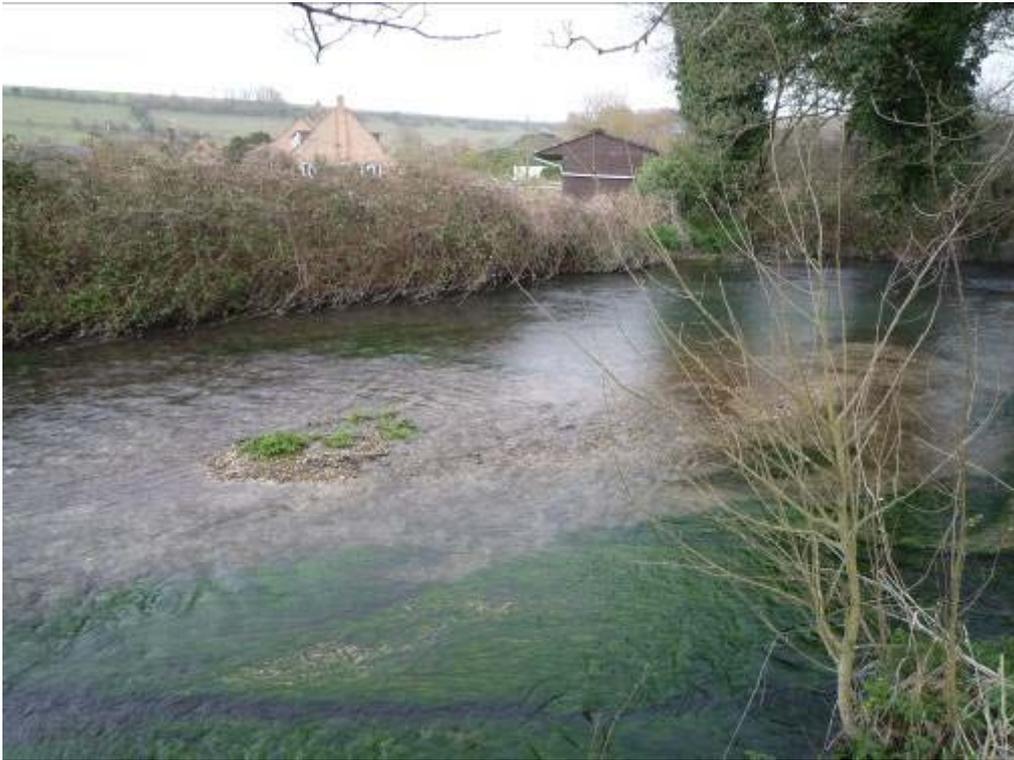
Excellent spawning habitat on the tail of the glide and first class cover for juvenile trout under the RB margin. Trout heaven!

In addition to the excellent spawning opportunities there is also a thick scrubby margin on the RB providing ideal cover for juvenile trout. This area could be further enhanced through the provision of some large woody debris (LWD) pegged to the river bed in one or two locations to promote further scour and loosening of the river bed gravels.

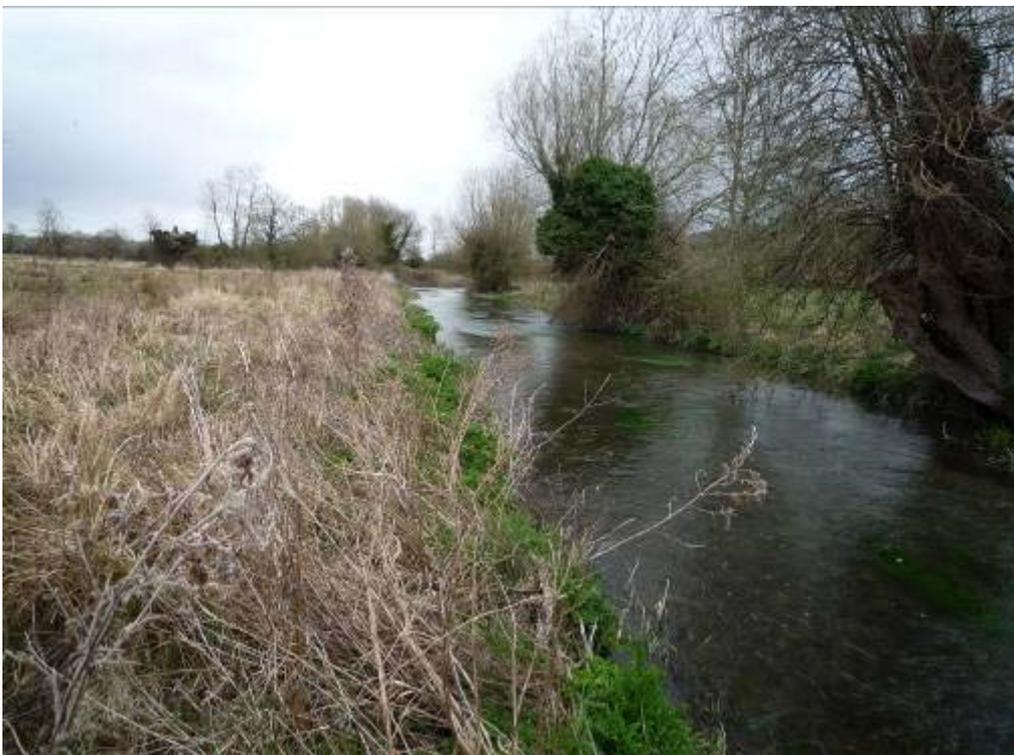
LB margin protected from cattle damage by fencing. This section could easily be fished from the bank or via wading with minimal maintenance then required.

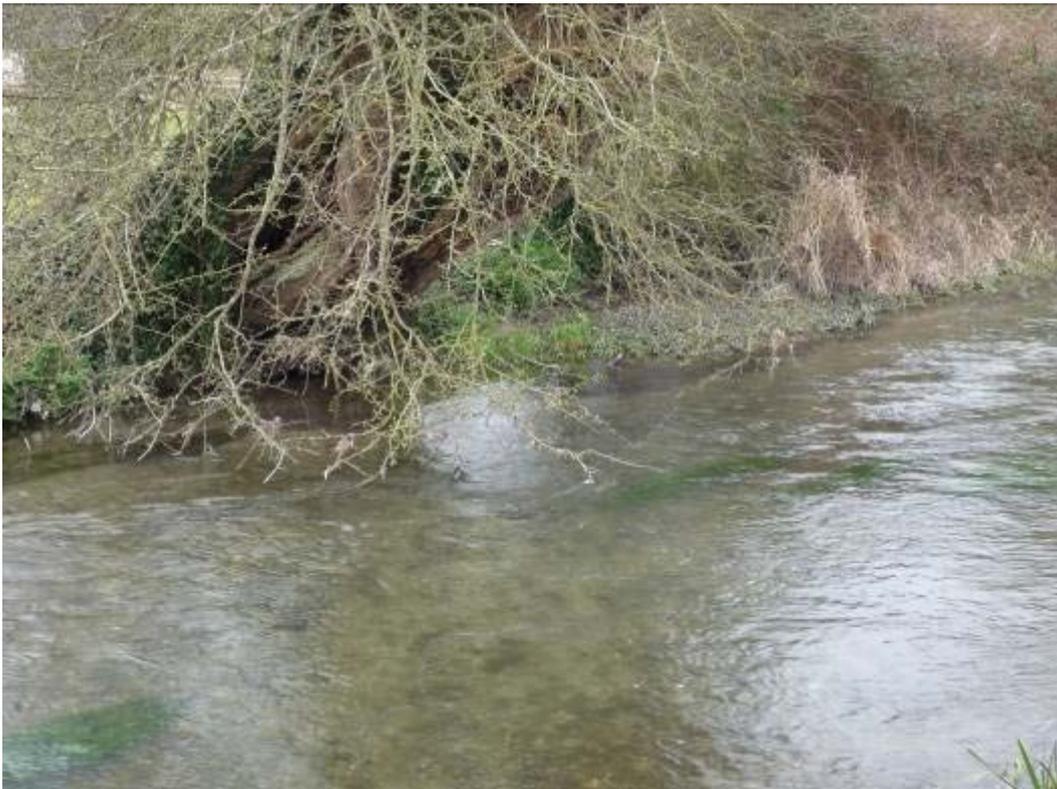
A low scrubby thorn tree waiting to come into leaf and provide a roof and larder for a trout.

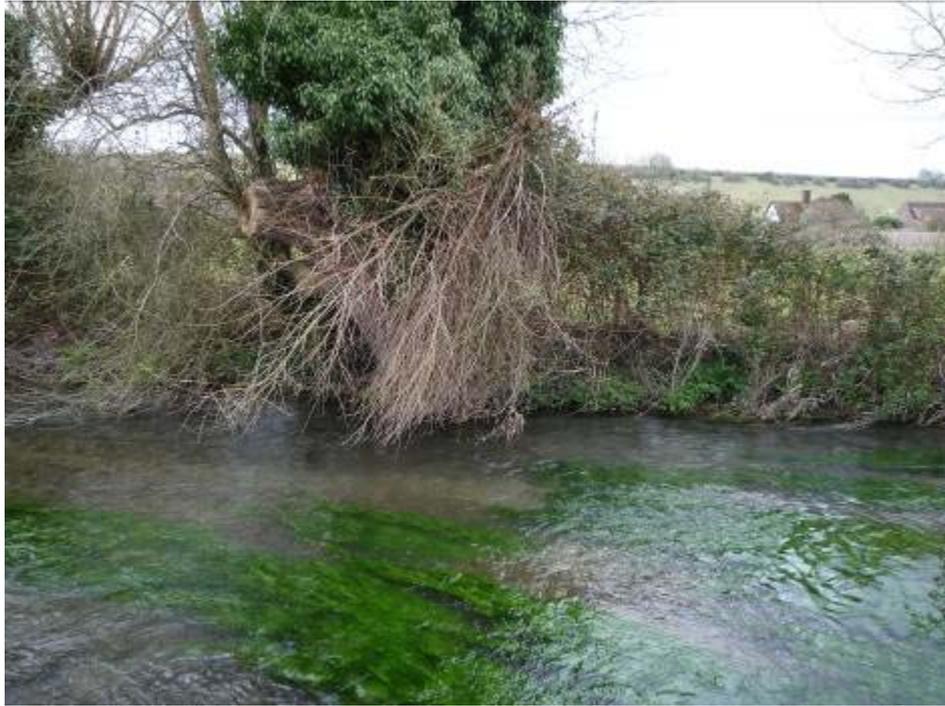
Another great example of excellent marginal habitat. Sufficient light to promote in-channel weed growth and a tangled margin of scrub to provide a safe refuge.

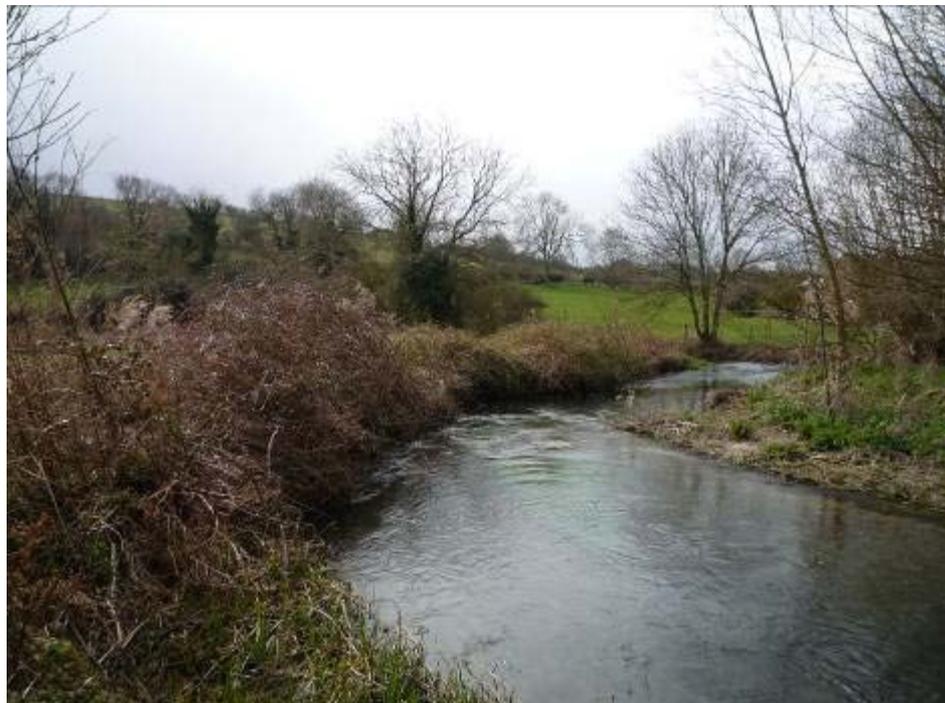
An area of bramble and scrub on the outside of the bend on the LB. Perfectly fishable via wading

There was some discussion about clearance of scrub on the LB (photo above). As already discussed, allowing the whole margin to revert to scrub is undesirable although leaving the odd patch to develop will provide some diversity in marginal habitats both for fish and other species. Striking the right balance with bank-side maintenance regimes can be extremely difficult. Leaving small blocks of scrub to develop, particularly on the outside of bends, can help to knit the bank together and proved valuable protection against erosion during flooding events, as well as providing all important habitat diversity. Encouraging a more diverse range of marginal habitats should not be too prescriptive or contrived. The very bottom section of river for example is very open, with very little in the way of marginal tree cover. Never the less, this section provided some excellent marginal habitat in the shape of thick fringes of sedge (*Carex sp.*), sweet reed grass (*Glyceria maxima*) and bur reed (*Sparganium erectum*). The low soft margin would not benefit from wholesale tree planting and the excellent growth of in-channel weed provides plenty of cover for fish.

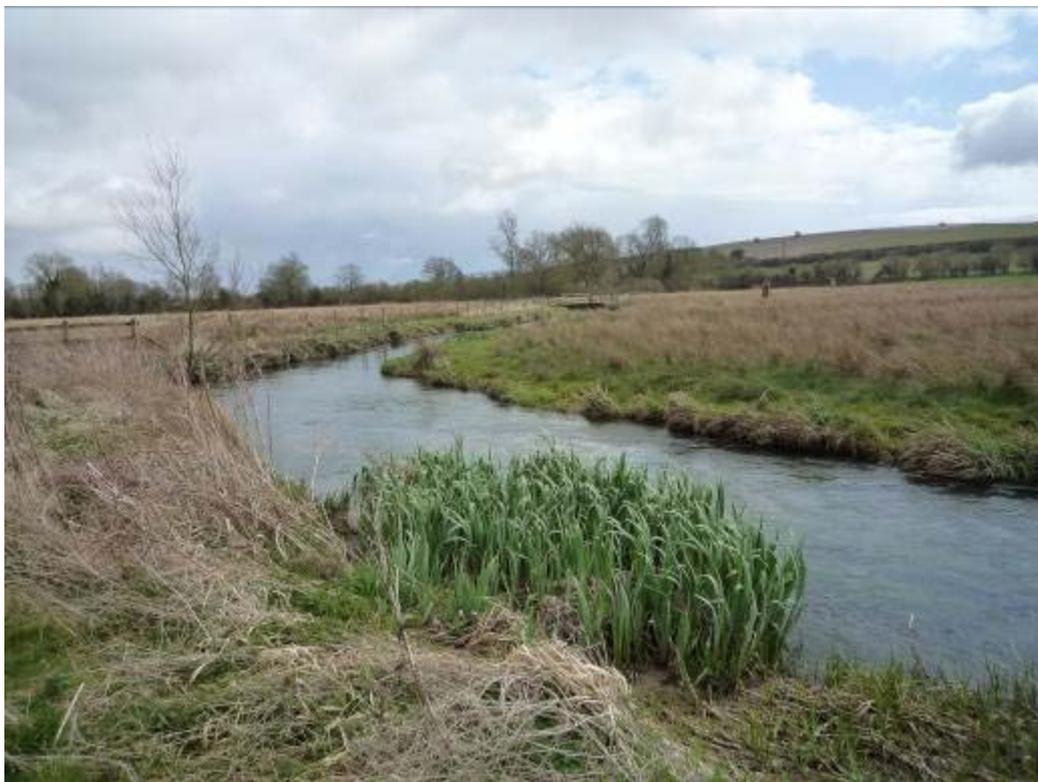
A short distance upstream from the hatches where the margin is relatively hard and possibly made up from dredged river bed material it may be pertinent to carry out some limited tree planting with locally procured willow whips. These should be the small goat willow or sallow. These open hard margins are poor environments for wet meadow plants and can be prone to erosion. The odd willow dotted here and there will provide great lies for adult trout and help to defend the outside of vulnerable banks from erosion.

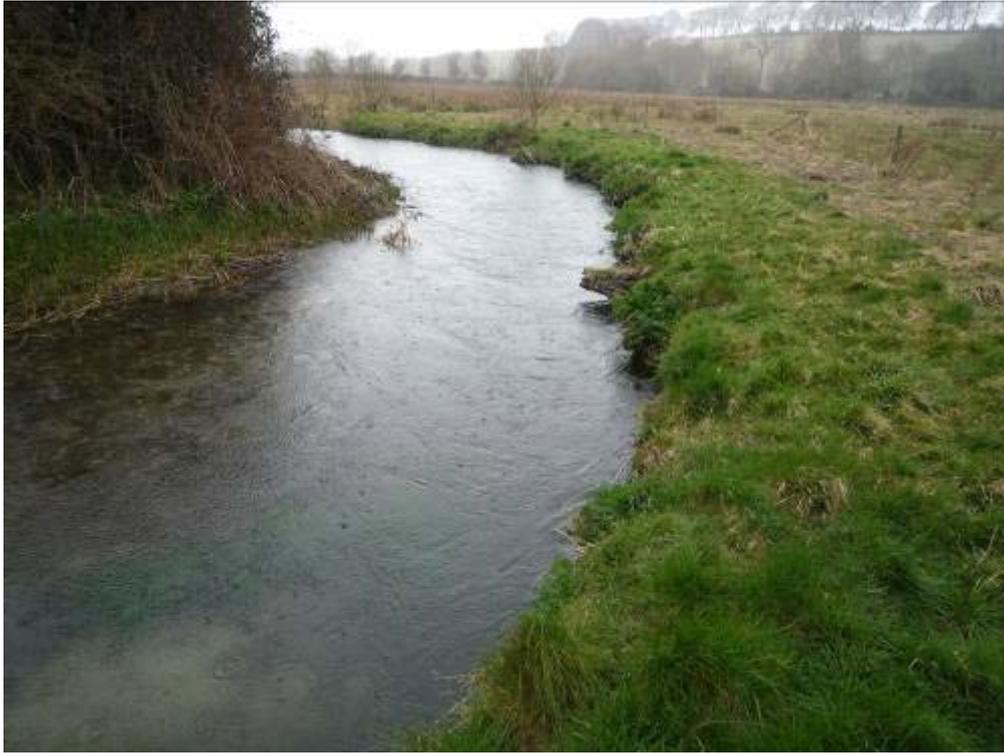
Sections like this LB margin would benefit from one or two water level willow whips being planted to provide holding habitat for adult trout and protection against bank-side erosion

- Undertake a modest programme of tree planting with willow or goat willow *Salix caprea* at water level on sections where the banks are comparatively high, hard and bare. Two or three whips pushed into the margin at 45 degrees are all that is needed. This is particularly effective on the outside of bends.

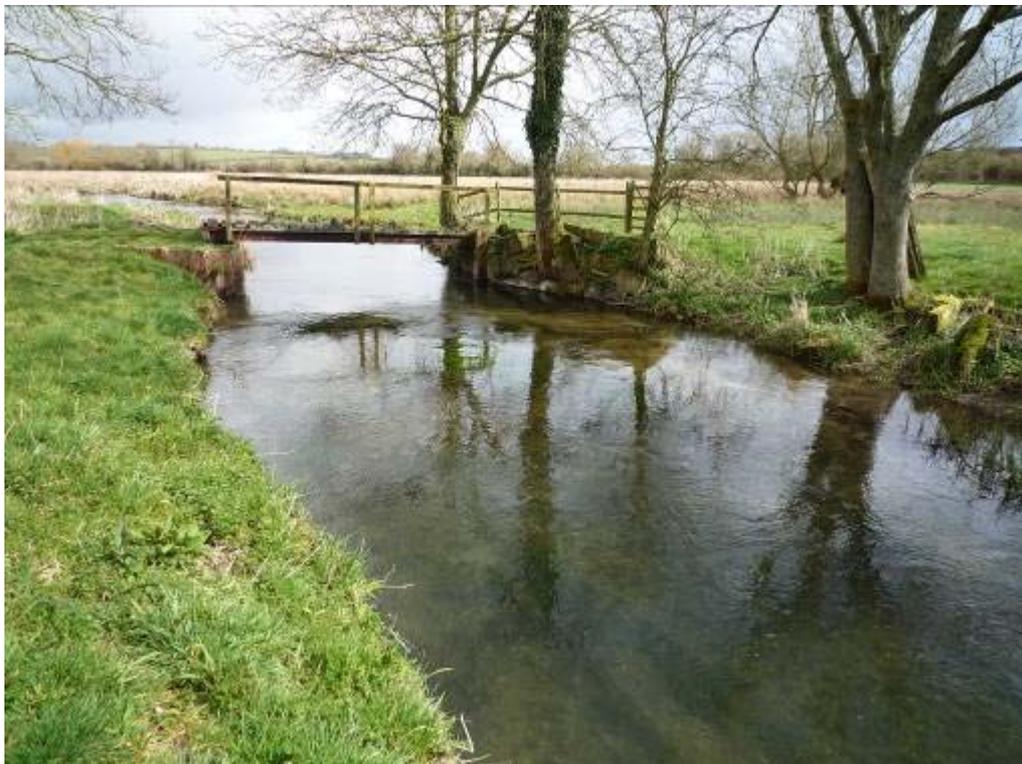
An old water meadow hatch just above the bottom meadow. The paddles from the hatch have been removed and should not be replaced.

Just above the bottom meadows there is an old water meadow hatch structure. Paddle boards have been removed and were apparently damaged following a flood event. The river bed upstream of the structure has benefitted from the increased water velocities promoted by the removal of the boards and it is recommended that no paddles, gates or boards are refitted to this weir in the future.

- Do not be tempted to put boards back into any of the old in-channel weirs or structures.

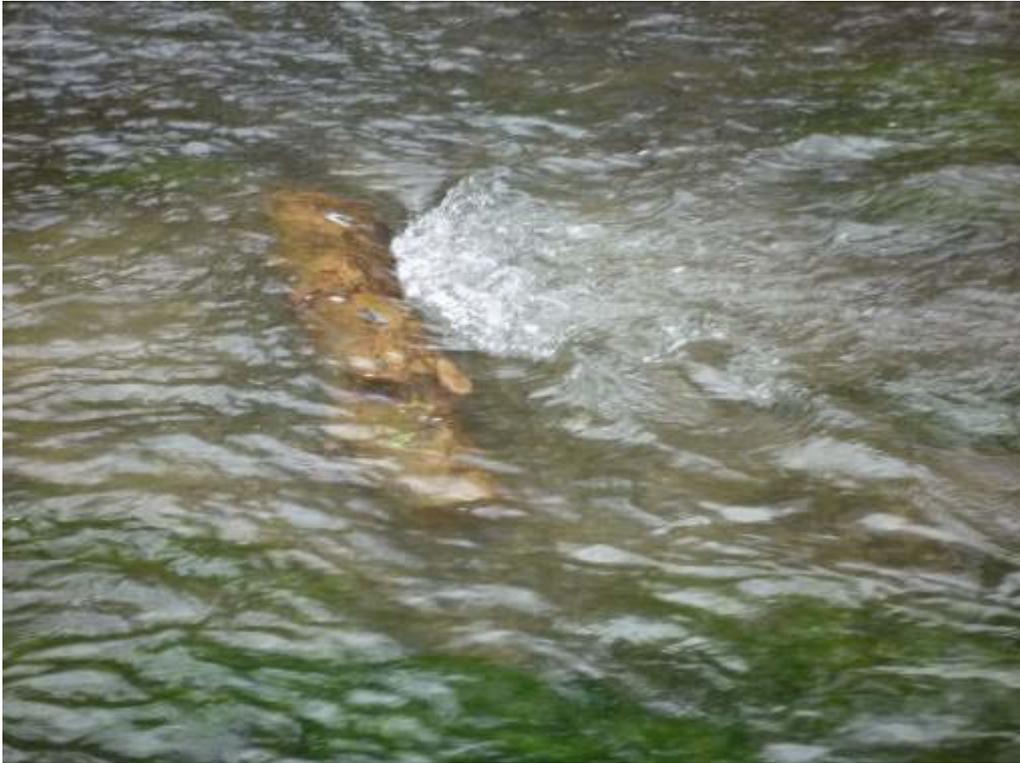
A piece of LWD pegged to the river bed with steel bar and configured to promote river bed scour downstream of the structure. This invariably blows up a small ramp of clean loose gravel that is ideal for spawning. This technique would work very well on the Ebbles

To improve spawning success on the main river riffles it is recommended that some Large Woody Debris (LWD) is pegged down on the shallows to promote local scour and sorting of river bed gravels. This technique is very simple and effective and can also have the knock on benefit of providing some small pocket pools where fish will lie up in the summer.
