Great Stour – Godinton Park

An advisory visit carried out by the Wild Trout Trust – July 2008

1. Introduction

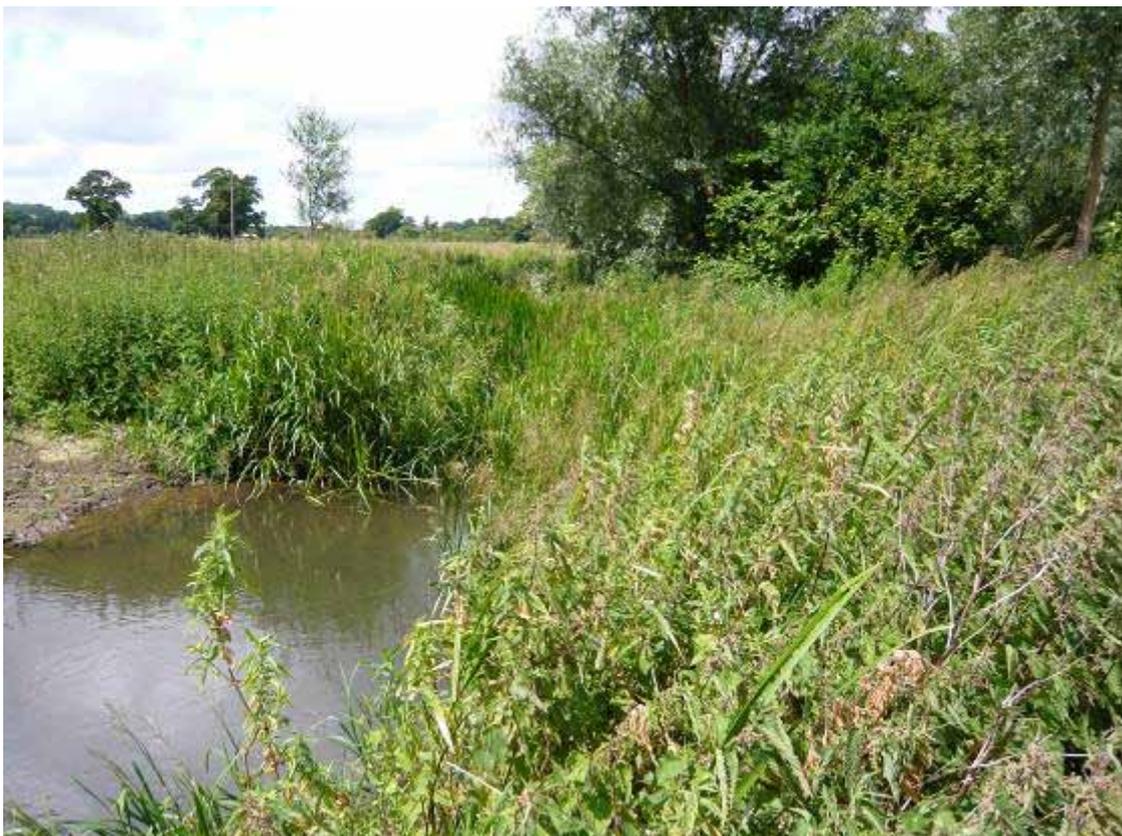
The lower third of the fishery has recently been subjected to an enhancement scheme designed and managed as part of an Environment Agency enhancement scheme. This project has taken a successful technique used on the River Darent, where a sinuous in-channel regime of pool, glide, riffle was created using an excavator to push existing bed gravels around within an historic over-wide river channel. The objective for the Stour project was to create some in-channel diversity along a realigned and dredged section of channel that was completely clogged with branched burr reed *Sparganium erectum*. Although some very deep pools have been created, it remains to be seen whether the work will benefit the fishery as a whole. Following some discussions about aspirations for the reach, it was decided that it would be sensible to allow the river to settle and for habitats to establish themselves before contemplating any further enhancements to this section.

Deep pool created using an excavator with the arisings used to narrow the channel

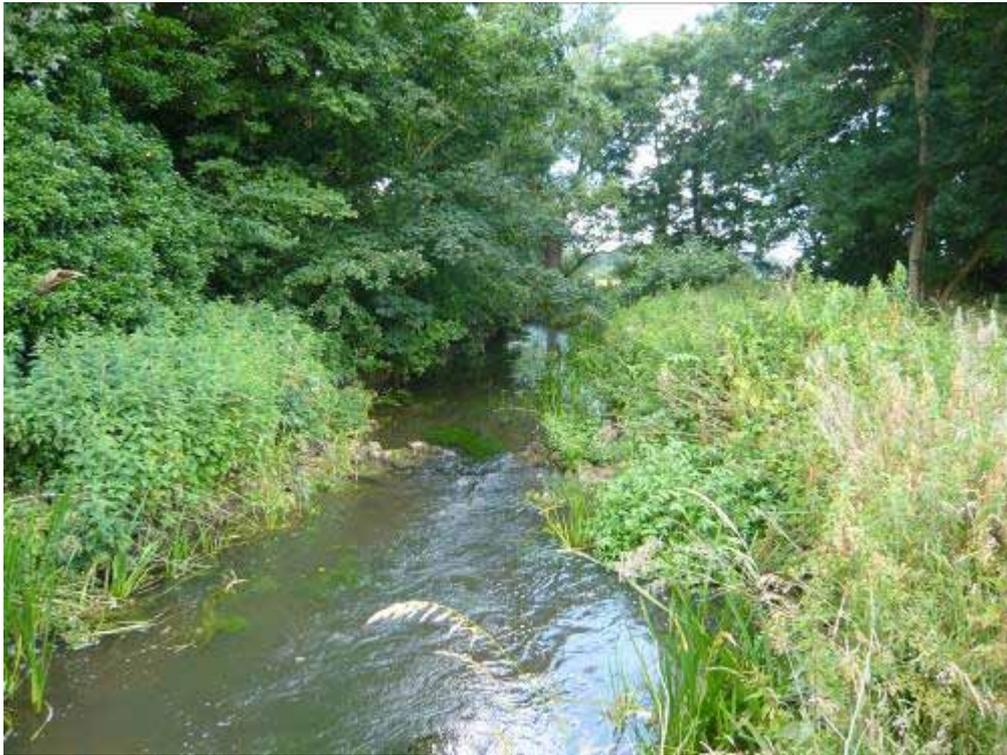
A low stone weir used to pinch the channel and create a central flume

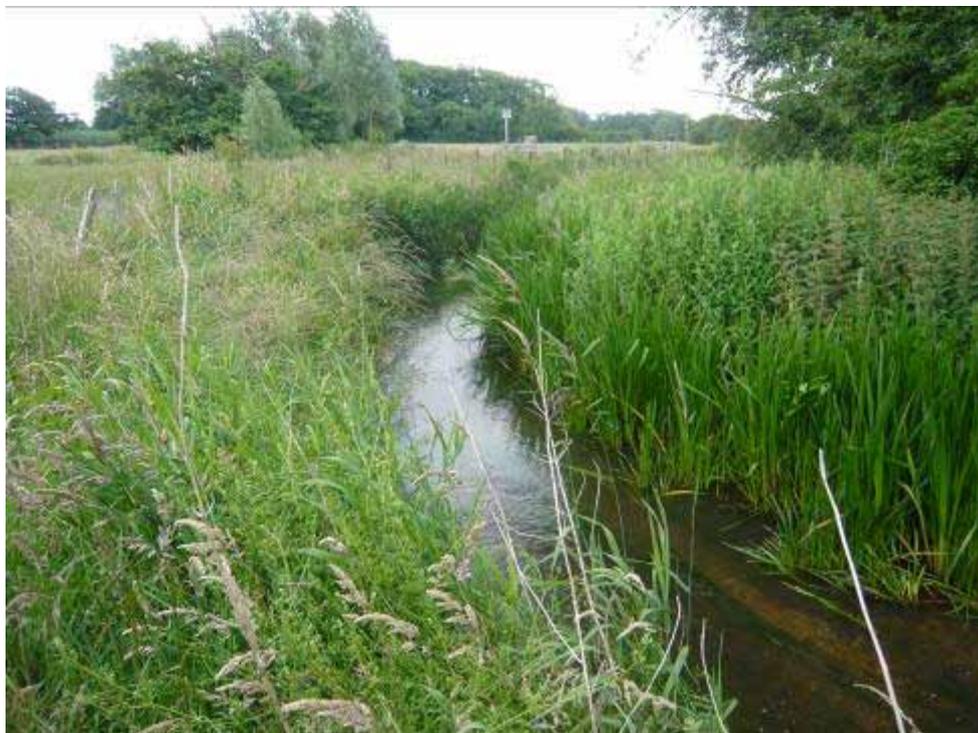
An excellent marginal fringe protected by stock fencing. Shallow gravel bed with plenty of inchannel cover - good trout water.

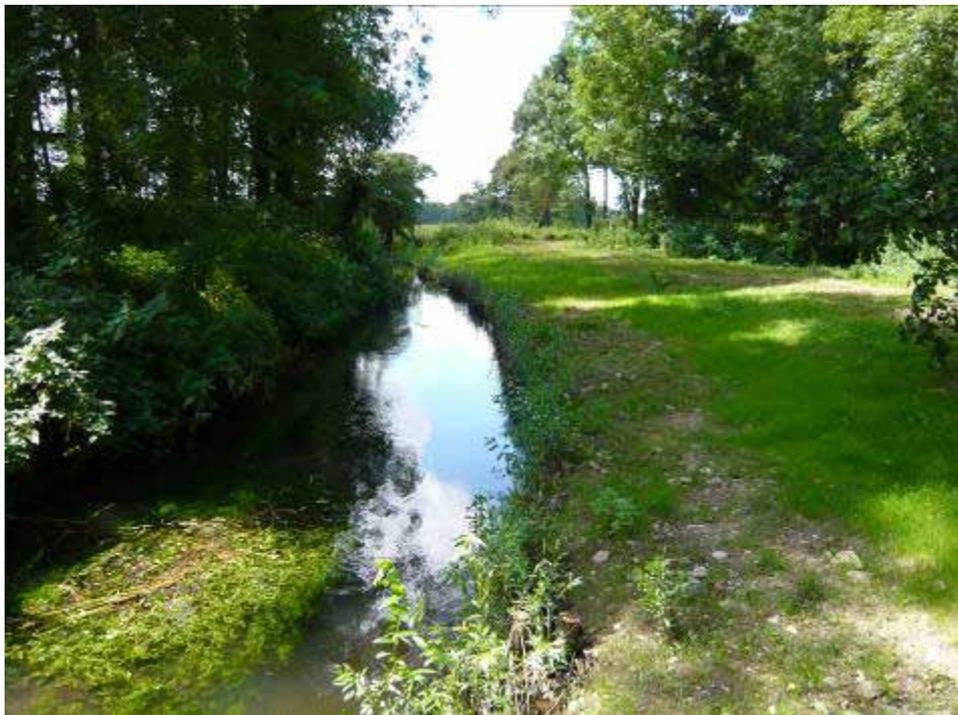
A recent enhancement has seen the syndicate narrow approximately twenty five metres of channel using a woven willow revetment and backfill obtained locally on the estate. The project has been very successful in terms of locally speeding up the river and creating a defined channel with good holding potential. Care should be taken in any future works to ensure that only appropriate local material is used in any backfilling operation. As most of the fishing is carried out from within the channel via wading there is no need to firm up the margins too much. A river bank, well protected with a thick fringe of suitable emergent plants and herbs is likely to become better established in soft, marshy soil, initially protected behind a natural woody revetment. Woven live willow is excellent but does sometimes have on-going maintenance requirements.

Live willow used to revet a newly narrowed section of channel

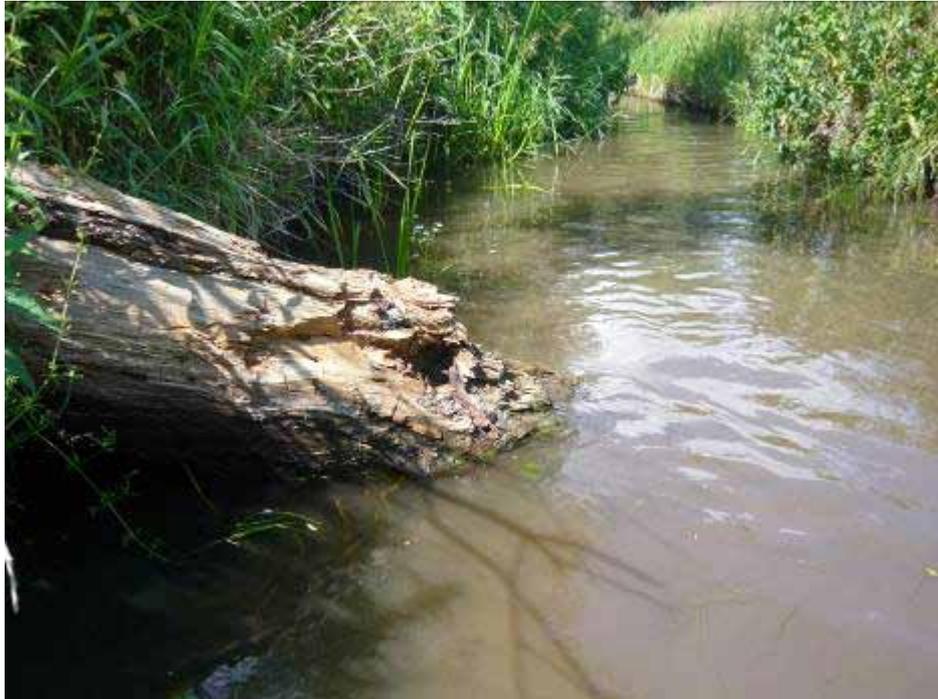
A number of small structures have been installed to promote local scour, deter plant encroachment and provide holding water for trout. Large pieces of fallen tree and stone has been used to create current deflectors. A number of the stone weirs have been present for many years and the material has simply been moved or replaced to create the desired outcome. Where these stone structures are obviously working they should be retained, however, it would be better to use large pieces of woody debris (LWD) in the future to promote scour and holding habitat. LWD has the benefit of being a natural material and so its

LWD used a flow deflector

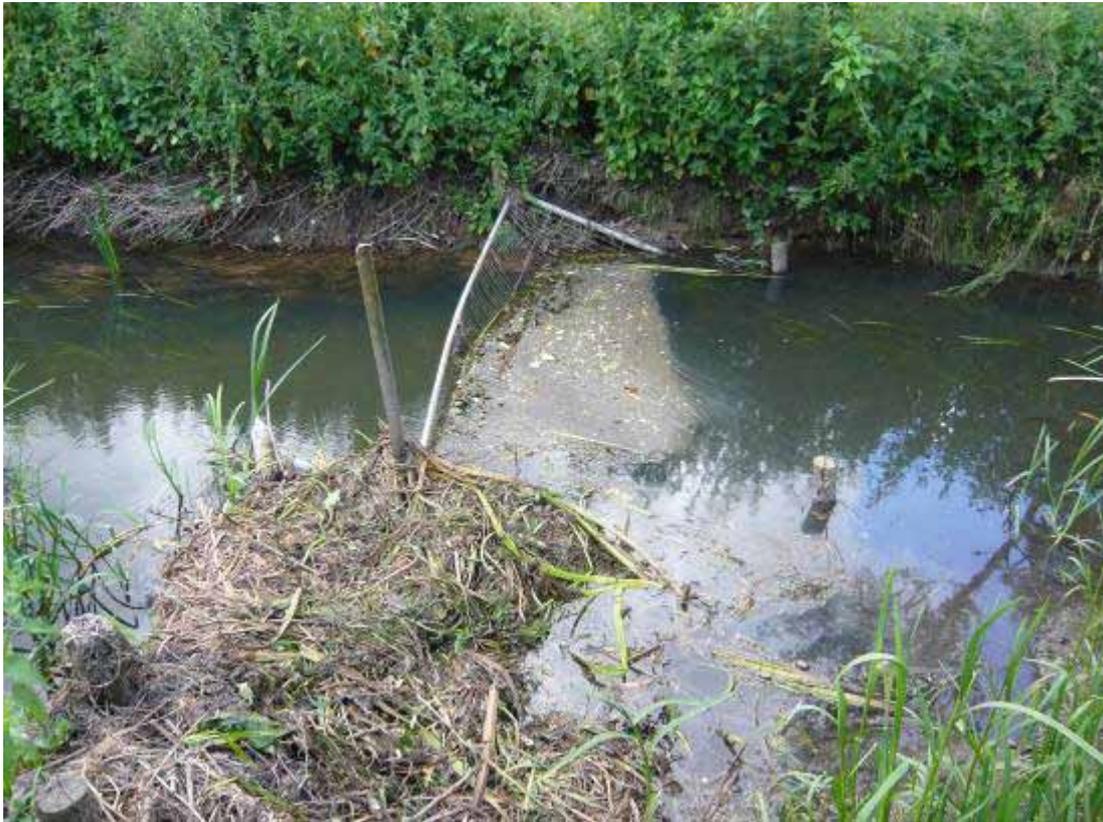
At the bottom of the improved section the syndicate have placed a rudimentary screen. This has been put in place to nominally deter pike from migrating up into the predominantly stocked and fished section. Excessive predation pressures are seen as a real issue for the syndicate members and controlling pike predation is seen as a priority. It is the opinion of the author that the screen is inappropriate and although it may at times deter large pike from migrating upstream it will also stop other species from navigating the river. In addition, pike are known to be well established further upstream. The screen will certainly not stop young of the year pike from making their way upstream and as a three year old jack is perfectly capable of taking a stocked trout there seems little point in keeping the screen. Screens also need regular maintenance and can pose significant flood risks. Pike in a stream of this size can easily be kept in check with two or three autumn pike fishing sessions. Research has confirmed that by leaving the odd larger female overall numbers are also trimmed through self predation. If this approach fails to work then it may be possible to have the reach electric fished. Hadlow College have in recent years carried out some pike removal work on behalf of a club further down the Stour and have agreed to relocate pike to a

It is recommended that the pike screen be removed

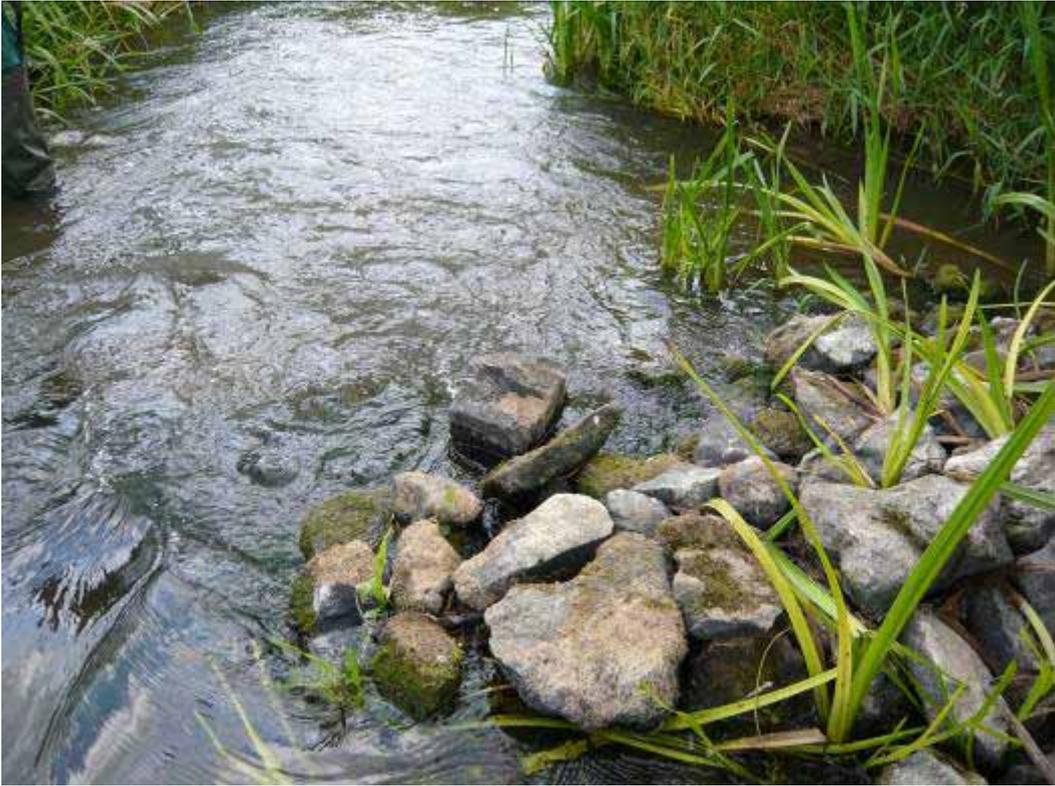
A stone half weir promoting increased water velocities

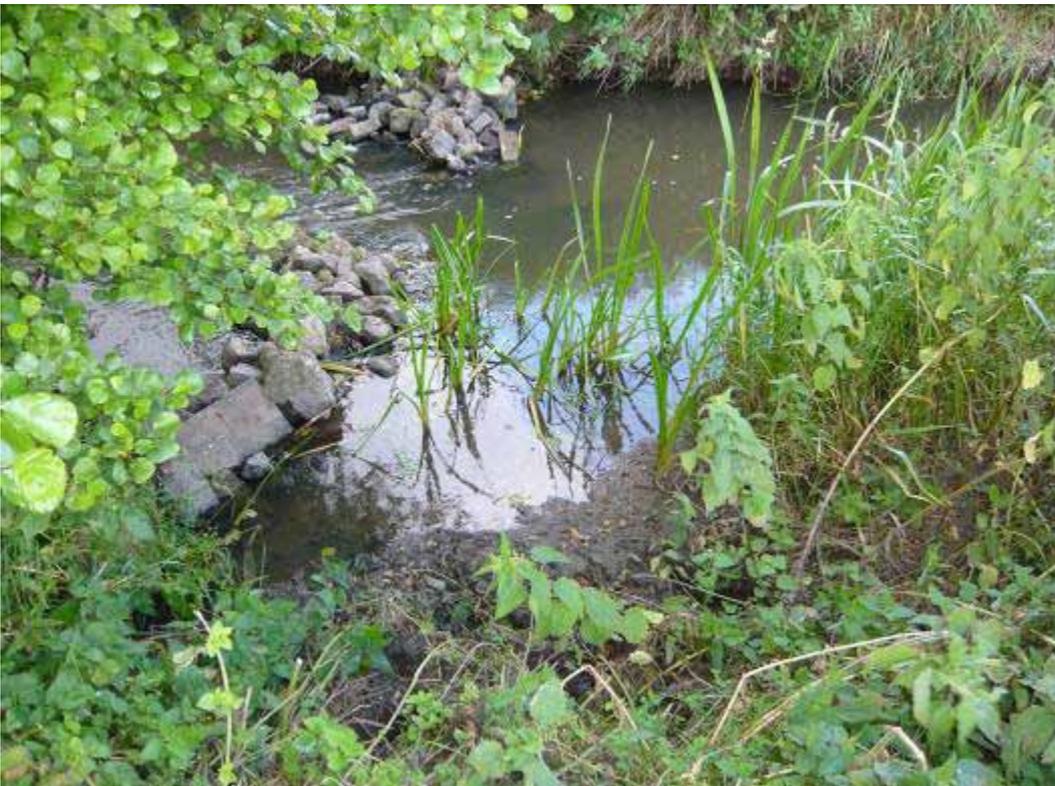
Care must be taken to ensure that where a flume is created it doesn't drown out potentially good habitat upstream

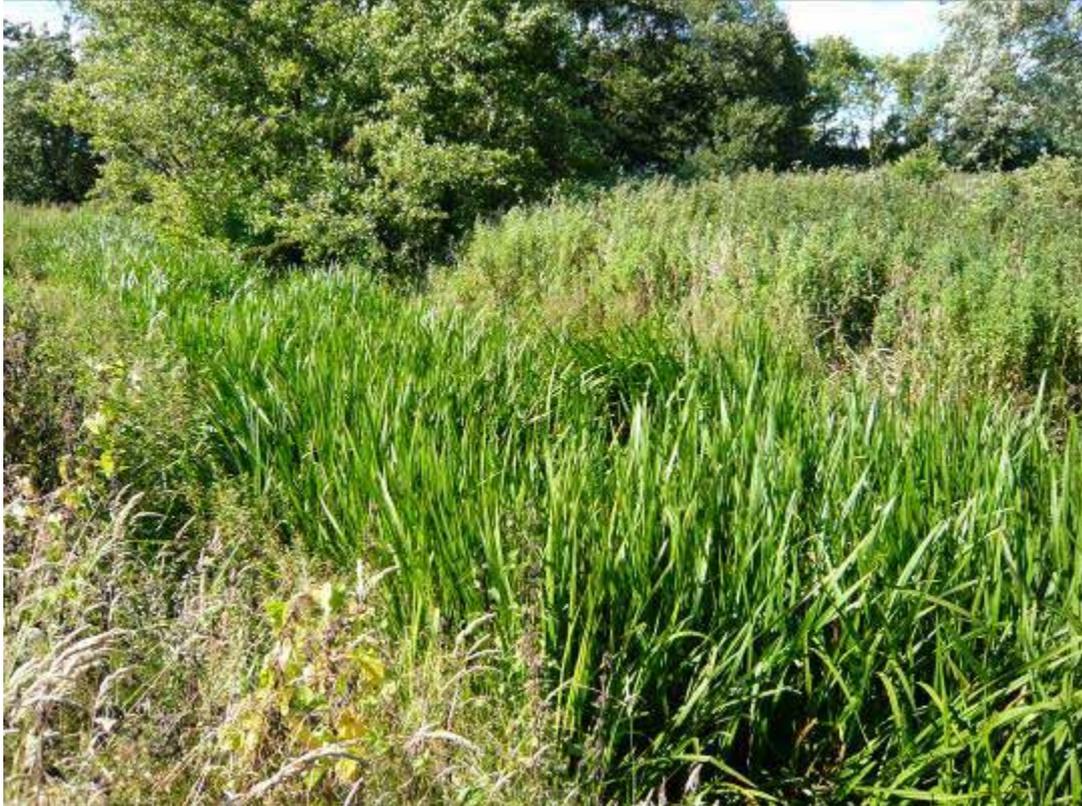
Much of the top section is choked by in-channel stands of burr reed. This has the net effect of backing the river up further, encouraging silt deposition and slower flows, which in turn favours the plant still further. It is highly likely that past land drainage works has resulted in the current imbalance and controlling this plant will be of fundamental importance in creating good trout habitat.

Bank to bank burr reed choking the channel on the upper section

There was much bankside discussion about how best to tackle this problem. Solutions ranged from hand digging or grubbing out rhizomes to using an excavator to scrape the roots out. Having discussed this problem with several colleagues, it would seem that a possible solution would be to treat the plants with a contact herbicide and re-establish the channel by importing gravels to replace the dredged materials. Removing the plants with a machine may result in further loss of in-channel gravels.

Herbicides should only be applied by trained operatives and any application within 8 metres of a river will require Environment agency consent.

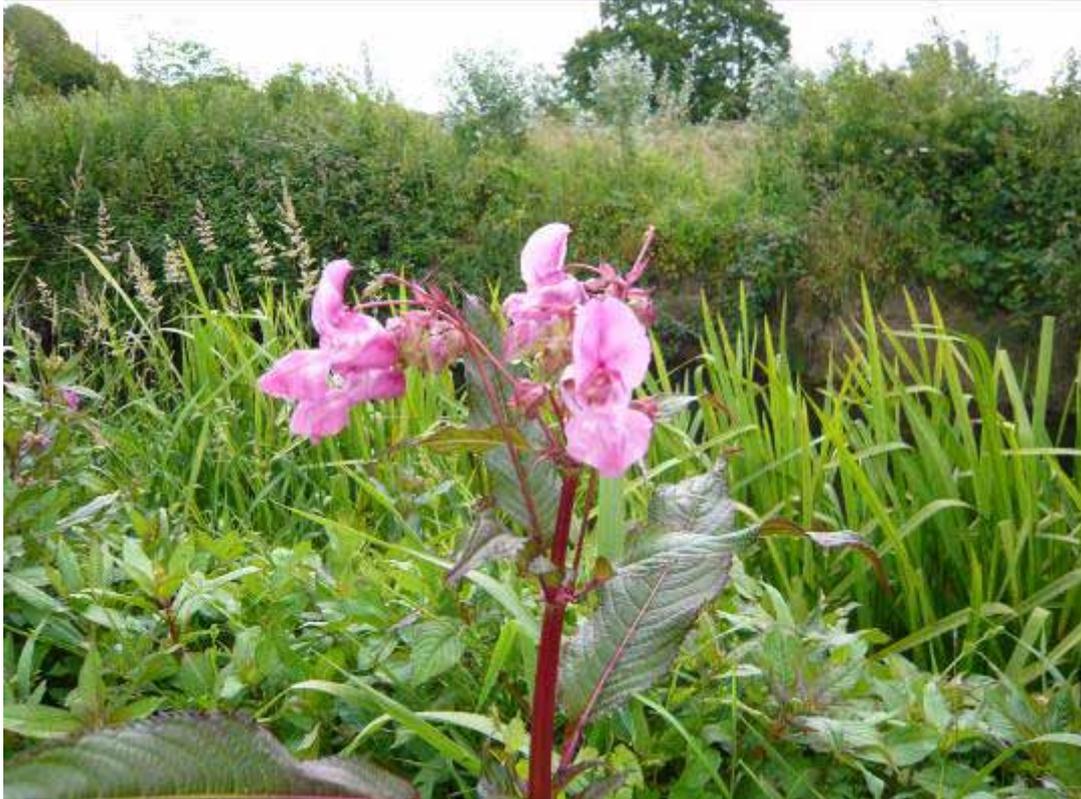
The non native plant himalayan balsam was evident on several sections

An area of potential concern relates to the presence of non-native plants. Himalayan balsam (*Impatiens glandulifera*) was observed on several sections of the river. It is a relative of the busy Lizzie and is known by a wide variety of common names, including Indian balsam, jumping jack and policeman's helmet. It is a tall, robust, annual producing clusters of purplish pink (or rarely white) helmet-shaped flowers. These are followed by seed pods that open explosively when ripe, shooting their seeds up to 7m (22ft) away. Each plant can produce up to 800 seeds. Himalayan balsam tolerates low light levels and, in turn, tends to shade out other vegetation, impoverishing habitats. In the autumn, the plants die back, leaving the banks bare of vegetation and vulnerable to erosion.

Currently only small patches were observed and it is recommended that efforts are made to eradicate the plant before it spreads too widely.

These plants can be easily pulled up by hand or treated with a contact herbicide (Environment Agency consent required).
