Honeybridge Stream

An advisory visit carried out by the Wild Trout Trust – June 2008

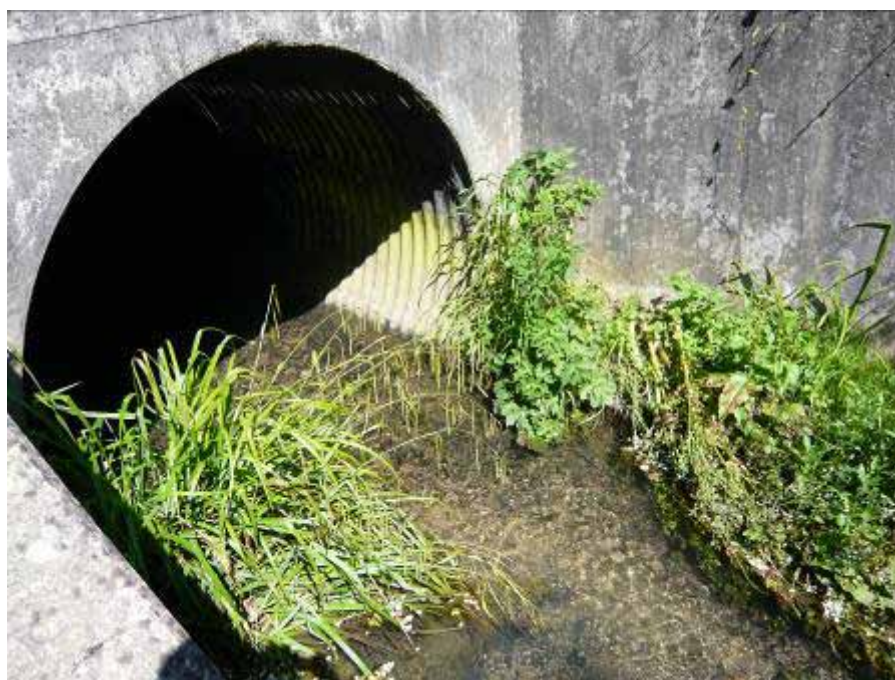
Culvert under the A24 marking the top boundary

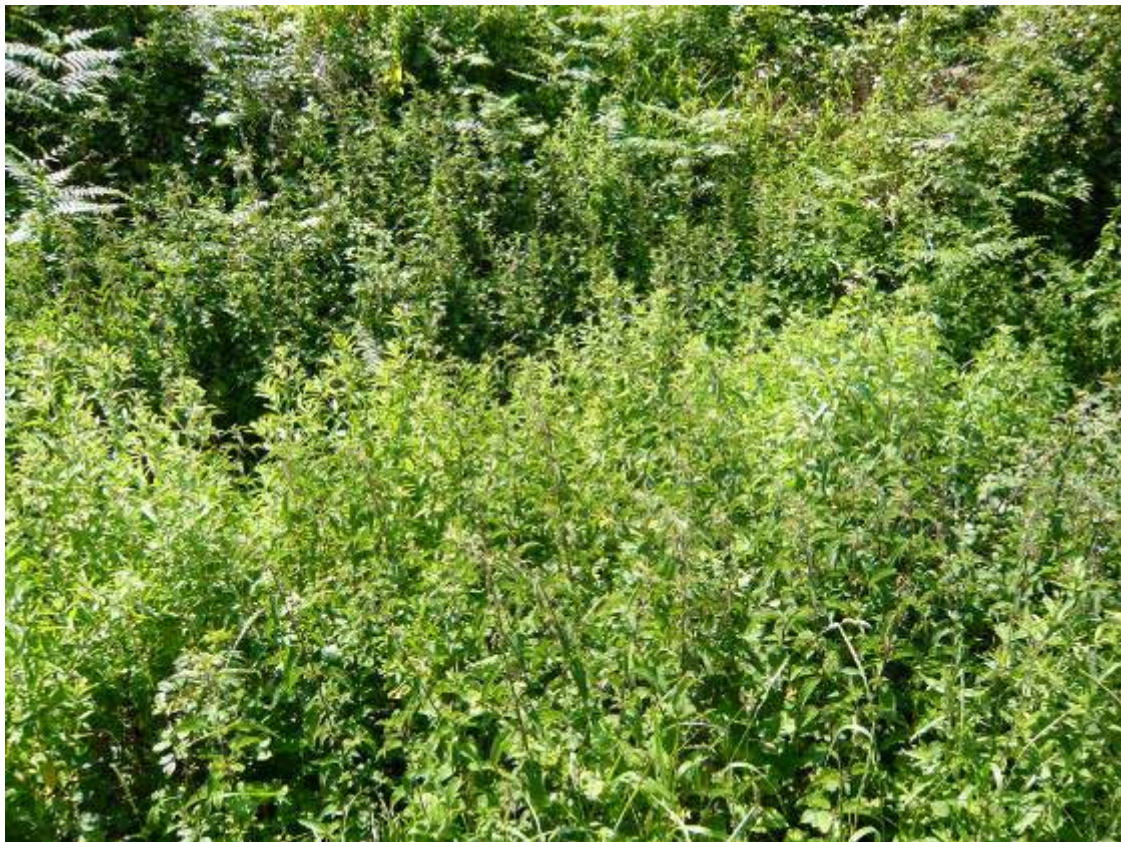
Throughout its length the river was extremely overgrown with thick stands of hazel, hawthorn and ash. The stream was only readily accessible in a few areas and generally the channel was in heavy shade. Even in the areas where the tree canopy was thin there was little light reaching the channel due to its incised nature and thick marginal growth of nettle and bracken. Most Sussex rivers were subject to heavy and unsympathetic land drainage schemes during the 1950s and 60s and it is highly likely that much of the Honeybridge stream was dredged to improve agricultural drainage of adjacent meadows.

Stands of nettle and bracken dominate the deep, incised channel

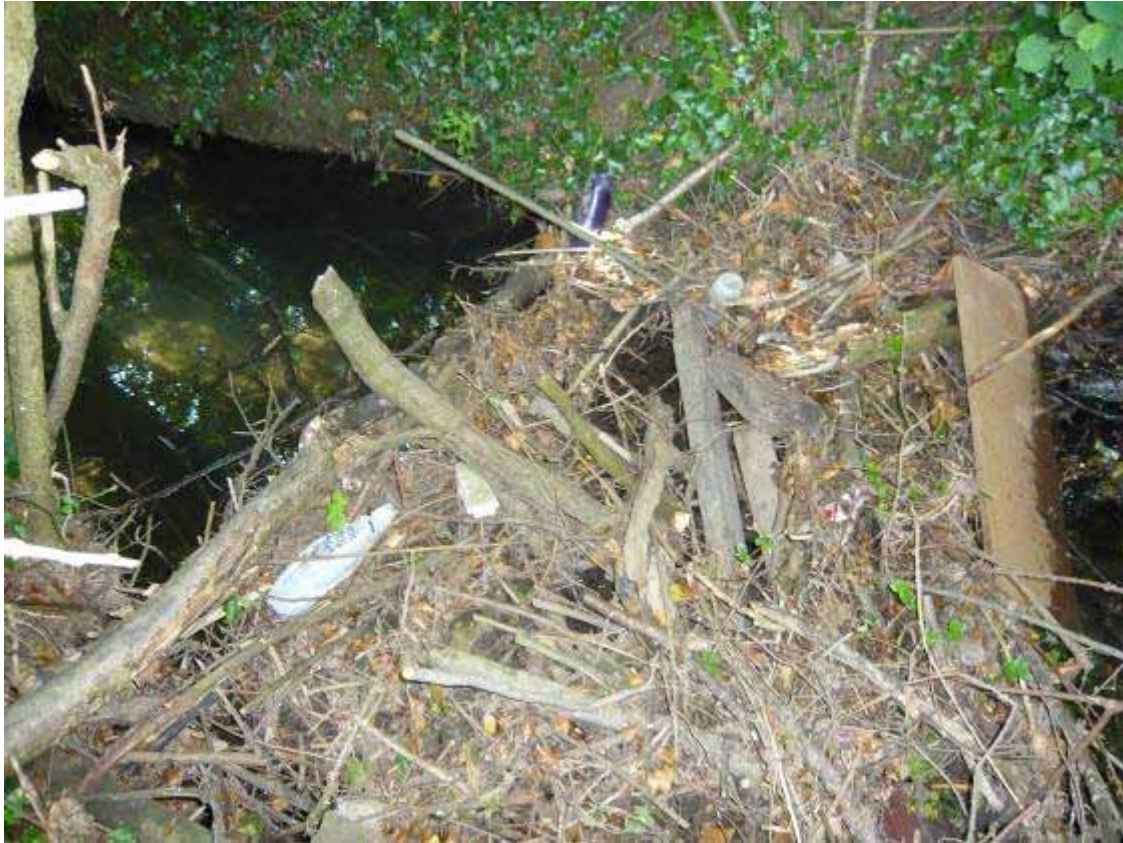
Debris dam on the Honeybridge stream

Discarded rubbish and cut timber is not desirable in any debris dam and occasionally when clogged with fine material they can create some difficulty for migratory salmonids. This is rare however, as most debris dams have undercuts that usually make them easily passable for fish, especially after any significant rainfall event. Removing the rubbish but retaining the large woody debris usually allows for access for migratory fish whilst still allowing the dam to actively promote channel scour, promoting pool habitat and freeing up fresh gravels for spawning.

Understanding the role of fallen timber in these streams is crucial. If management is contemplated then you should adopt a policy of retaining LWD in the river channel wherever possible. The West Country Rivers Trust provides a useful guide to the management of natural LWD:

1. Is the debris fixed, if yes then continue to 2, if not continue to 5.

2. Is the debris causing excess erosion by redirecting the current into a vulnerable bank? If yes then go to 5 if not then go to 3.
3. Would fish be able to migrate past it (take into account high river flows). If yes got to 4, if no go to 5.
4. **Retain the woody debris in the river.**
5. **Extract the debris.**

Note: If the debris dam needs to be removed but there is still a significant amount of the root system attached to the bank then it is recommended that the stump be retained for its wildlife habitat value and its stabilising effect on the bank.

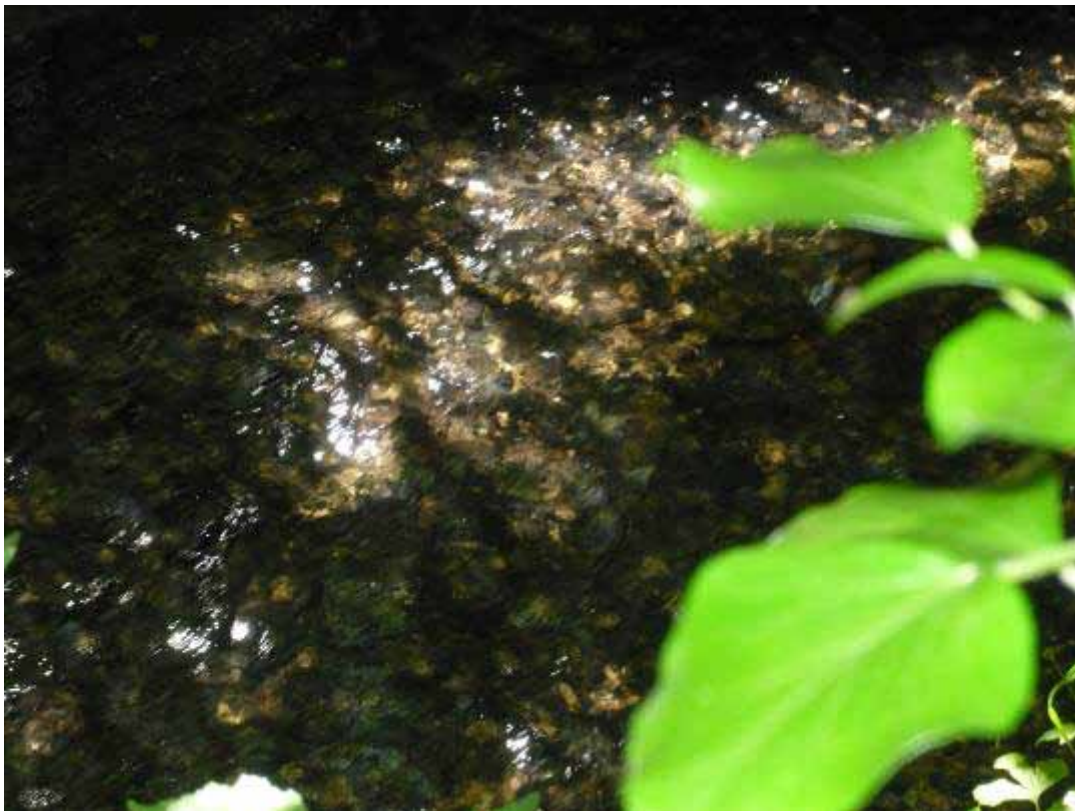
Trout and sea trout spawning and nursery habitat was relatively abundant with plenty of gravel riffles. The gravel did not appear to be too compacted and there was lots of shallow marginal cover for juveniles in most locations.

A typical example of a Honeybridge Stream riffle. An excellent spawning habitat with some dappled light reaching the bed.

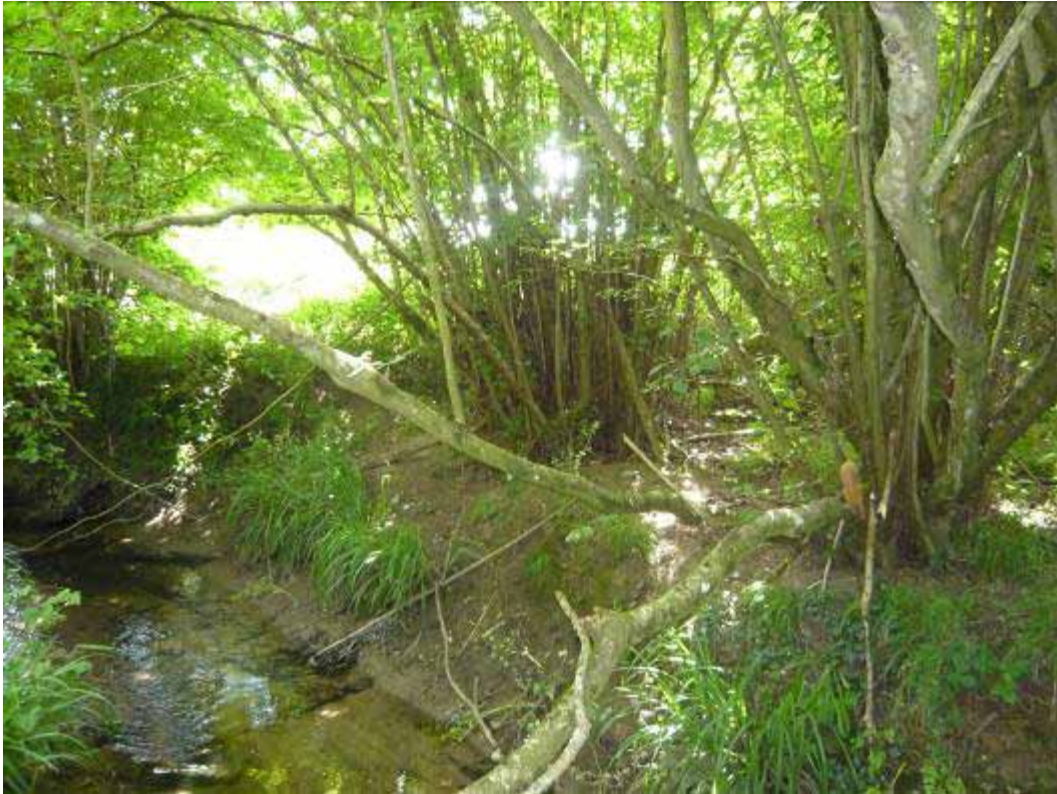
Evidence of previous coppicing. Some rotational coppicing will help to promote marginal herb growth which in turn will stabilise the banks and help prevent bank erosion and potential silt deposition.
