Little Ouse at Knettishall

A Project Proposal by the Wild Trout Trust - April 2015

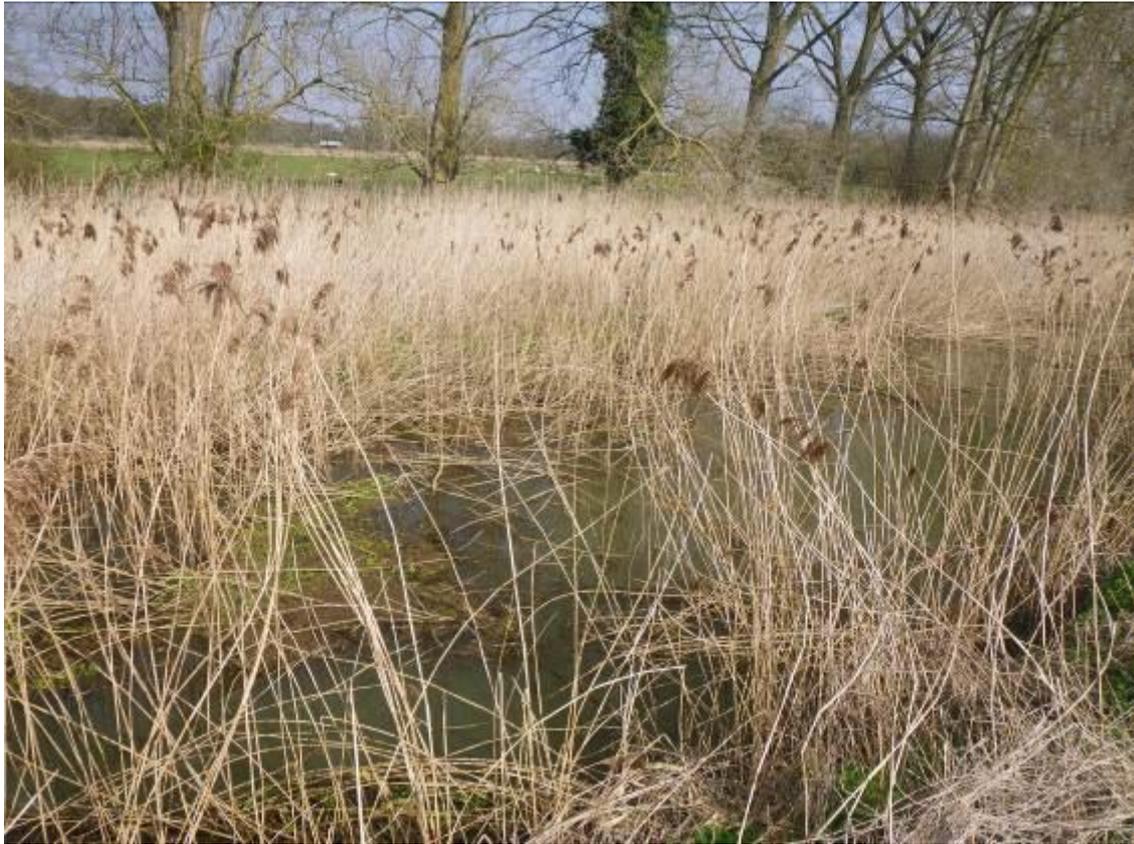
Habitat quality within the target reach running upstream from Knettishall Heath Bridge can best be categorized as straight, uniform glide habitat flowing over a soft, sediment-laden river bed. The RB margins are ill-defined, without a conventional river bank and in places are dominated by emergent reeds, mainly *Phragmites australis* (photo 1 and cover). The LB is more clearly defined and has been raised, in all probability as a direct result of many years of maintenance dredging, or weed clearance work.

Photo 1. No defined river bank on the RB and dominated by Norfolk reed

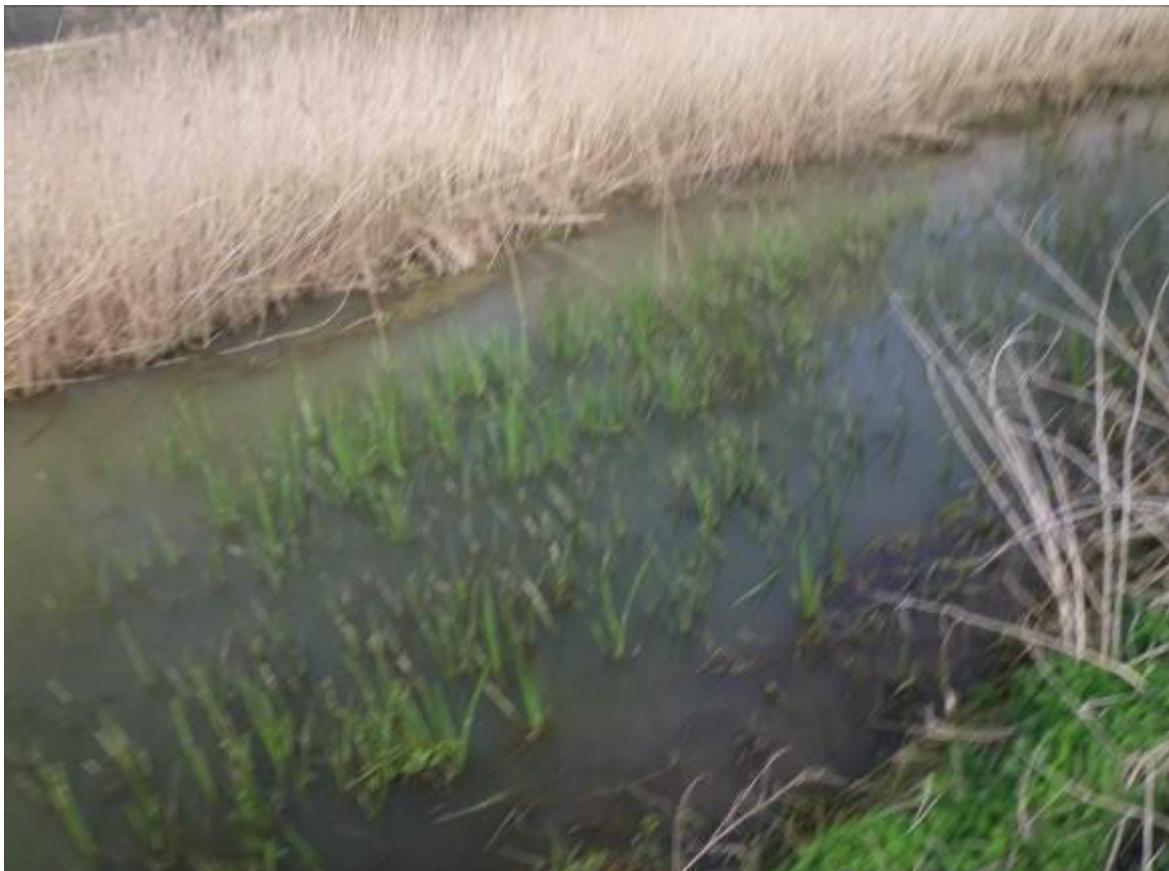
Dense beds of emergent watercress *Rorripa* sp, were also present in the margins and were comparatively dormant at the time of the site visit in early April. In a few locations, beds of emergent burr reed *Sparganium* sp, have established, sometimes in central channel locations (photo 2), as well as isolated clumps of yellow flag iris *Iris pseudacorus* in shallower marginal areas.

Photo 2. Branched bur reed, encroaching into central channel locations.

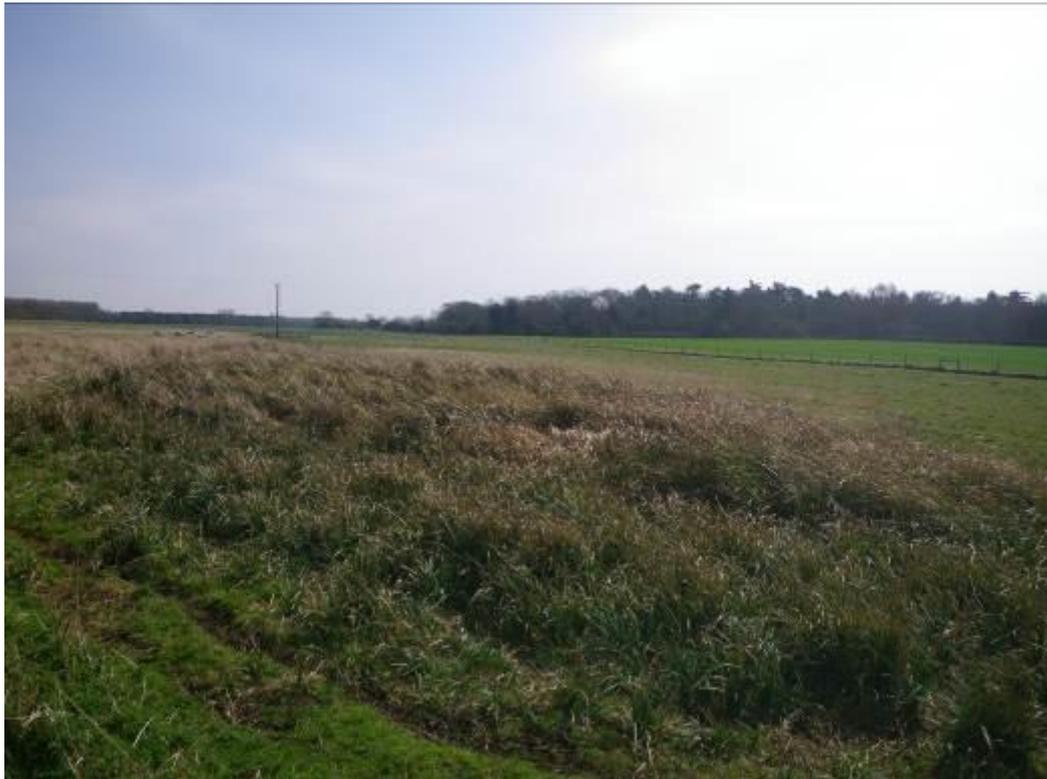
Photo 3. Sedge could be won to form scrapes in the LB meadow.

One option to create support on the outer edge of low, wet berms is to relocate sedge sods, which are currently growing in low-lying damp areas of the adjacent LB meadow (photo 3) and use them to create a new, low bank line. Potentially these plants and associated root mass can be dug up whole and used to form the revetment. Hopefully the material will be "sticky" enough to have sufficient integrity so that it can be swung into position and pushed in place with the bucket of the machine. Some in-channel redistribution of existing river bed sediment deposits may also be required to ensure the outer edge of the revetment is sufficiently shallow enough to support the new revetment.

If this work were to be sanctioned, it would create additional new habitat in the meadows through the action of winning the sedge sods and creating wet scrape habitat. Temporary standing water, particularly in the winter and early spring might encourage a more diverse range of species to colonise, or temporarily visit the area, including wading birds. An early conversation with the land owner is recommended to explore whether or not there is potential to win the necessary materials and create a new habitat in the meadows, as well as in the river.
