Wild Trout Trust Habitat Advisory visit  
to the Little Brosna, Counties Offaly  
and Tipperary .  
Undertaken on behalf by Vaughan  
Lewis, Windrush AEC Ltd  
September 2011

## **1.0 Introduction**

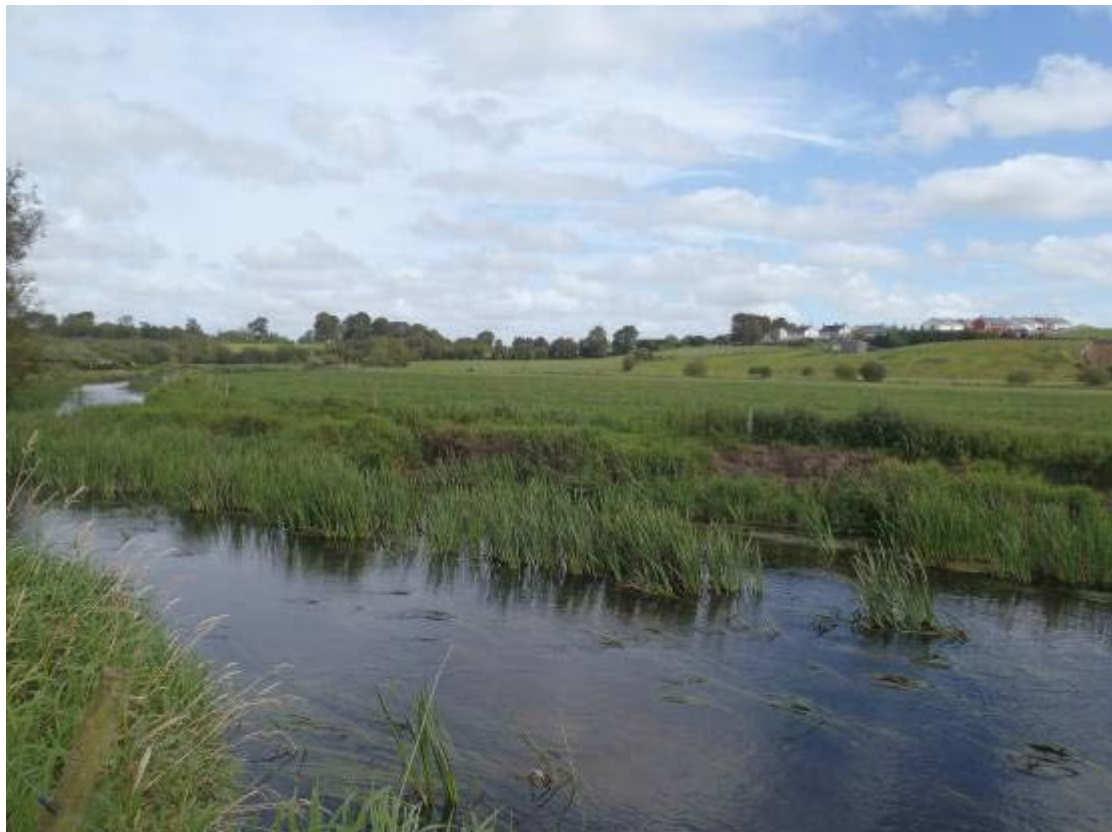
The main section walked was reach of some 600m downstream of Birr. The river at his location ran between grazed grass fields on both banks. Long sections were unfenced, with significant erosion in places. Where the banks had been eroded, extensive stands of emergent vegetation had grown in the river. The consequences of this damage were a general over-widening and shallowing of the channel, with a reduction in water velocity and scouring of the bed.

**Typical length of the Little Brosna showing eroded bank and resulting emergent vegetation stands**

- ❖ Fencing of the river bank, either seasonally or permanently is vital to reduce the damaging impact of overgrazing. There is also a need to provide a clean water supply once fencing has been erected, probably by the construction of well-designed cattle drinking areas. Fencing should ideally be erected at least 5m from the river in order to create a well vegetated buffer strip capable of reducing erosion and minimising run-off from the adjacent fields. Densely vegetated buffer strips of this type will also benefit other key species including otter, hence increasing its general value to wildlife interests.

- ❖ Bundles of smaller logs/brushwood can be securely pinned to the banks of the streams where erosion has taken place. They not only help to protect the bank (particularly willow that will re-grow into the bank, helping to form a protective living mattress) but provide dense and valuable cover for juvenile trout.

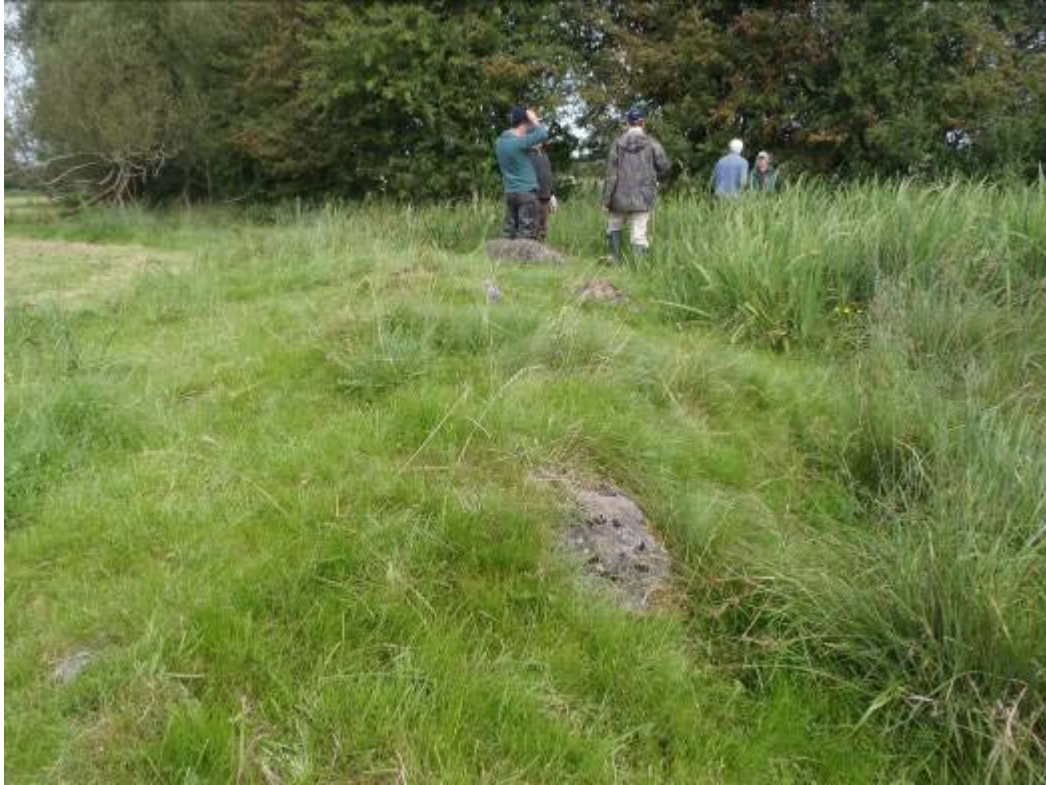
The resulting channel was some 12m-15m wide and heavily incised following past dredging, with the bed perhaps 2m lower than the natural level. The river was gently meandering, with a depth varying between 0.3m and 1+m. The evidence of the extent of the past dredging was abundantly clear from the raised bund on the LB and the associated piles of exposed stone.

### **Raised bund of dredged material on LB with rocks clearly visible**

Stone and gravel for riffle construction may possibly be obtained from on-site excavation of the spoil from previous dredging deposited on the river's edge. This will not only be the cheapest option, but will remove the undesirable bund alongside the LB of the river. If this option is not possible, then gravel and stone will need to be imported to the site from a nearby quarry.

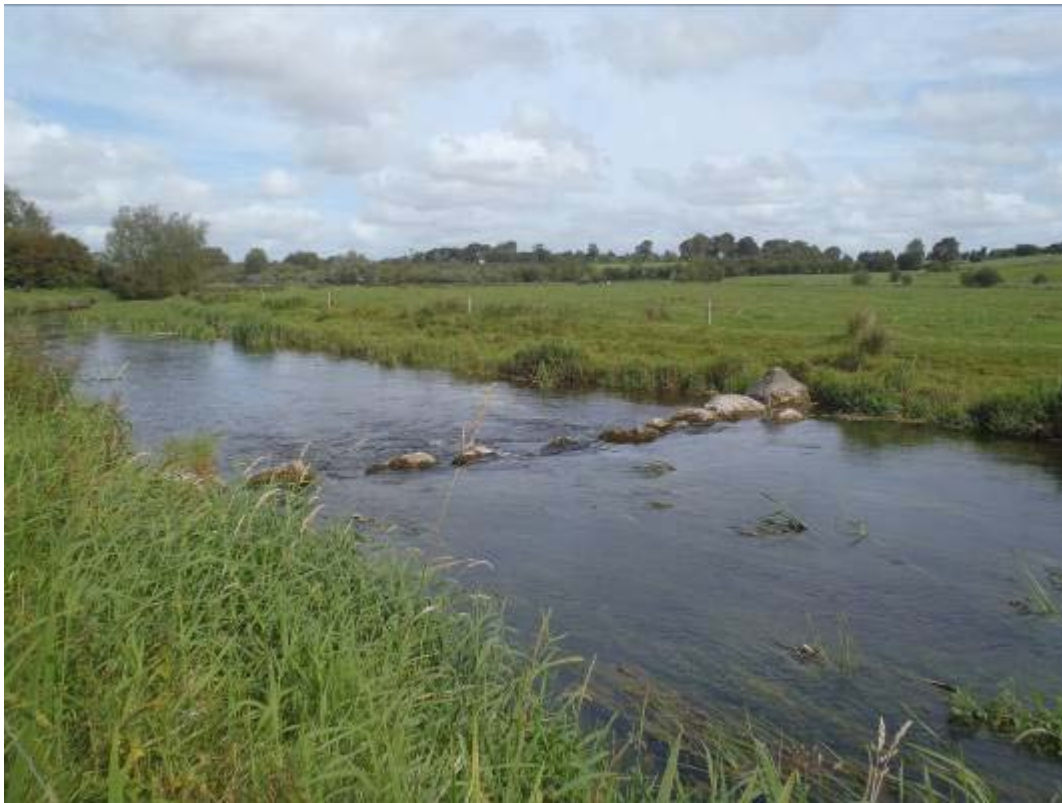
A series of small stone weirs had been installed in the past in an attempt to improve habitat within the fishery.

**One of series of small stone weirs present in the fishery**

- ❖ The small stone weirs should be totally or partially removed so as to reduce their impounding effects. The stones resulting from removal can be spread at random in the downstream reach, forming individual lies for trout and salmon, or used to form 'D' shaped deflectors (see below)
- ❖ There is a lack of LWD in the channel. This is important for scouring channel form and creating areas of deeper water and gravel shallows. Where possible, trees should be introduced into the channel at strategic locations and fixed using a combination of wooden stakes, metal pins and wire. Generally, LWD should protrude up to 50% of the width of the channel, and should face in an upstream direction to optimise mid-stream scour. Further details are available from the Upland and Chalkstream manuals on the WTT website.

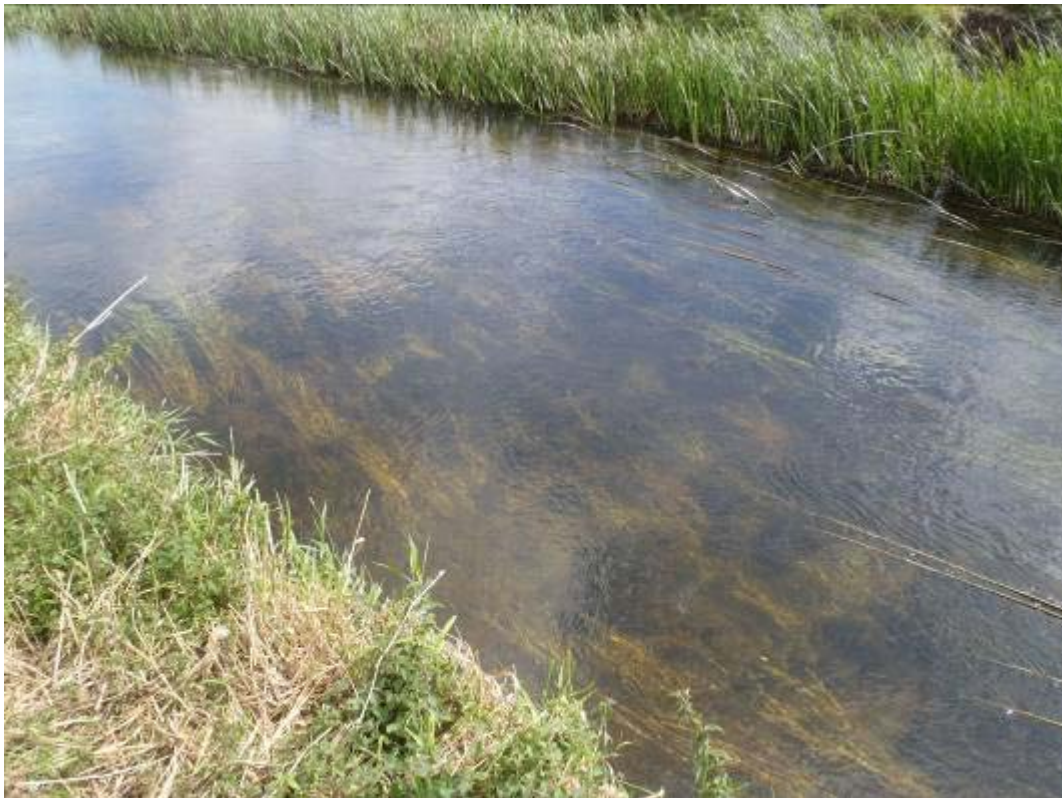
Mixed submerged and emergent weed was common throughout the fishery, with species including un-branched bur-reed, common rush, water crowfoot, starwort and hemlock water dropwort present.

**Extensive growth of submerged weed**

The impacts of nutrient enrichment are expressed by the luxuriant weed growth in the river, with the water quality perturbations reflected in the presence of pollution tolerant macro-invertebrate species.

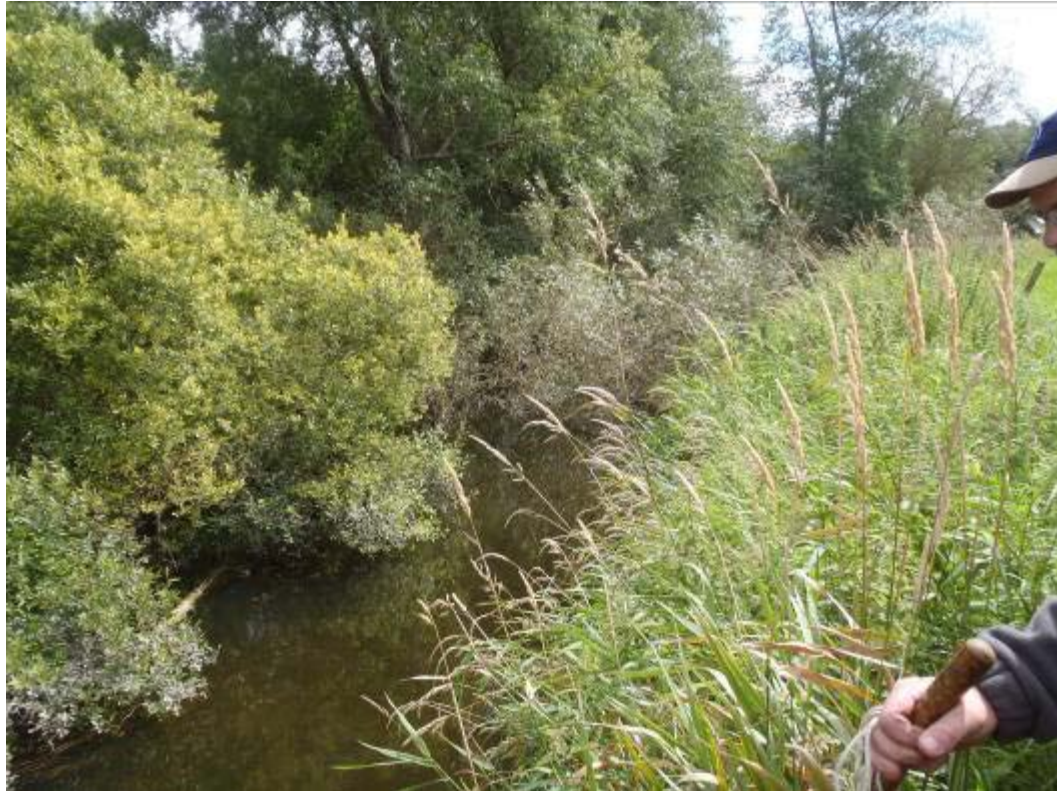
The lower section of the reach was deeper and more impounded, as a result of the general morphology of the river, and partly due to the influence of an increased abundance of Large Woody Debris (LWD), which had in places formed significant debris dams. There was also significant shading in this section as a result of extensive riparian tree growth on the RB.

There was again a significant bund of deposited dredgings on the LB, and evidence of extensive cattle poaching in places.

### **Deeper downstream section showing shading by riparian trees**

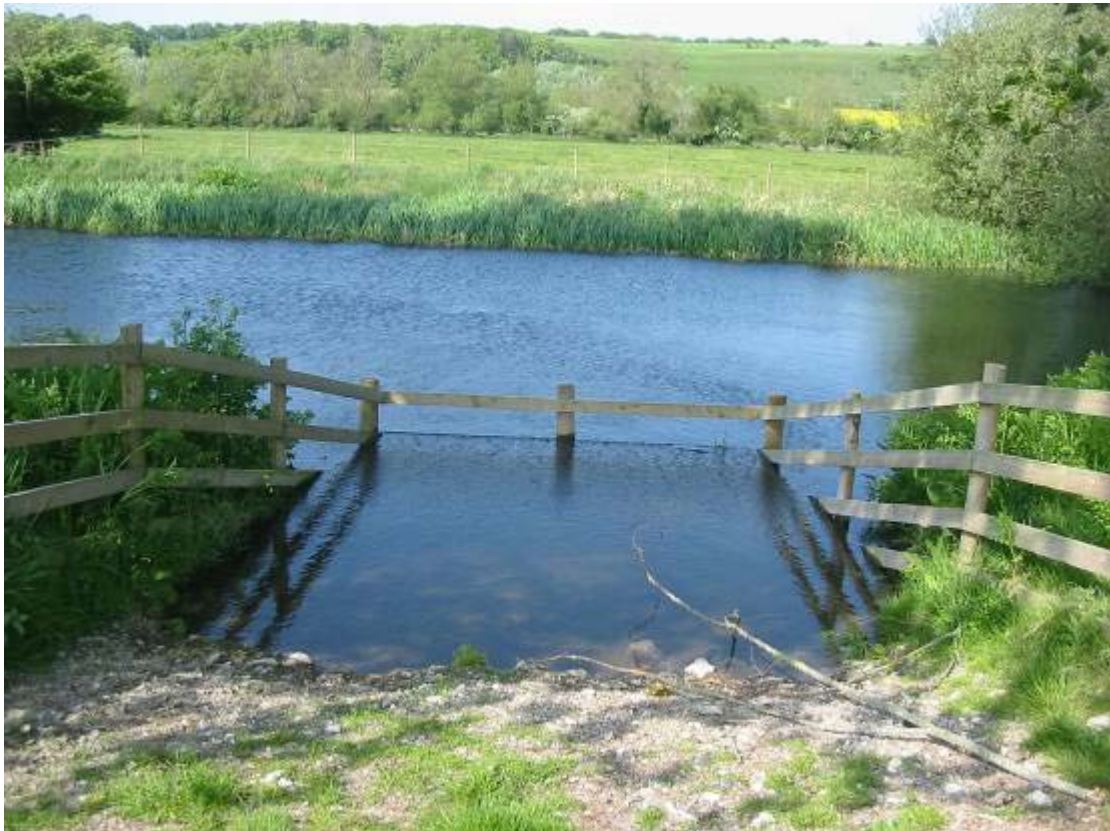
**Well designed cattle drinking area**

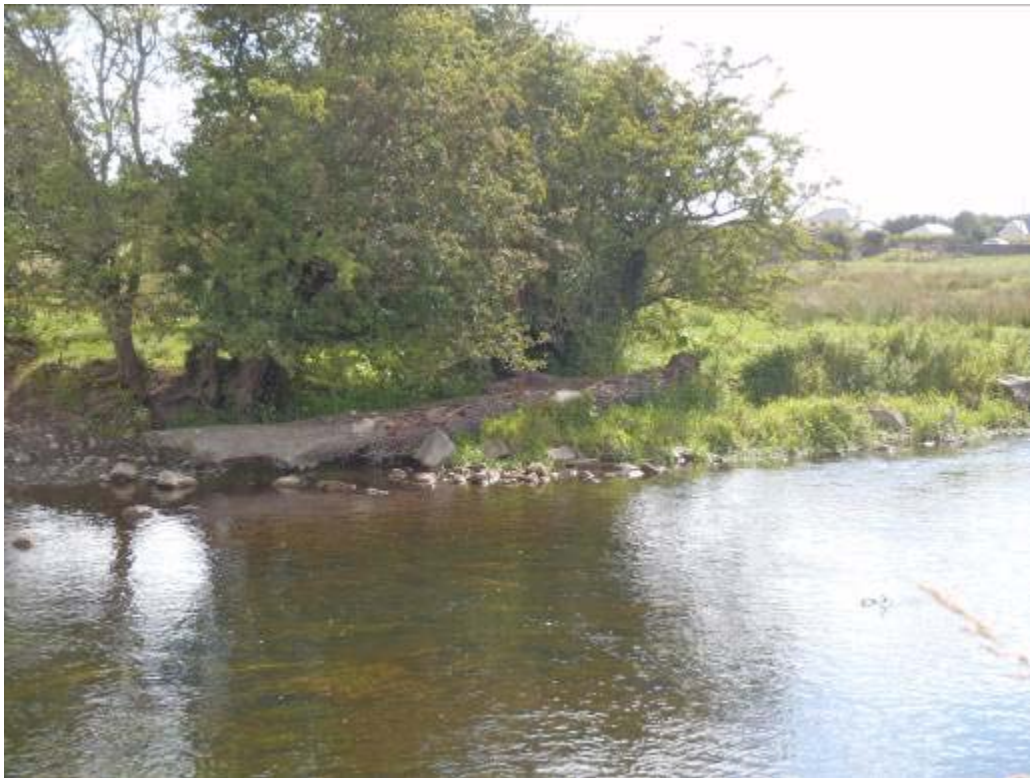
### **Tree trunk on RB of the Little Brosna: a suitable candidate for introduction as LWD**

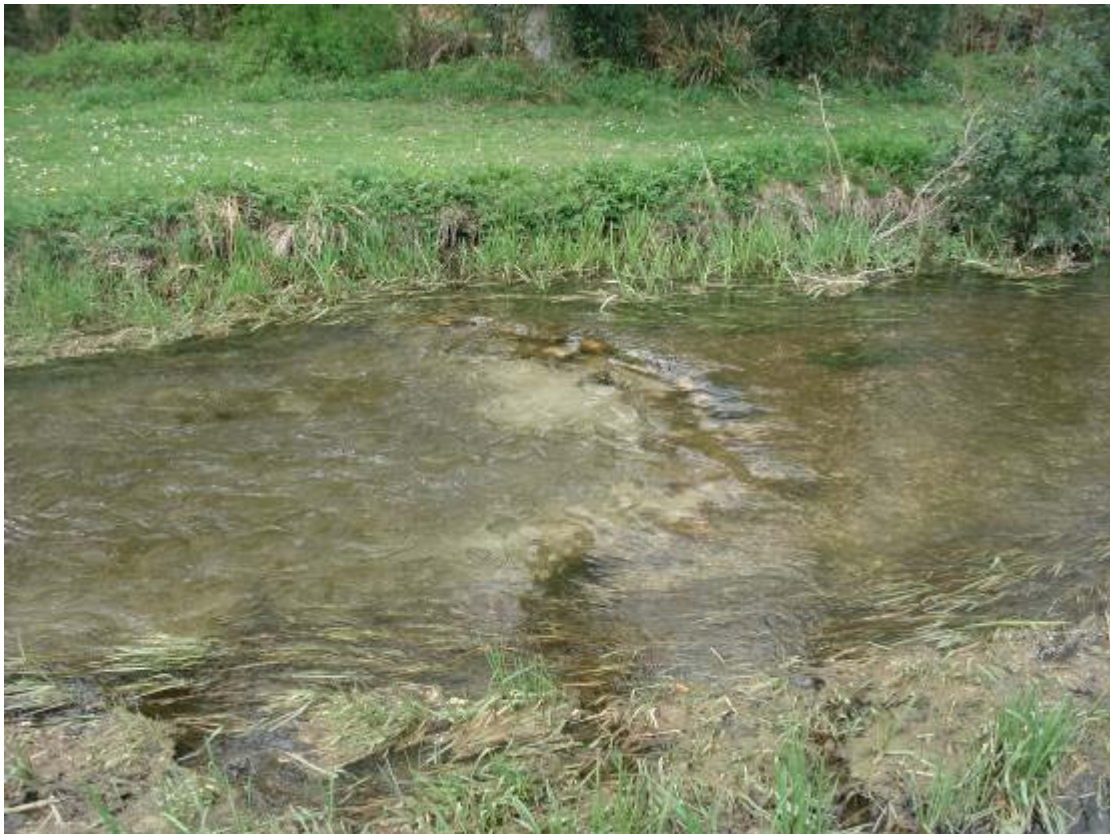
#### **A 'D' shaped deflector in a small limestone stream**

- ❖ Increased amounts of cover and bed variation can also be provided by the use of stone deflectors. These comprise of a series of large boulders arranged into a rough upstream facing 'D' shape in the centre of the channel. In combination, they increase water velocity creating scour and cleaning fine sediment away from potential spawning gravel.
