River Medway – Kingscote

An advisory visit carried out by the Wild Trout Trust – November 2010

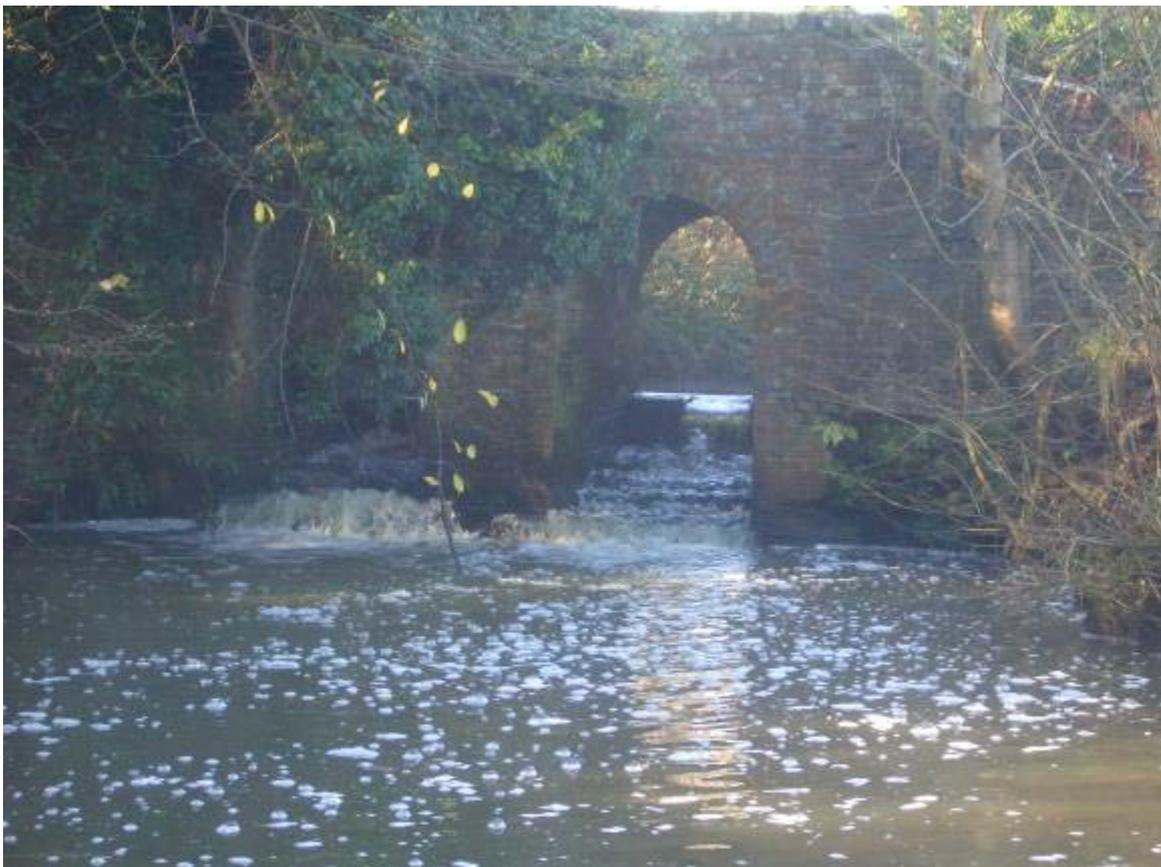
The weir (cover photo) impounds the stream for a considerable distance upstream, resulting in comparatively deep water with slow flows. Habitat suitable for wild brown trout was scarce on this section although the occasional adult fish has apparently been caught here. No suitable habitat for trout spawning (shallow, gravel-bottomed glides) or habitat for supporting juvenile trout was seen until a considerable distance upstream, when the impounding effect of the weir was lost. A small tributary which enters the RB of the main stream a short distance above the weir has potential to be developed into spawning and juvenile habitat.

The impounding effect of the weir is having an adverse effect on habitat quality on the reach upstream of the structure. It is recognised that this might be a listed structure and modification not desirable. If the height of the impoundment could be lowered by removing some blocks from the crest of the weir then improvements to upstream habitat quality will develop over time. Lowering the impoundment will also help fish to freely migrate up and down the stream over a much wider range of flow conditions.

- Explore options with the Environment Agency for lowering the crest height of the impounding weir.
- Leave as much fallen woody material in the channel as possible.
- Do not be tempted to peel the marginal reed fringe back too far. A narrow but briskly flowing channel will suit trout better than a wide, deep and slow-flowing one.
- Control emergent bur reed when it starts to grow in central channel locations potentially blocking the channel and backing up flows.
- Plant some additional willows (sallow) or thorns to promote low overhead cover on long open sections above the weir, particularly over pool habitat or on the outside of bends.
- Consider introducing more structure into the channel on the top and bottom beats, particularly on shallow gravel sections by using LWD flow deflectors to scour pots and promote ramps of loose gravel for improved spawning opportunities.

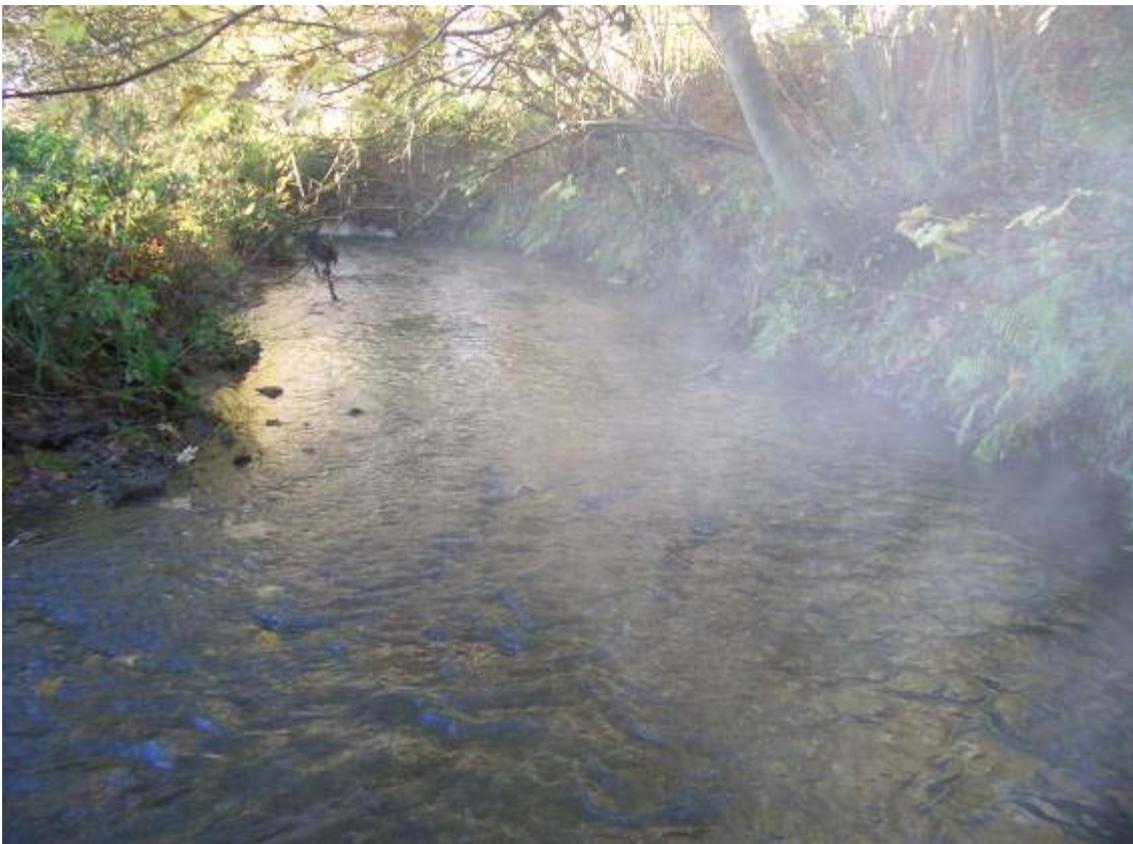
A long gravel riffle downstream of the weir. A good habitat for spawning and juvenile trout.

There was some first class spawning habitat a short distance below the weir pool. These sections could be further improved with the addition of some large woody debris (LWD) flow deflectors to help locally scour small pots in the gravel bed and blow out and sort gravels into small ramps idea for trout spawning. Creating occasional small "pockets" in the bed of the riffles will also encourage some larger trout to hold throughout the year. Details of how to create this type of habitat is described in the conclusions and recommendations section of this report.

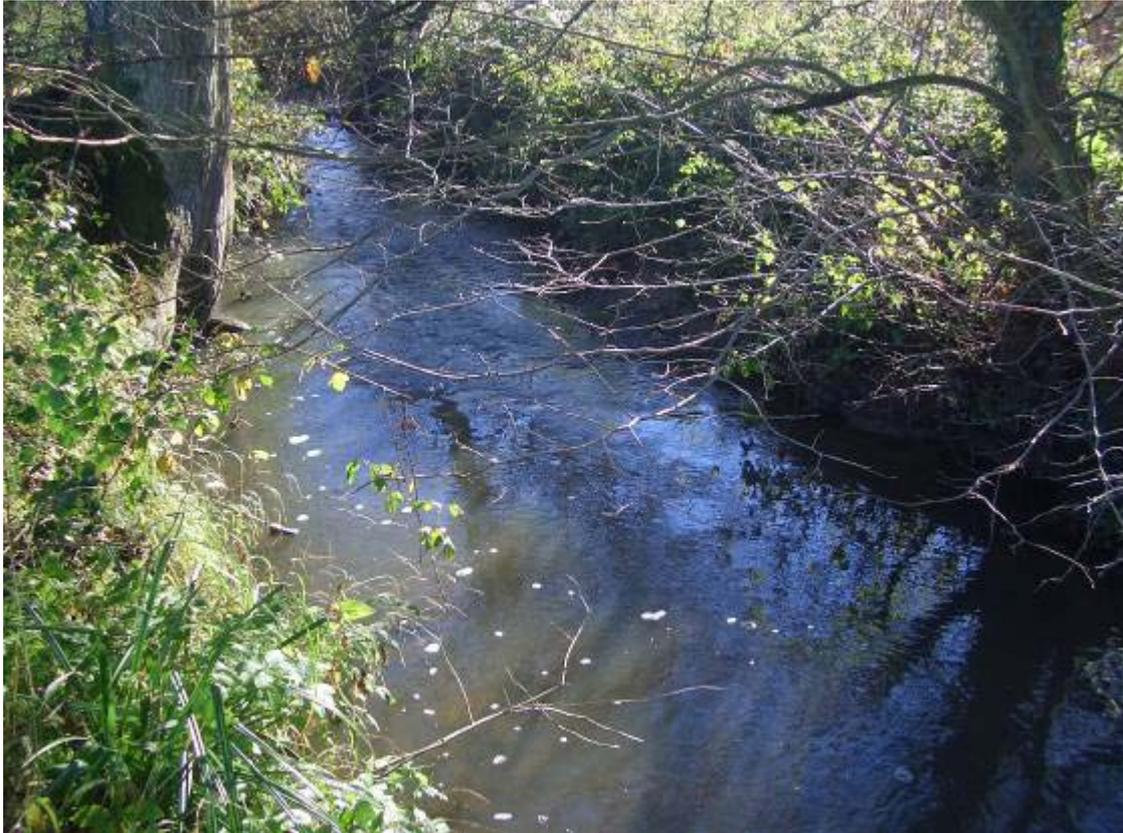
Typical holding pool on the bottom section.

Numerous high quality holding pools like the one above were seen. Many of these were rendered virtually unfishable by a tangle of shrubs and brushings. Light thinning of some of the high level brush will bring the water into a fishable condition. It is vital however, to maintain as much of the low brush and overhanging scrubby cover as possible. Taking out the odd branch to facilitate a cast here and there is perfectly possible but wholesale clearance must be ruled out if the wild trout that are present are to remain.

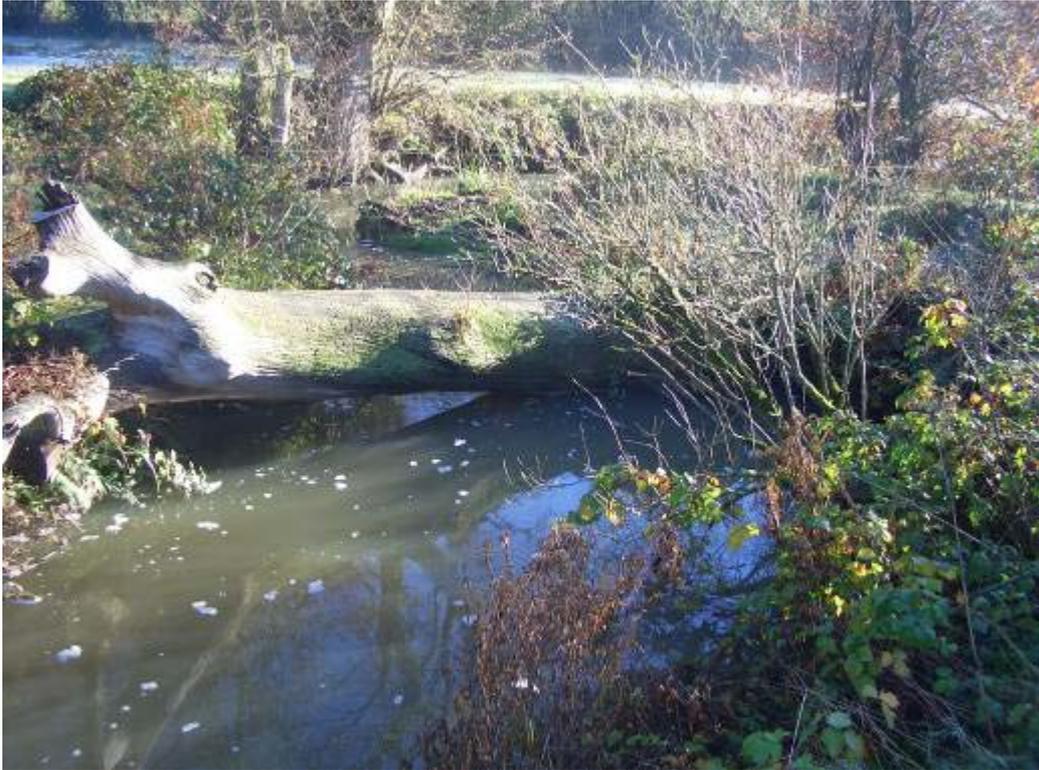
Throughout the reach there were good examples of how habitat has formed around fallen trees and in-channel chunks of woody debris. Retaining as much of this fallen material within the channel as possible is crucial. As already described, LWD helps to provide cover and promotes dynamic river morphology. The wood as it rots also provides a primary source of food for some aquatic invertebrate species. If a fallen tree is responsible for unacceptable bank erosion then it can often be moved and pinned to ease pressure on the bank and usefully scour river bed gravels to help form pools and provide new spawning substrate.

A large fallen tree that has caused the river to scour a fantastic holding pool and help form a gravel riffle downstream. High quality habitat for trout.

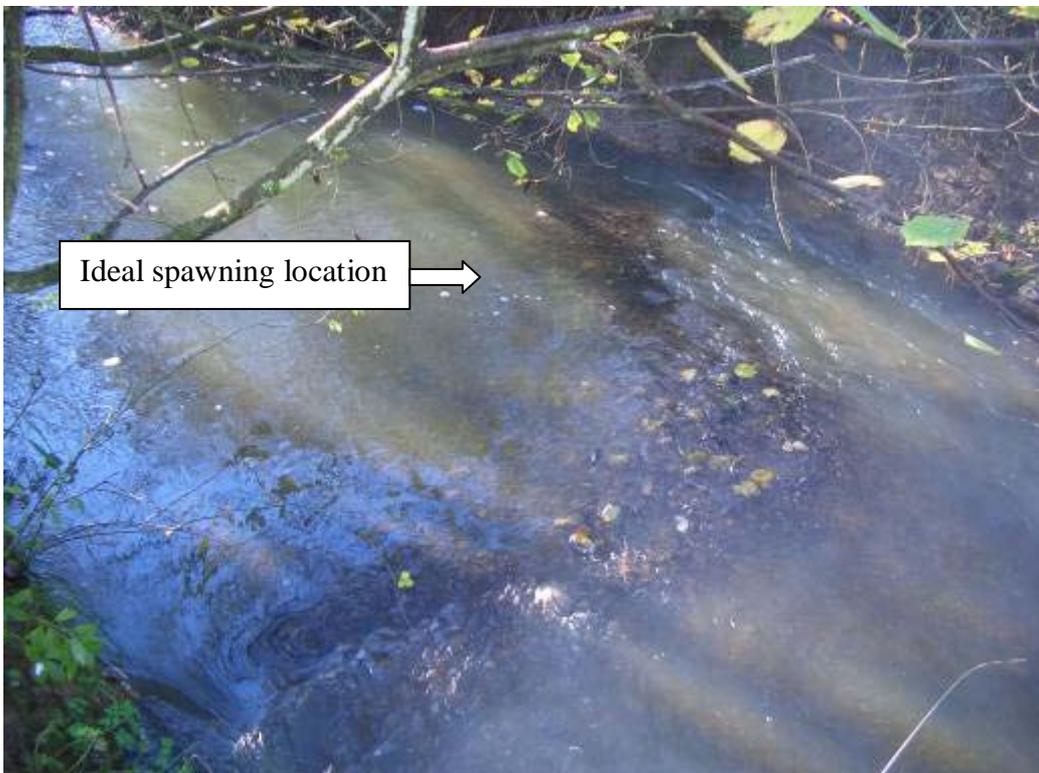
A ramp of loose gravel thrown up below a pool.

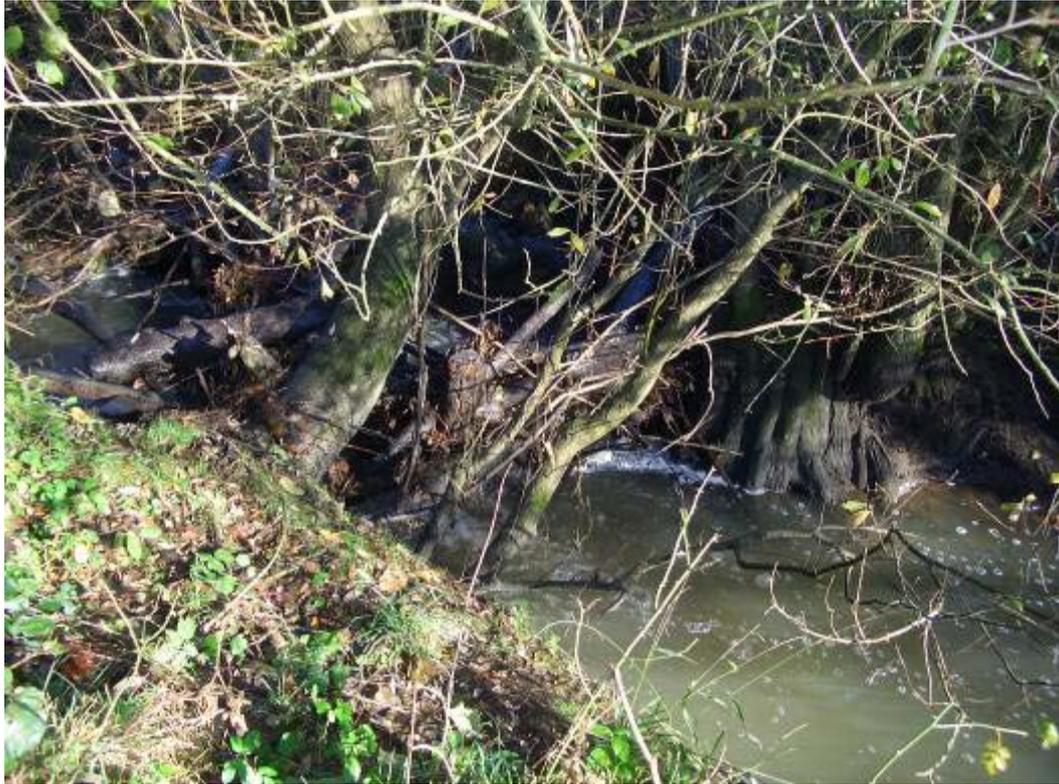
A debris dam near the bottom boundary.

In one or two locations some small debris dams have formed. Generally these do not cause any serious problems for fish migration, however any dam should be monitored to ensure that large amounts of sediment do not build up on the upstream side of the dam. If the bed levels differ by more than approximately 250mm then it is wise to ease some wood out of the dam and peg it in somewhere else.

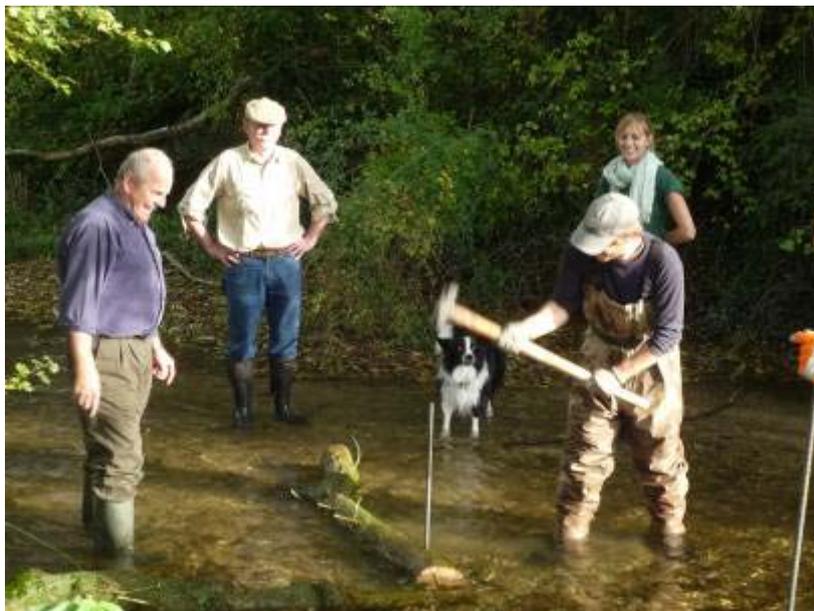
Volunteers securing a log to the bed to help scour the bed and free up gravels for spawning

Some light rotational coppicing of marginal trees will help to provide some access for angling and maintain the desired dappled light and shade regime favoured by trout. Leave as much fallen woody debris in the channel as possible and if considered to be a nuisance then relocate it elsewhere and secure it to the bed to promote local bed scour.
