**River Meon at Titchfield  
Park Gate Royal British Legion Flyfishing Club**

**An advisory visit carried out by the Wild Trout Trust – July 2009**

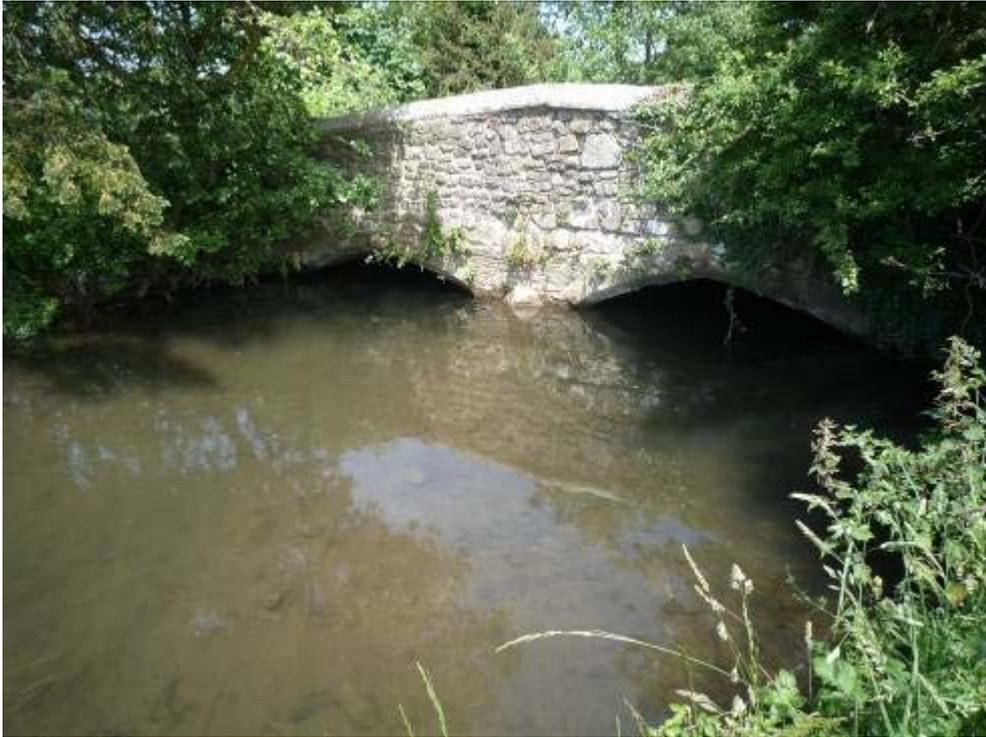
The section immediately upstream of Anjou Bridge is predominately deep and slow flowing and appears to be under the impounding influence of the milling structure down at Titchfield. The very limited capacity through the two small arches under Anjou Bridge may also act as a significant impoundment. The bridge is believed to be extremely old and is in all probability a listed structure so there is limited scope for pulling the water through.

The small arches of the Anjou Bridge probably impound the river in the meadow above.

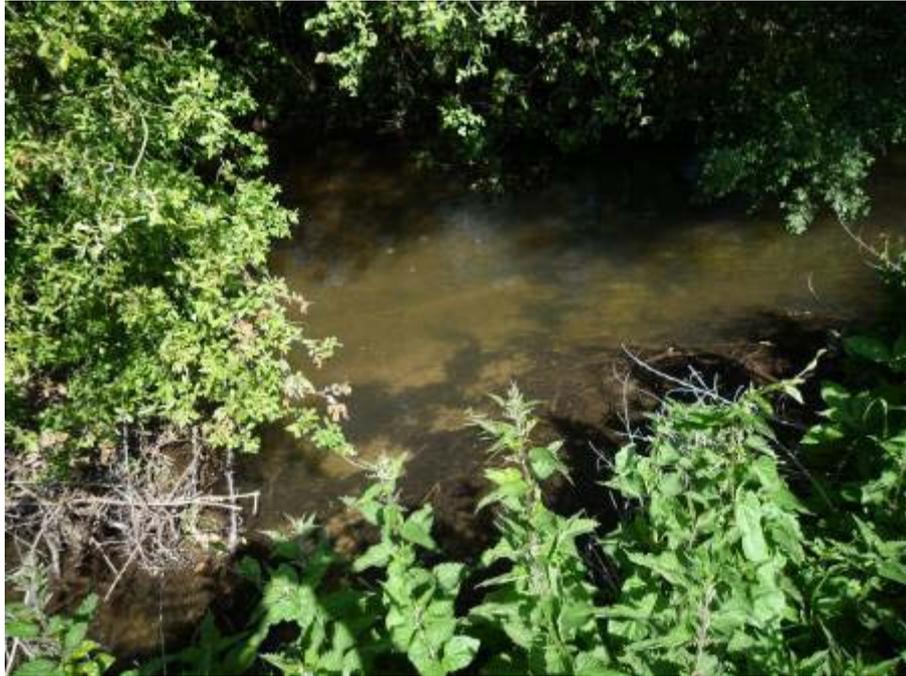
On the section between the railway bridge and the M27 bridge, there are numerous pools and shallow glides. Despite the heavy marginal shading from trees located mainly on the western bank, there is some excellent holding water for adult trout.

Decent habitat for trout above the railway bridge although spawning sites were mainly restricted to the very top of the beat

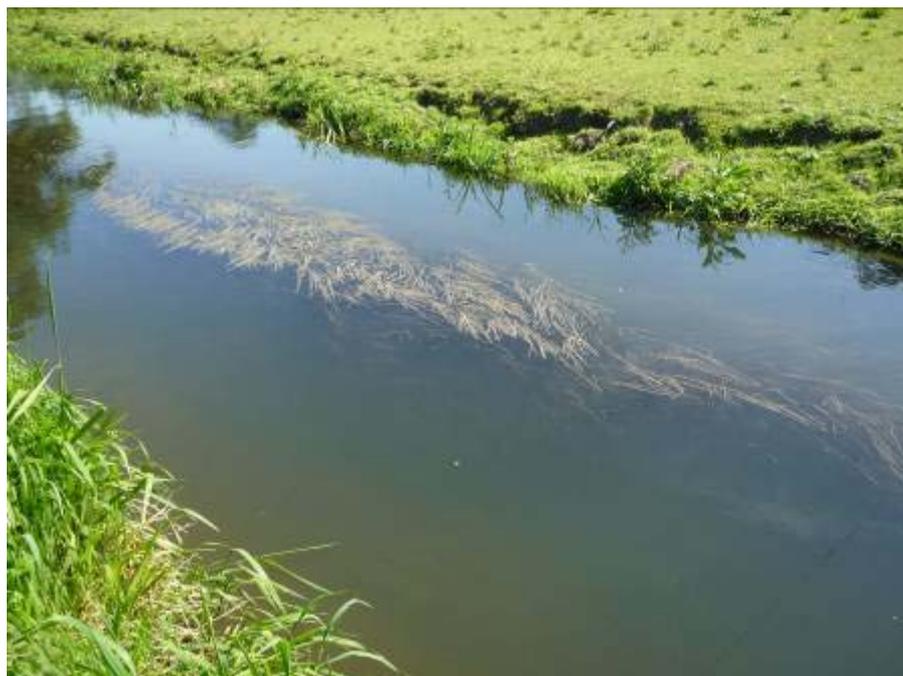
The section is characterised by glide habitat with occasional deeper pools and on some sections significant marginal shading provided mainly by alder trees (*Alnus glutinosa*) on the LB. In-channel weed growth appears to be dominated by submerged and emergent beds of ribbon or strap weeds (*Sparganium sp*). Some startwort (*Callitriche stagnalis*) was seen on shallow glide sections where there is sufficient light penetration.

Typical habitat on an unshaded section of the reach above Anjou Bridge. Note the ribbon weed which although not synonymous with brown trout is known to be a favoured habitat for holding sea trout.

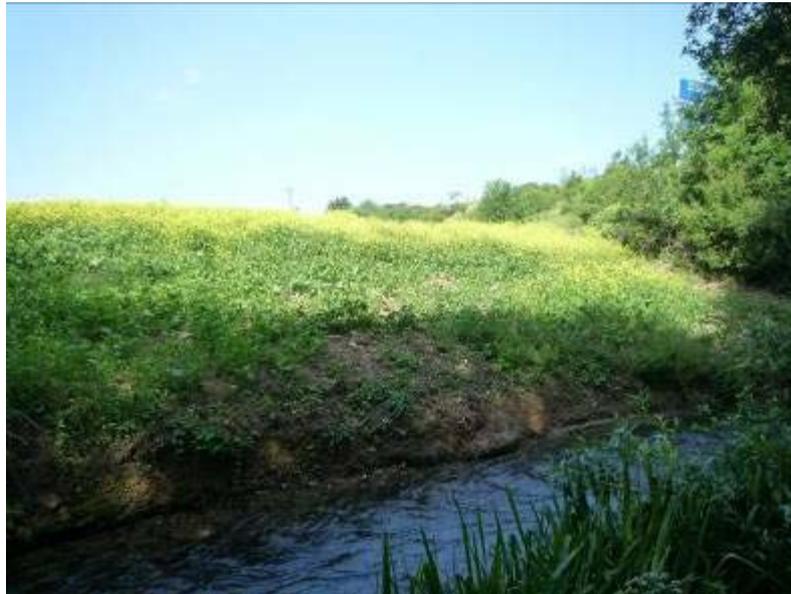
Considerable scope exists for improving the spawning and nursery habitat that exists at the very top of the beat. Some earth works have been undertaken on the RB immediately adjacent to what is probably the best spawning site on the top stretch. The planting of an arable crop on a steep slope so close to this

section is also undesirable. Comments and recommendations regarding this section appear later in the report.

The Meon near the M27 road embankment. Good spawning habitat potentially threatened by inappropriate land use on the RB

- Open up a dialogue with the neighbouring farmer on the top beat and discuss the possibilities of a decent buffer zone adjacent to the river to protect it from excess siltation and enrichment.

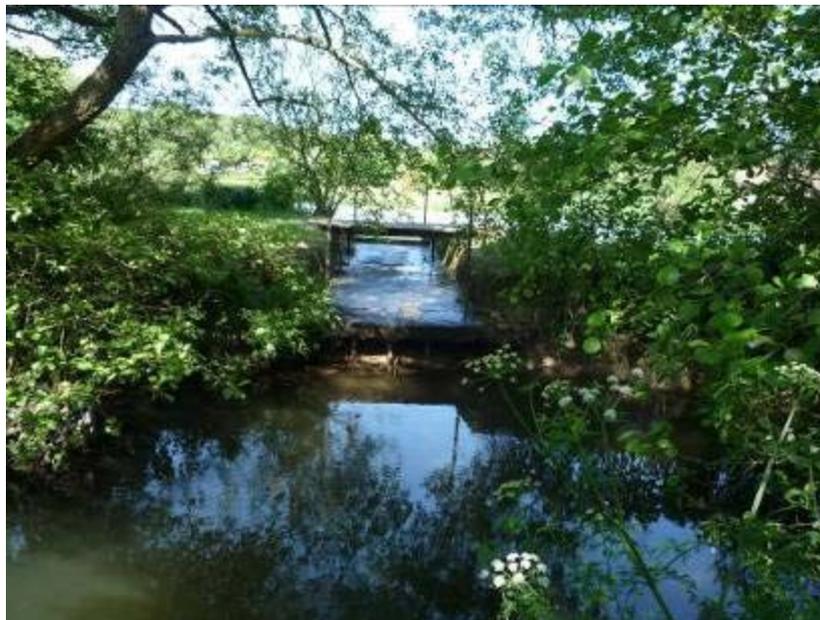
Outlet from an adjacent coarse fishery discharging directly into the RB of the river. The high density of benthic feeding cyprinids does nothing to improve the quality of the water running into the river

A close eye should also be kept on the discharge emanating from the coarse fishery on the RB. Nutrient rich turbid water flowing into the Meon is not conducive to high quality salmonid habitats. A dialogue should be opened up with the Environment Agency to ensure that water quality and the control of escapee coarse fish is monitored at this site.

- Remove the stands of Himalayan balsam by pulling before seeding.
- Maintain a close eye on water quality entering the river from the adjacent coarse fishery. One excellent method of self monitoring water quality is to link up with the Riverfly Partnership. The Partnership provides simple training and a robust method of assessing fly life through periodic sampling of macro invertebrates. This is a simple and effective way of keeping a close eye on water quality performance. More information can be found at [www.riverflies.org](http://www.riverflies.org)

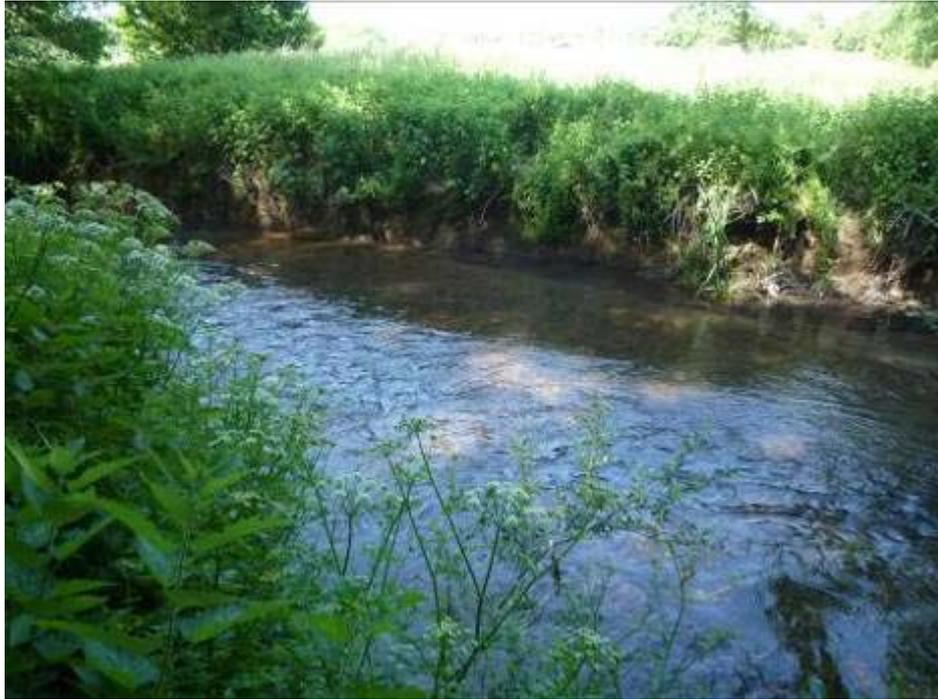
Some excellent quality spawning and nursery habitat can be found on the top of the beat. Gravels may however be compacted and in need of work to promote enhanced levels of wild trout production

Some additional tree work to encourage more light into the channel and the use of large woody debris materials to peg into the channels would improve this section. This is discussed in more detail in the conclusions and recommendations section.

- Improve the spawning potential of the top reach by strategically pegging down LWD onto selected shallow gravelly sections.
- Undertake a programme of early autumn gravel cleaning. Guidelines for gravel cleaning are attached as an appendix to this report.

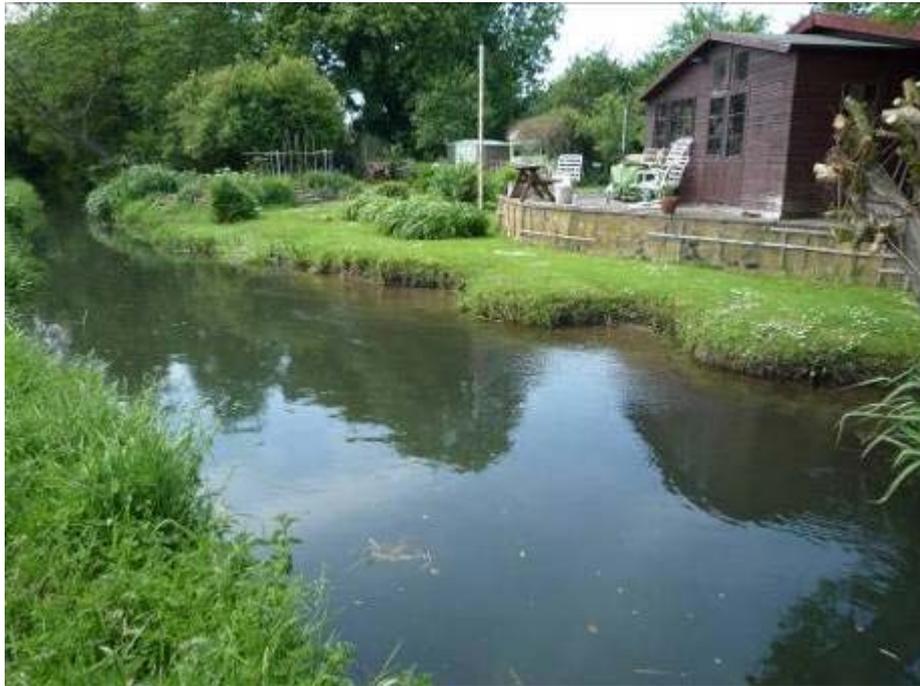
Properties with gardens backing down to the RB of the river would benefit from receiving advice on erosion control. Grubbing out marginal shelves of sedge and

reed canary grass and replacing with lawn is leading to erosion and could ultimately cause bank failure.

[This land owner would benefit from some help and advice on how to arrest marginal bank erosion.](#)

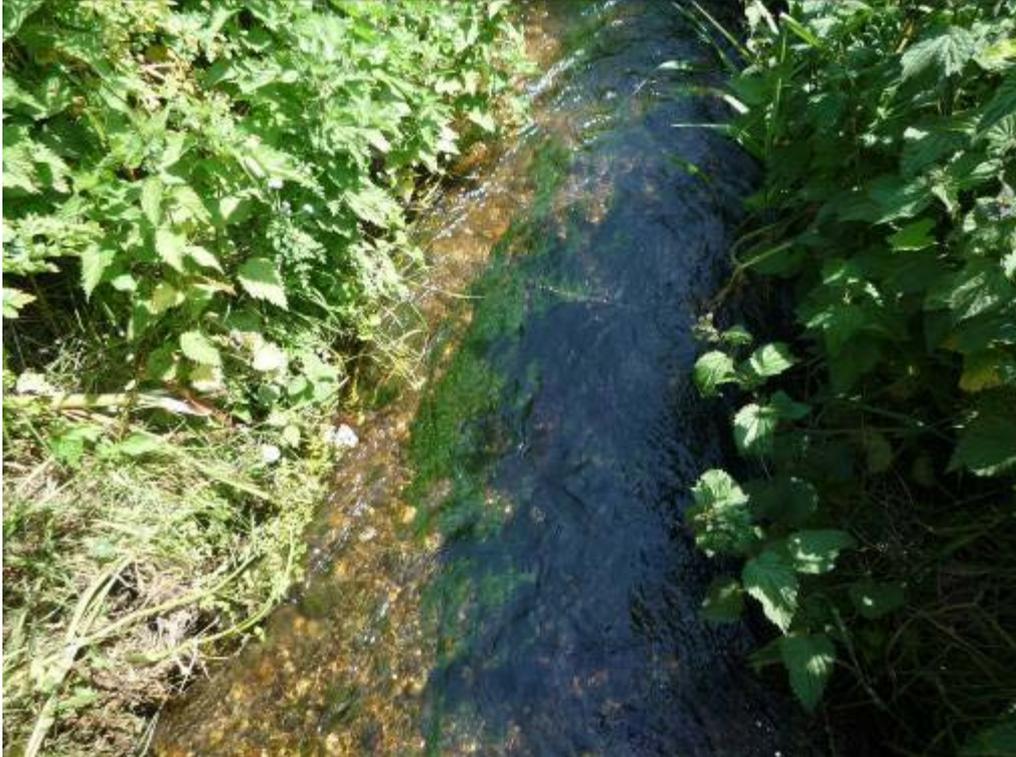
Habitats on the back channel are varied with good examples of pool, glide and riffle, providing fine habitat for all life stages of both resident and migratory trout.

Fast flowing shallow water over a clean gravel bed – good trout habitat in the back channel

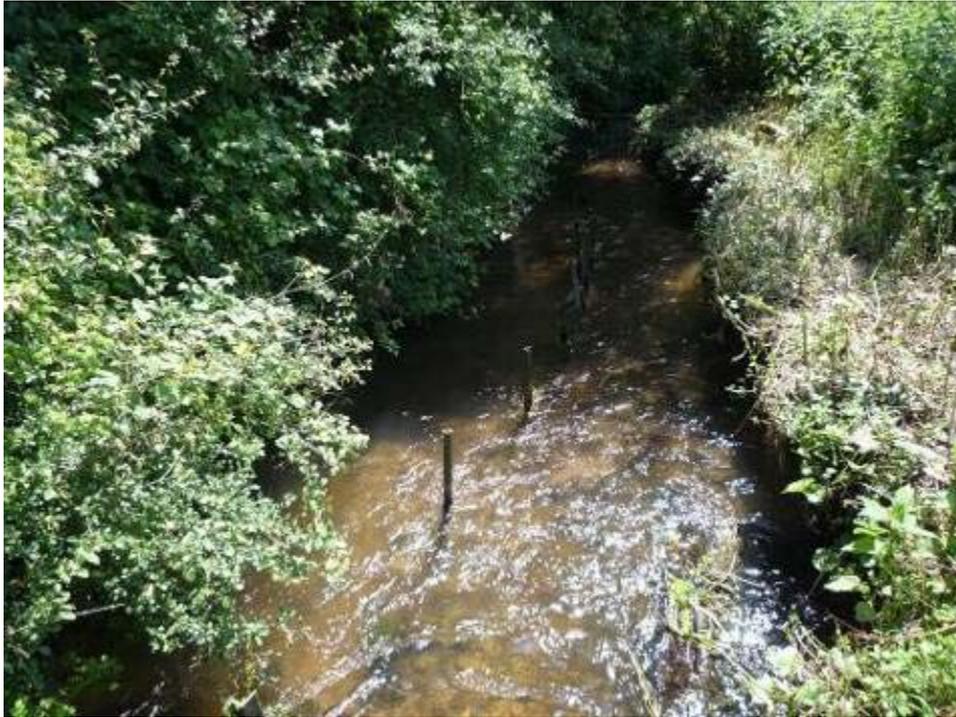
At some stage attempts have been made to either arrest bank erosion or to promote scour using corrugated iron sheeting supported by driven angle iron. Whatever the objective, this work has failed and is probably unnecessary as the margins appear to be stable and in-channel habitats are healthy and varied.

Wobbly tin and angle irons should be removed

- Undertake a programme of tree planting with sallow or goat willow on long open sections of the back channel.
- Remove old tin sheet and steel posts from the back channel

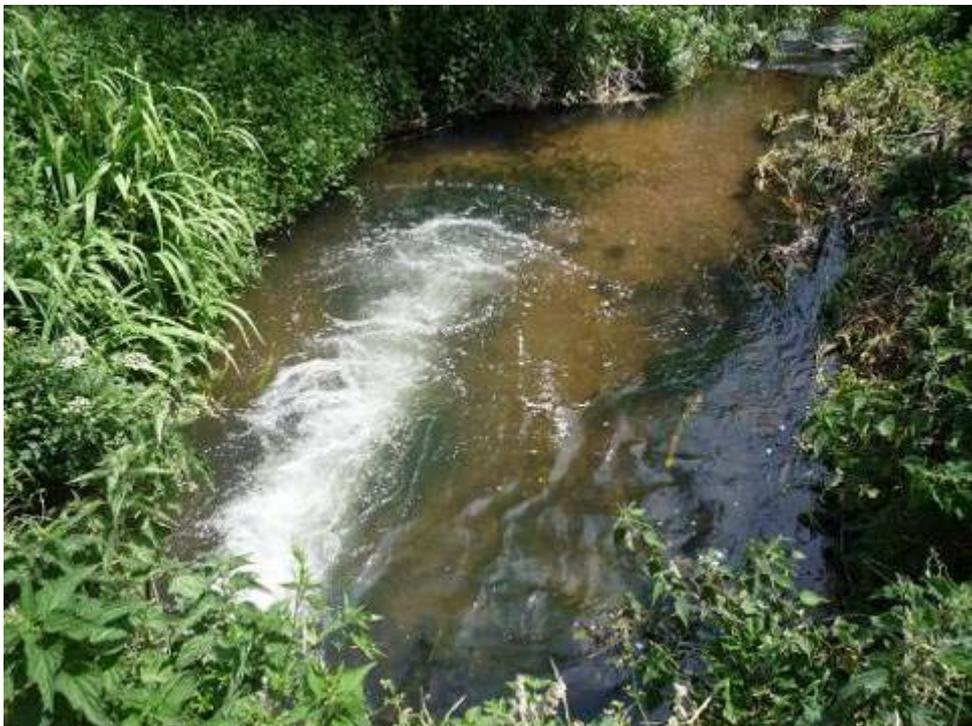
Main flow into the back channel enters half way down the meadow. If this flow entered the channel at the top end it would enhance several hundred metres of channel

The option of returning the majority of the Meon flow to the back channel just below Anjou Bridge should be given serious consideration. The potential benefits of this scenario are discussed in the recommendations section.

- Consider any proposals to redistribute flow into the old natural channel as a fantastic opportunity to enhance the whole fishery.
- Review your trout stocking programme to ensure that wild stocks are given as much protection as possible.

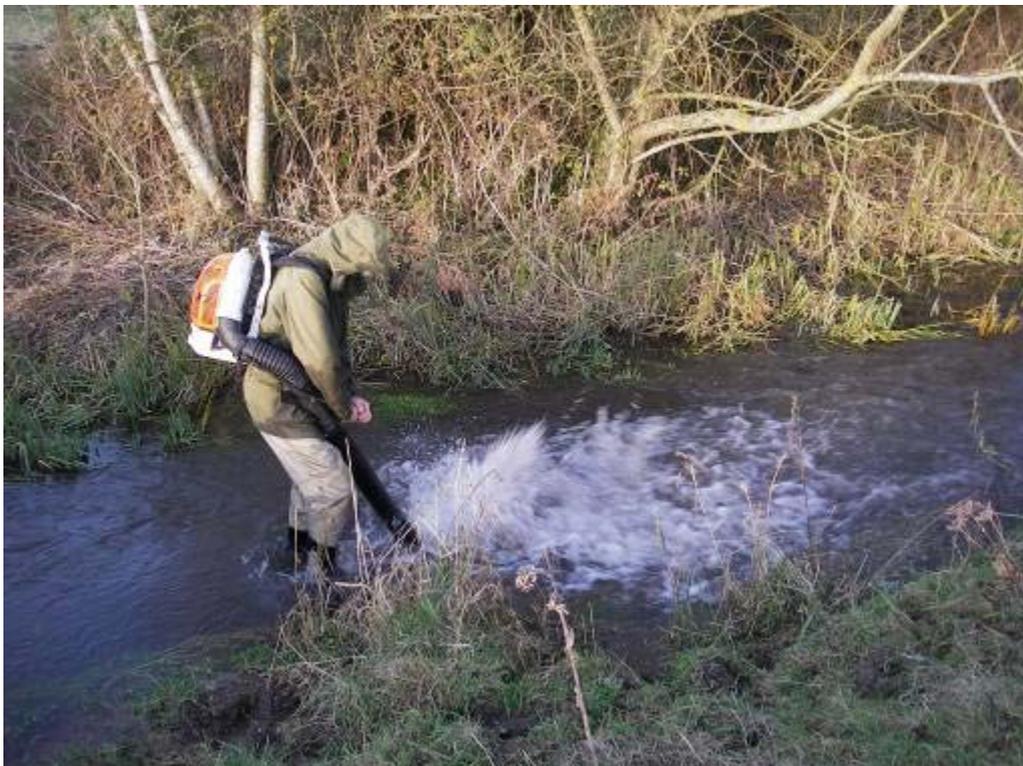
**Gravel cleaning using a back pack leaf blower. Cleaning gravels on the top beat is recommended**
