River Piddle – Binnegar Farm

An advisory visit carried out by the Wild Trout Trust – April 2010

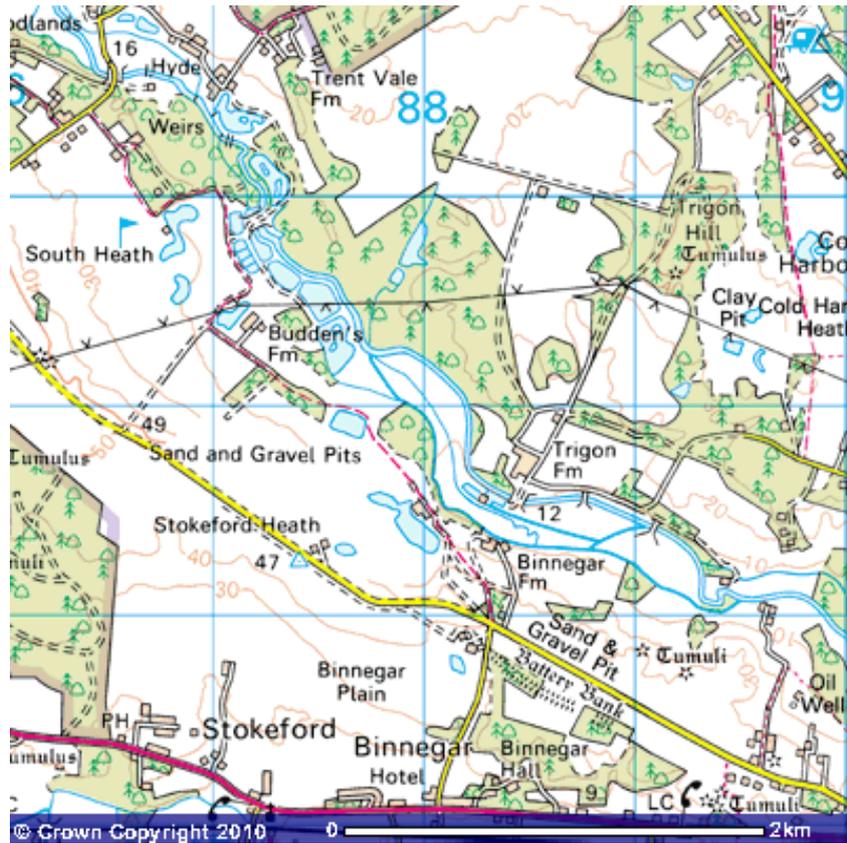
The Binnegar Farm Fishery is formed by the southerly carrier leaving the main river just downstream of Budden's farm

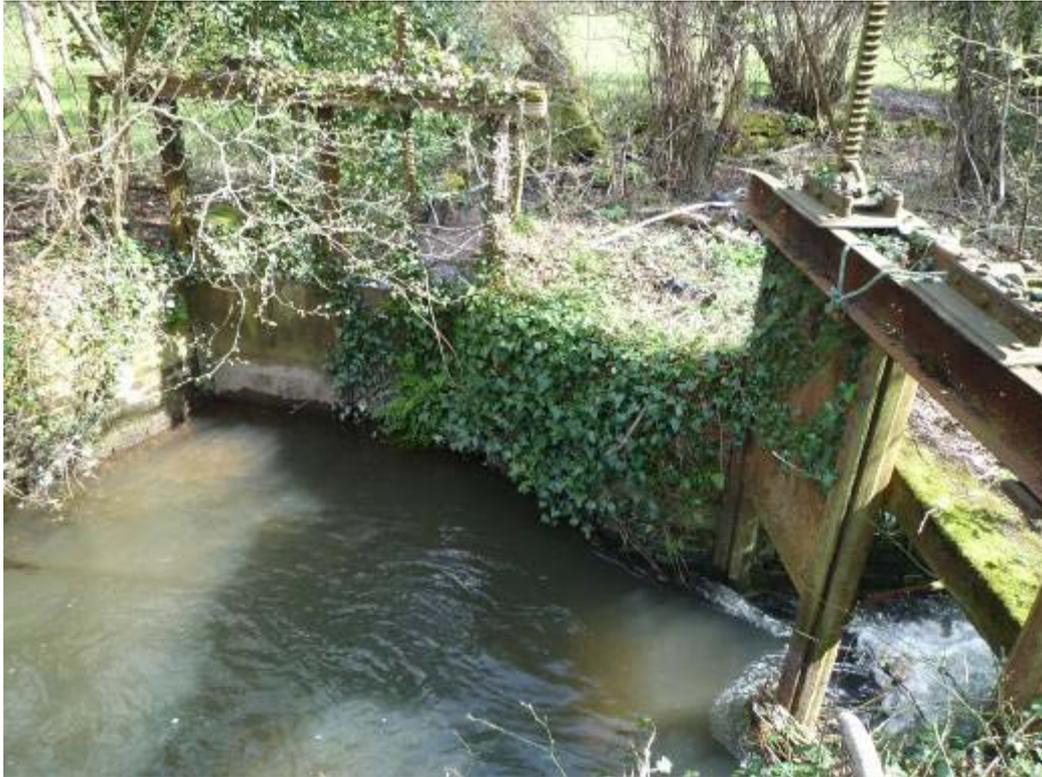
A crucially important factor which has undoubtedly favoured trout habitat in this reach is the fact that an old hatch straddling the river has been permanently left with the undershot gates in the fully raised, or "open" position. So often this type of structure is either left partially down to provide raised water levels upstream or constantly manipulated to maintain a given upstream water level at all times, even during extreme fluctuations in flow. When these structures are closed they invariably reduce upstream water velocities, encourage siltation and degrade potentially good trout spawning and nursery habitats.

Old water meadow hatches with the main structure fully drawn and the drowning gate fully closed

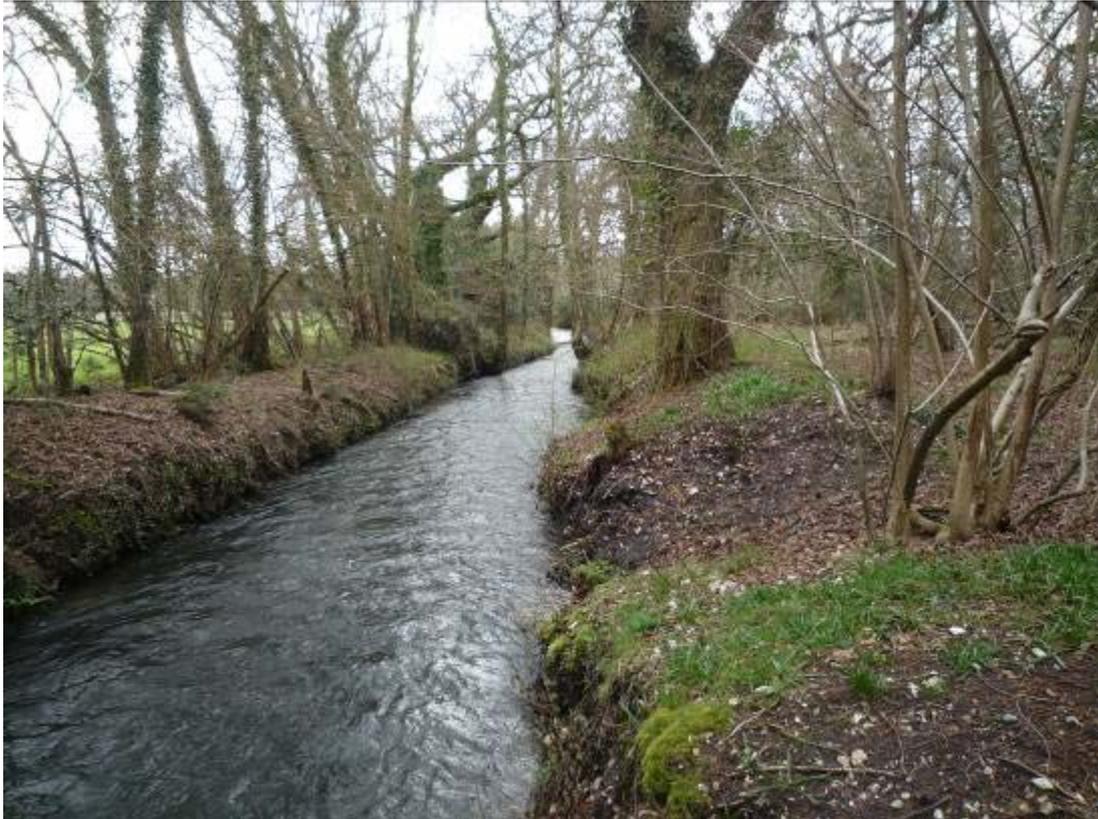
Significant shading of the bottom section but precious little in the way of low level shade and in-channel cover

The comparative lack of marginal in-channel cover can be seen in the photograph above. The very occasional short section of undercut bank does provide some cover but on the whole there is precious little cover here for juvenile trout.

This section could be significantly enhanced by planting some low level shrubby trees such as willow or goat willow or perhaps even thorn bushes. Some light thinning of a few of the mature trees that are set back from the margin may be required to promote improved marginal low level cover. Another method for providing improved habitat on this reach is to introduce pieces of large woody debris (LWD) to promote river bed scour and enhance spawning opportunities as well as providing improved holding areas, particularly for adult trout. Additionally pieces of brash or coarse woody debris (CWD) could also be pegged into the margins to provide valuable refuges from predators such as fish-eating birds. These techniques are described in more detail in section 5 and 6 of this report.

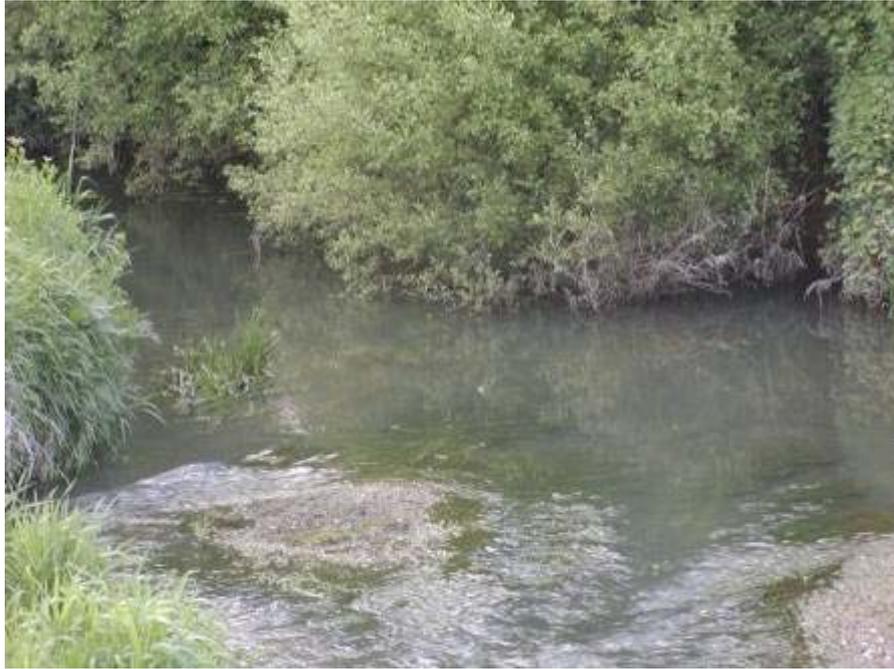
A low overhanging goat willow providing a superb refuge for trout on the Sussex Rother. Willows can be easily planted by cutting a stake or a "whip" off a live tree and simply pushing it into a bare margin at just above normal water level. Three or four of these would provide a "bolt hole" refuge on the lower section of the Piddle at Binnegar Farm.

Pushing in stakes of goat willow at water level will provide some much needed low scrubby cover, particularly on the outside of bends and over pool habitat. The willows will provide cooling shade during long hot dry spells and an external food source via terrestrial invertebrates.

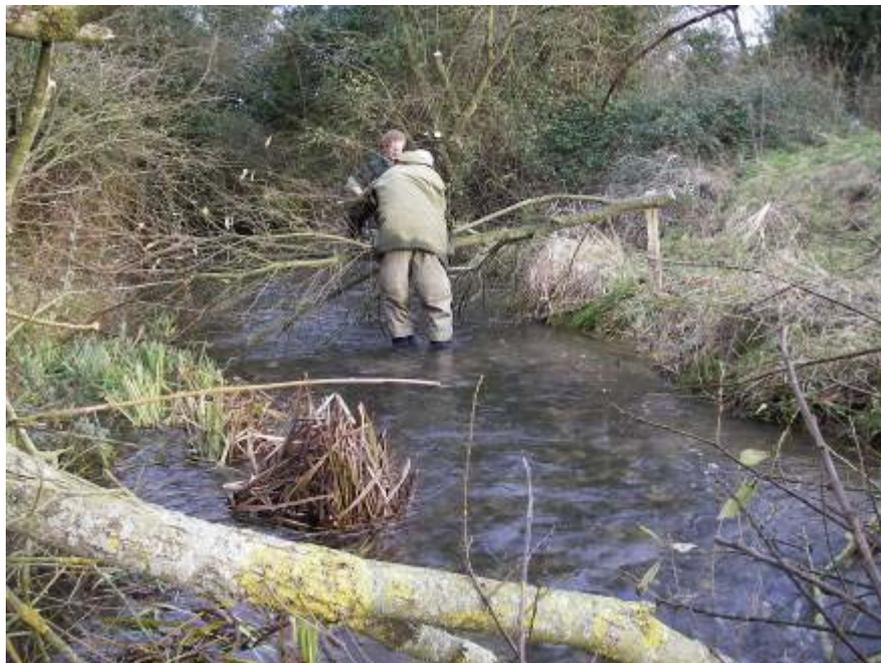
Installing brushings designed to provide improved cover for spawning trout and their offspring on a tributary of the Wylfe. This could be a way of providing temporary cover until thicker marginal cover has established.

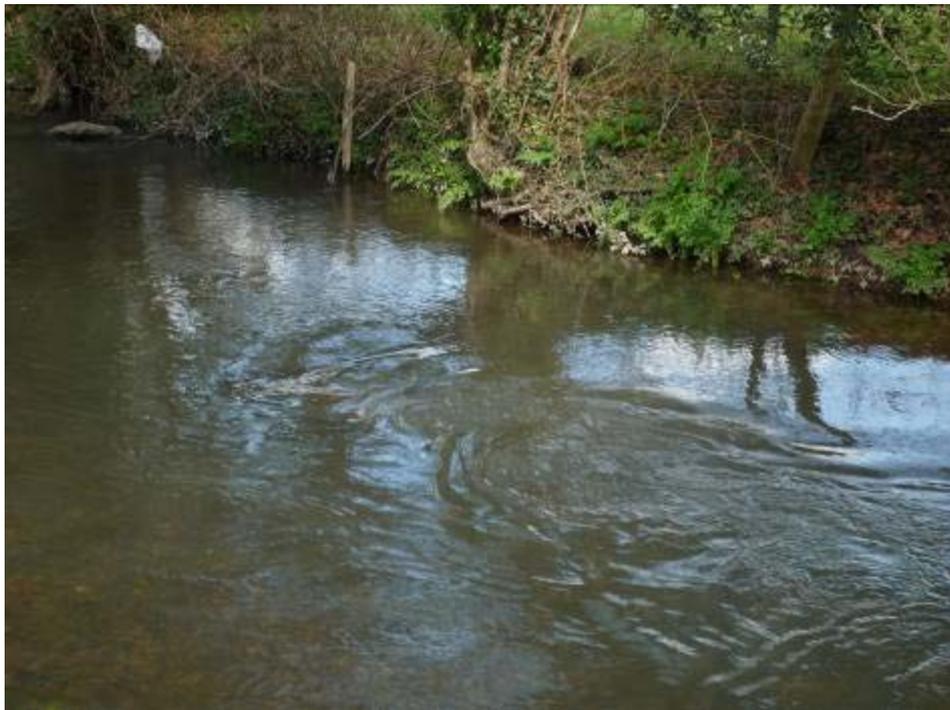
A large stone in the centre of the channel promoting some surface boil and localised bed scour. A stone like this can make all the difference to whether a fish takes up residence or not.

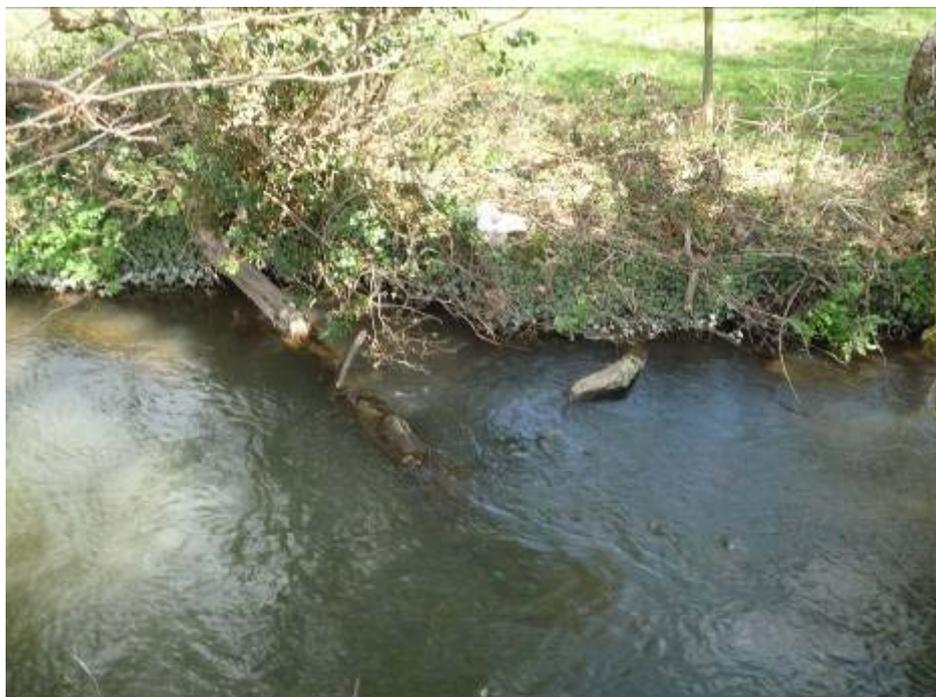
A scoured pot created by the fallen LWD – a great lie for a trout

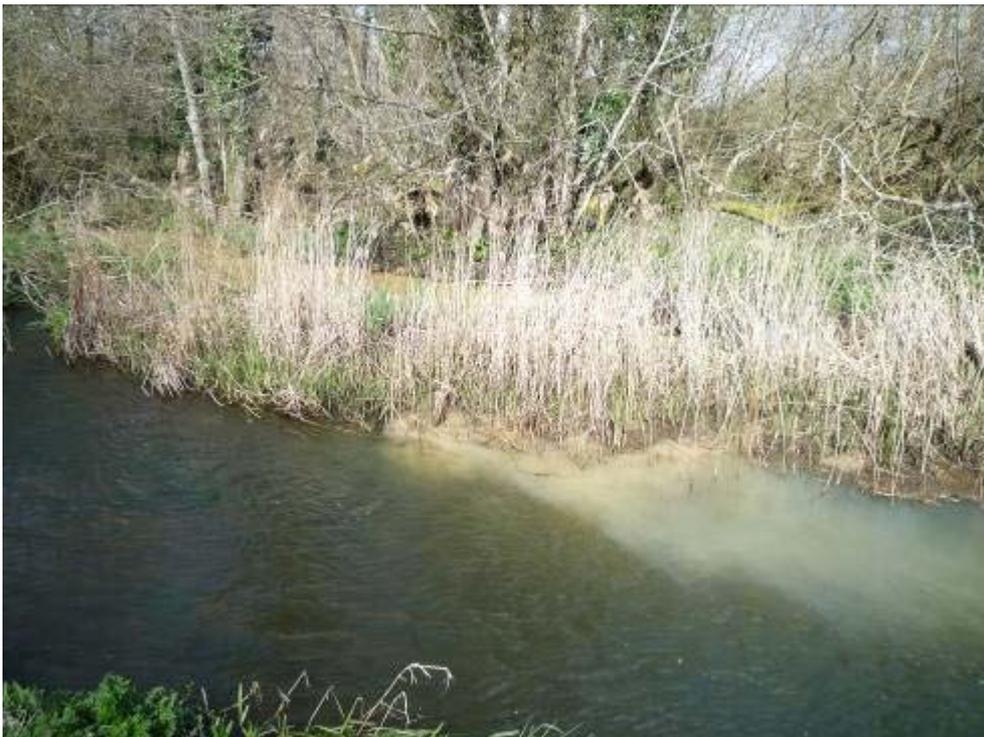
A short distance downstream of Binnegar Farm, a ditch discharges through a Norfolk reed bed into the carrier from the LB. On the day of the visit this ditch

was carrying an unacceptably high level of suspended sediments. It is understood that this ditch carries water that is pumped from a working quarry nearby. Presumably the company will have a licence issued by the Environment Agency to discharge water into this ditch and then on into the Piddle. It would seem unlikely that the levels of suspended sediments observed entering the Piddle would meet levels deemed acceptable for a high quality salmonid fishery. It is recommended that further investigations are made into the conditions of the discharge consent and whether the site is properly monitored. High levels of suspended solids adversely impact upon spawning success, macrophyte growth, invertebrate communities and the amenity value of the fishery.

Unacceptably high levels of suspended sediment entering the river

The quality of waste water entering the carrier via the ditch needs to be investigated. The solution may simply be to improve maintenance on the ditch to provide increased settling capacity and an increase in time of travel. Many angling clubs now take part in the Anglers' Monitoring Initiative in order to maintain a close eye on water quality, which is reflected in the invertebrate populations. One excellent method of monitoring water quality is to link up with the Riverfly Partnership. The Partnership provides training and a robust method of assessing fly life through periodic sampling of macro-invertebrates. This is a

- Arrange a meeting with the quarry company to ask for remedial works to be put in place to avoid damaging levels of suspended sediments entering the river. Consider contacting the EA for assistance if necessary.

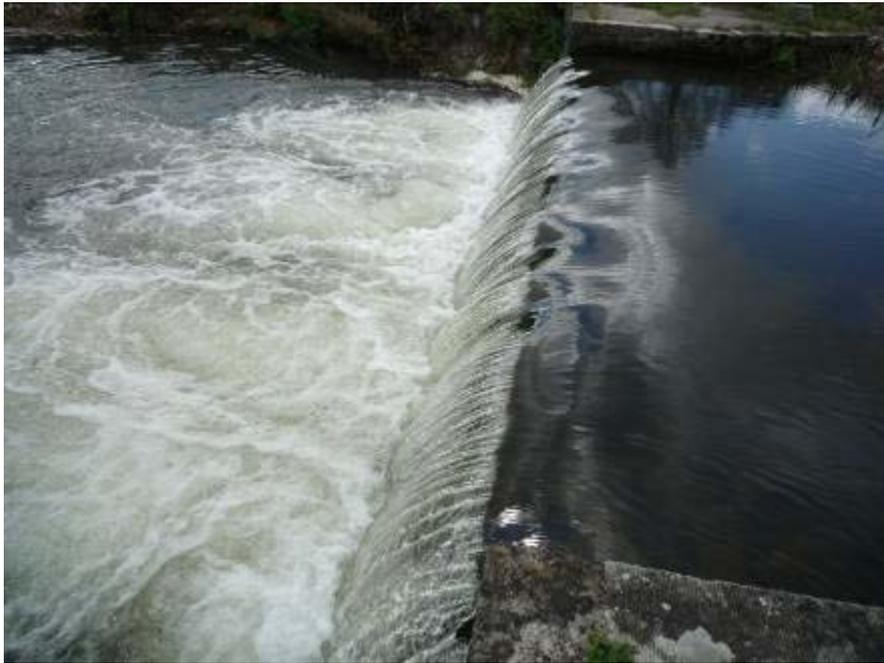
Approximately halfway along the fishery and adjacent to Binnegar Farm there is a weir. The purpose of the structure is not entirely clear but it is possible that it is a replacement for an old water meadow structure designed to raise upstream water levels or possibly installed to create deeper water for an abstraction pump approximately 300m upstream.

In addition to the slowing down of water velocities and the potential silting of available habitats, weirs often fragment fish populations that would normally move up river to exploit good spawning habitats, with the offspring then dropping back down to take up residence in good quality holding habitats. This natural process can be impossible on rivers with large impounding structures. This particular weir does not look as if it is high enough to be of major concern and following significant rainfall the tail height is likely to rise sufficiently to allow most fish to be able pass without too much difficulty. The removal or lowering of a central section would greatly improve the ability of fish to be able to pass the

The weir at Binnegar Farm. Removing the central third of the weir would improve habitat upstream and facilitate improve fish access through the structure.

structure under normal or low flow conditions and would speed up water velocities above the structure.

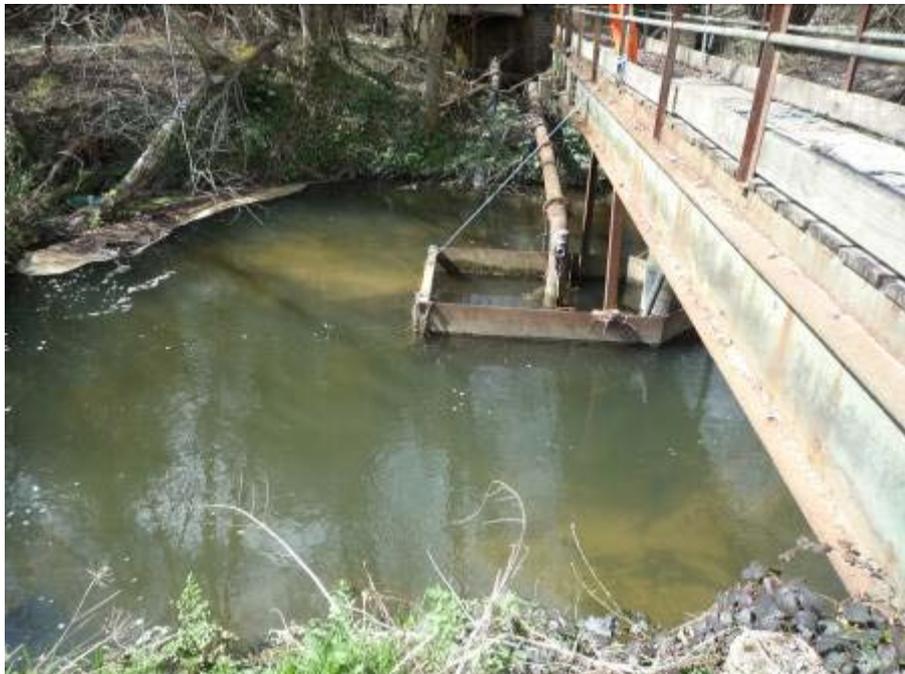
The pump located upstream of the weir. Lowering the weir could impact on the efficiency of pumping at this location.

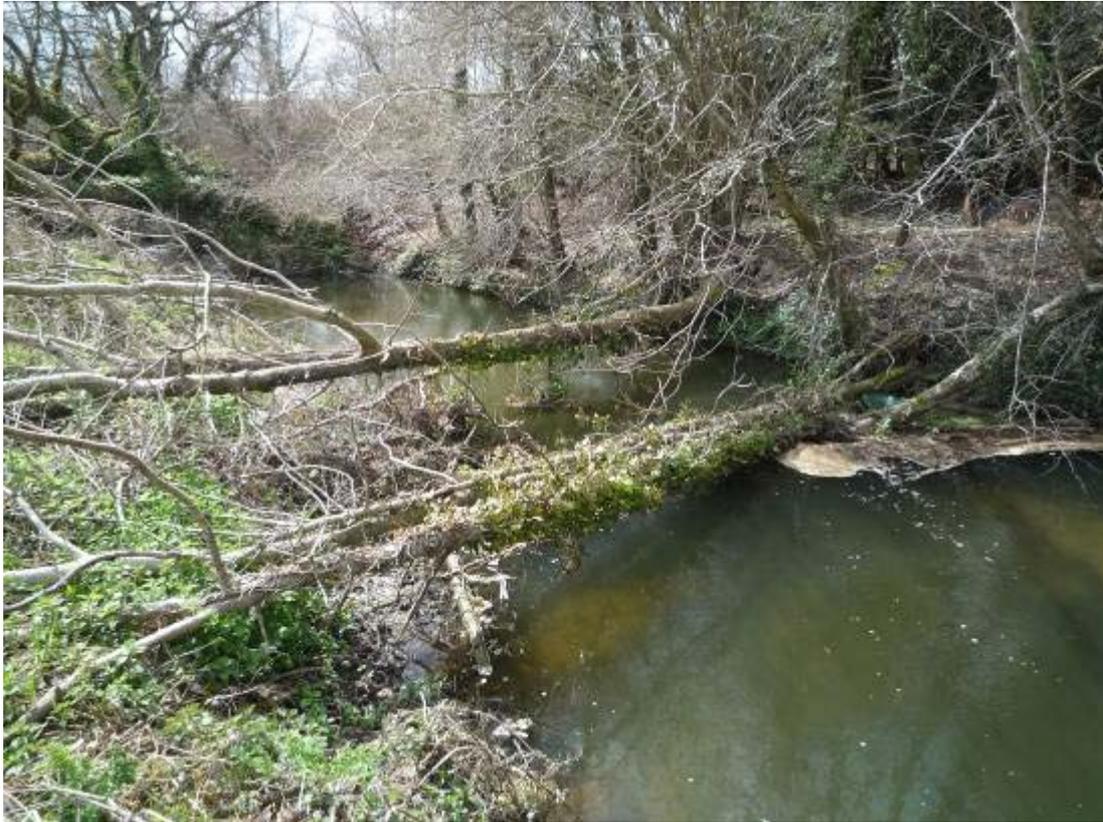
At various locations along this reach, trees have fallen right across the channel. It is recommended that most be left in situ or if some are deemed to be a real

issue crop the trunk and pin the end into the river bed. Attached tree trunks that overhang the river in this way make superb flow deflectors and provided they are secured to the bank and bed, will promote some undershot scour that will inevitably dig a good holding pool with the additional benefit of throwing up a ramp of gravel, ideal for spawning.

Remove the downstream tree but retain at least one third of the upstream trunk in situ to promote pool creation.

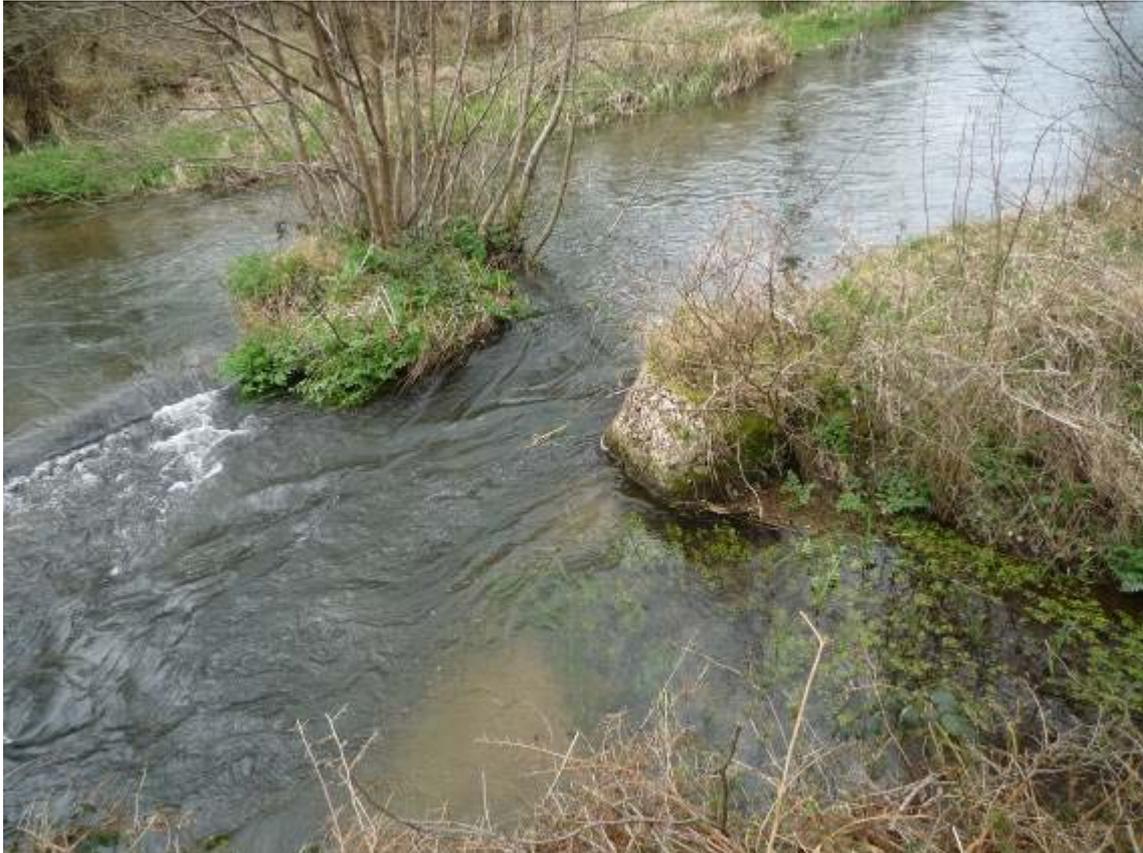
A large weir marks the upstream limit of the fishery. At this location two structures originally controlled the flow, splitting it between the main river and the carrier. The structure at the head of the carrier is largely intact, however the structure which regulates flow into the main river has failed and significant flow is now directed down via the main channel. This is obviously of major benefit to the main channel and the fishery interests who own it. There may also be strong fishery and ecological arguments that support the current flow split. Unless this structure is either rebuilt or reinforced, it is highly likely that the percentage of flow dropping down into the main channel will increase at the expense of flows into the Binnegar carrier.

Formal structure to the left of the island regulates flow into the main channel. The gap to the right of the island appears to be a moveable feast.

Arguments over flow splits can often lead to unnecessary disputes. It is recommended that a meeting is held with the owners of the adjacent channel and an agreement reached over how flow splits are to be managed in the future. A 40% to 60% flow split in favour of the main channel would seem reasonable but this should be measured (via the EA Water Resources team) and actions taken to secure the agreed amount of water for each party.

- Arrange a meeting with your neighbour to discuss the issue of flow splits and set up an agreement to measure and manage the flows in the future.

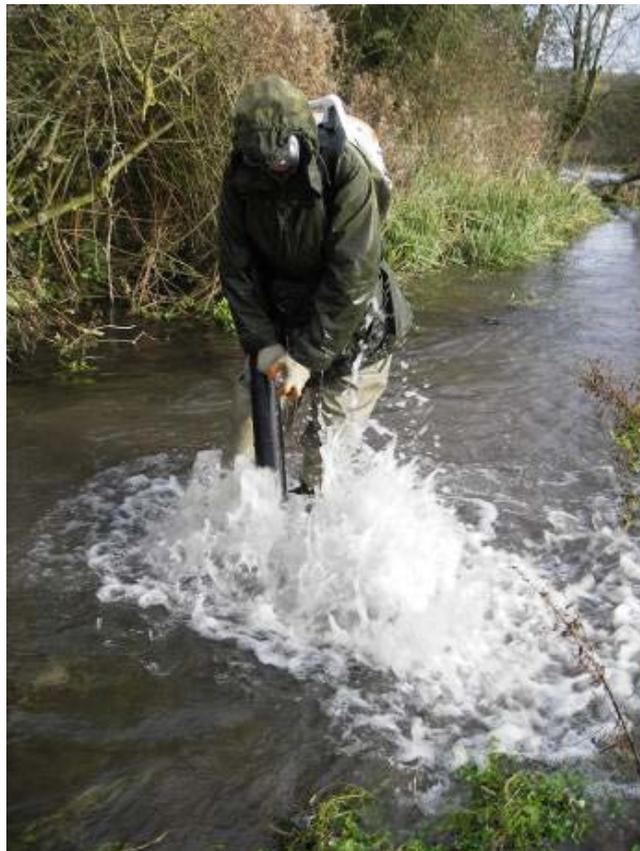
Gravel cleaning can significantly boost spawning success on rivers with compacted gravels

On those sections where there are shallow gravel runs, some effort should be made in October to break or loosen the surface crust of the river bed prior to the trout spawning season. This can be achieved with fencing spikes and rakes, or high pressure pumps or leaf blowers to remove fine sediments which restrict egg survival.

- Instigate an early autumn programme of gravel cleaning to boost trout egg survival rates.
- Consider signing up for some training in undertaking simple surveys as part of the Anglers Monitoring Initiative with the Riverfly Partnership. This is an excellent initiative and will give you a much better understanding about the productivity of your stream and an indication of long term water quality performance.

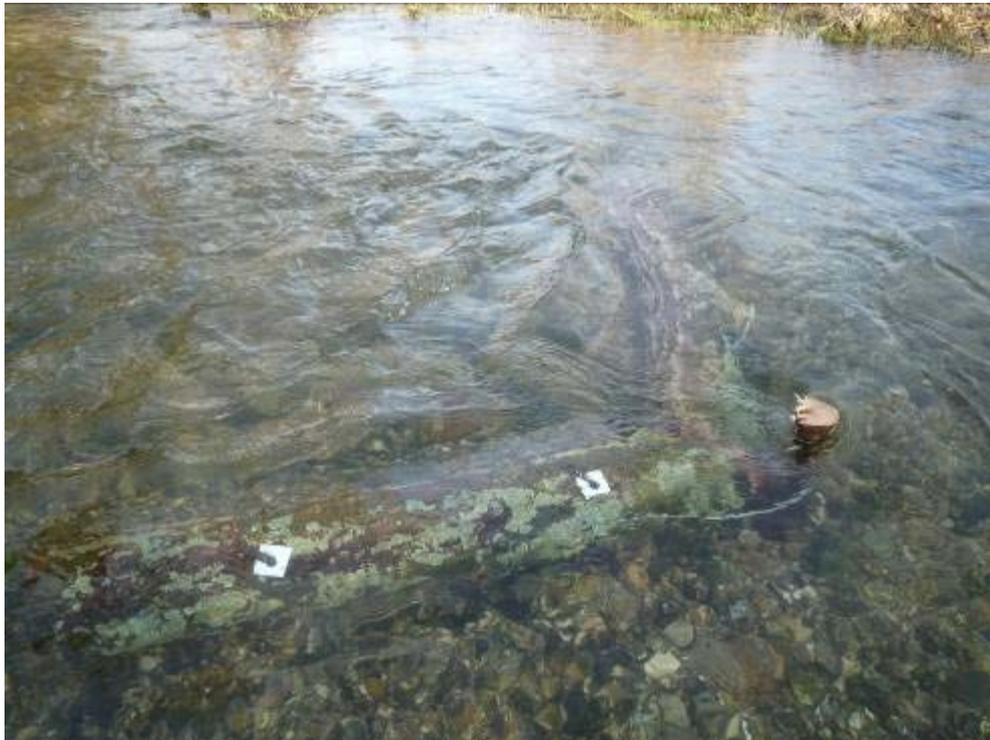
Another good method of improving spawning success is to use pegged down pieces of large woody debris to help scour, clean and sort river bed gravels. This method is extensively used by the WTT as it not only helps to boost spawning success but also provides holding habitat and cover for a range of fish species. As the wood rots it also provides a primary source of food for aquatic invertebrates.

Two pieces of LWD configured to form an upstream "V". Structures like this scour local pots in the shallow bed and promote a clean, loose ramp of gravel downstream.
