River Lyde, Hatch

Advisory Visit May 2017

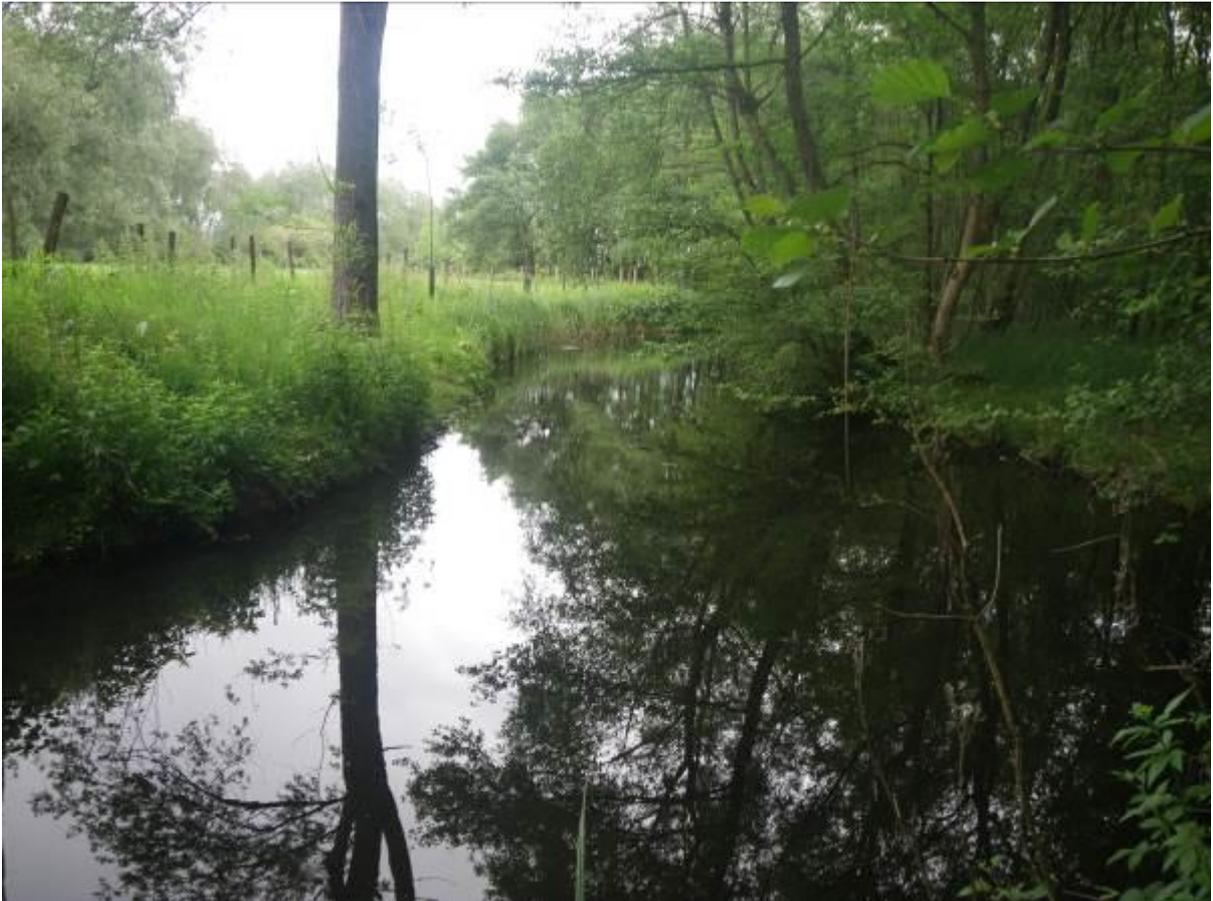
The majority of the channel is made up of uniform, deep glide habitat, with the LB mainly forming the margin of some grazing meadows (cover photo and photo 3). The RB is heavily wooded and casts significant shade across the whole channel. As a result, rooted aquatic macrophytes, particularly submerged varieties are comparatively sparse for a chalkstream environment.

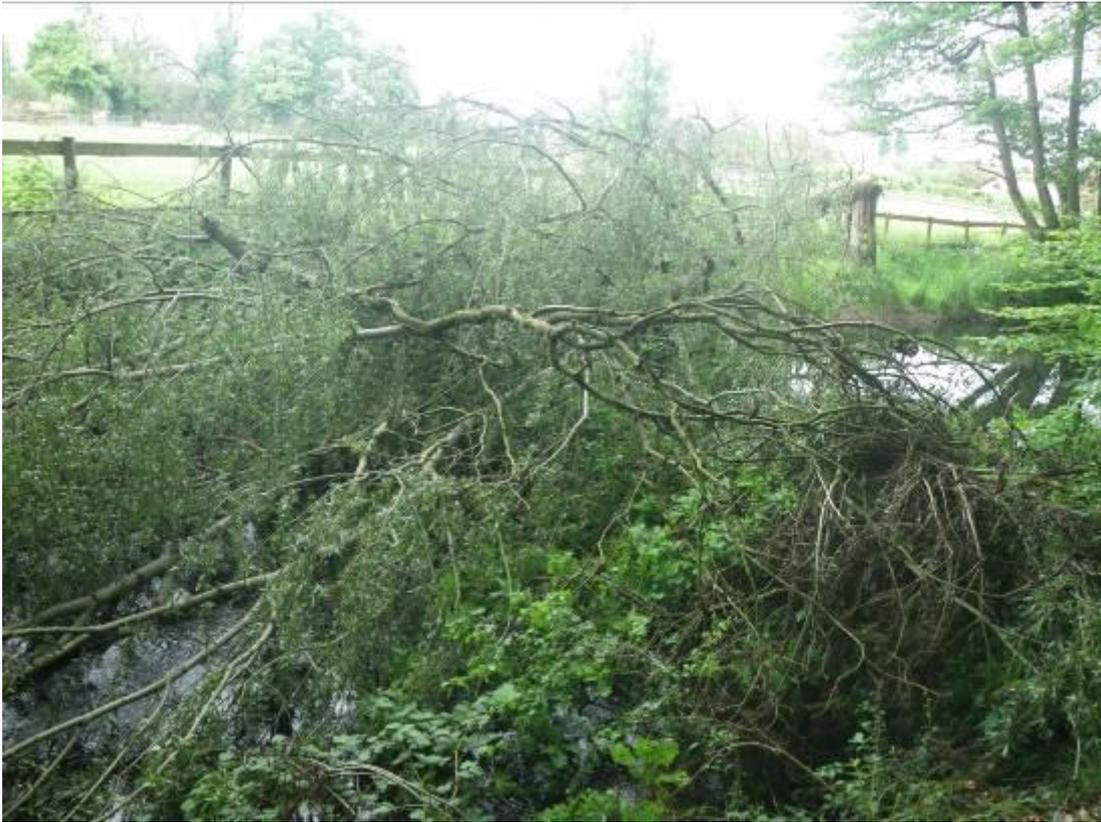
Photo 9. A fallen tree with lots of fine brush material attached. Easing out a narrow gap to avoid a full width dam developing is recommended.

Where full channel width debris dams have formed (photo 9), it is recommended to cut out a narrow slot to avoid the debris dam becoming completely occluded with fine material, potentially causing a complete obstruction and impoundment to flow. A light touch is recommended and the general advice regarding fallen wood is to move and secure it if deemed a problem but never remove it from the channel.

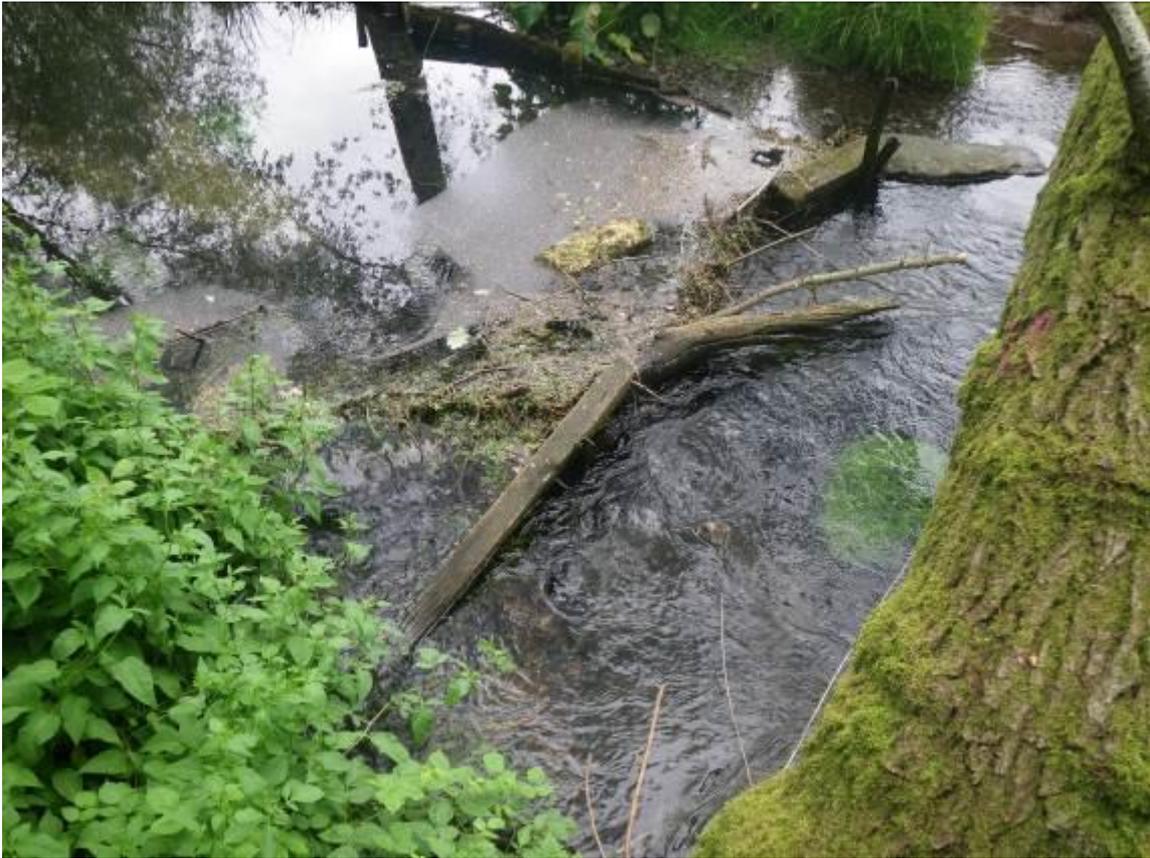
At one particular location, a tree trunk has fallen adjacent to an old plank weir board structure (photo 10). It is assumed the weir was constructed in an ill-advised attempt to create increased water depth in the reach above. When trying to create pockets of deeper water suitable for holding large adult trout, it is recommended to try and drive the soft river bed down using woody flow deflectors to create and maintain more depth with natural scour, rather than impounding the channel and slowing down the flow with a weir structure.

Photo 10. Fallen trunk and the remains of an old “plank” weir. The action required here is to remove the remains of the old weir and simply trim off the end of the fallen tree to maintain a narrow gap adjacent to the LB.

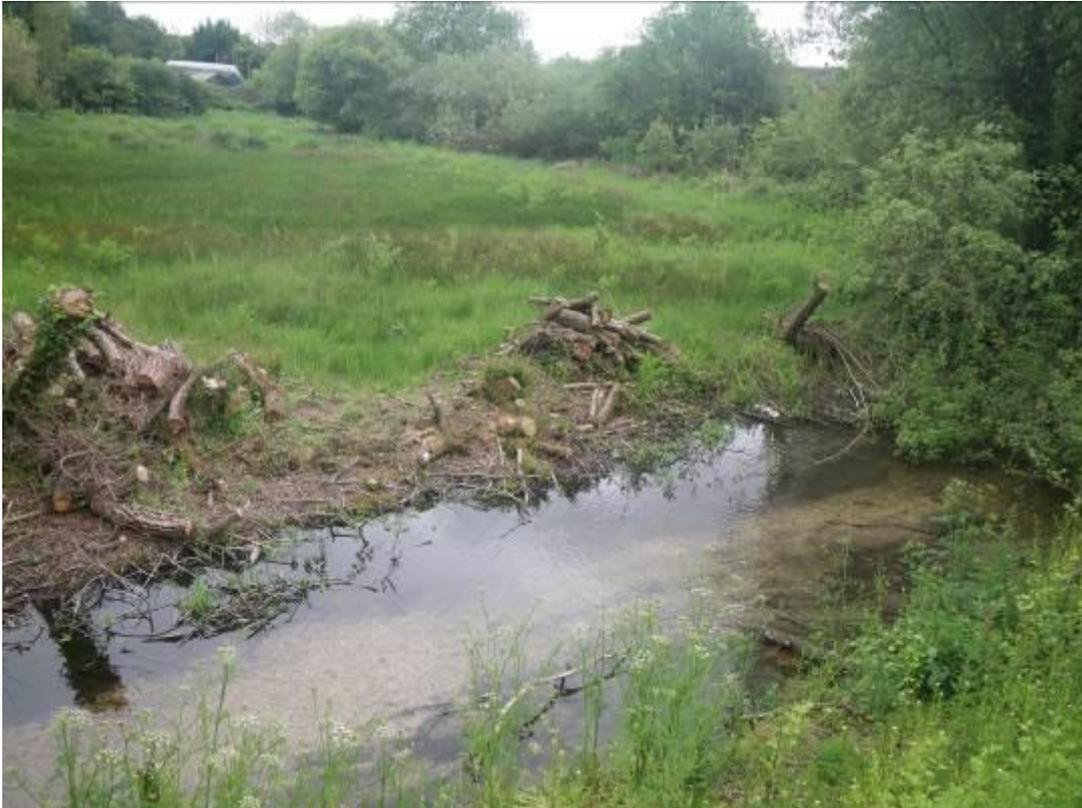
How the river is managed both upstream and downstream of this reach will impact on how the target reach performs. Determining whether or not there is free and easy access for migrating trout at Andwell Mill will be important. Although there is no significant spawning, or nursery habitat in the target reach, there is good quality habitat available upstream adjacent to the Conkers Garden Centre. Unfortunately, one section that was inspected has been unsympathetically cleared of all woody material and cover (photo 11) which will impact on its value as a spawning site and negatively impact on the target reach. Even if high-quality gravel beds are present, fish may be unwilling to use them (or suffer excessive predation) in the absence of critical cover habitat. If

this is the only section to be cleared then the impacts should not be too severe, or long lasting but a dialogue with the upstream owners to raise awareness that their management and maintenance will also impact on your interests is recommended.

Photo 11. Heavy tree clearance adjacent to potential spawning habitat upstream.
