Advisory Visit

River Swift, Warwickshire on behalf of
Warkwickshire Fly Fishers

13th June, 2008

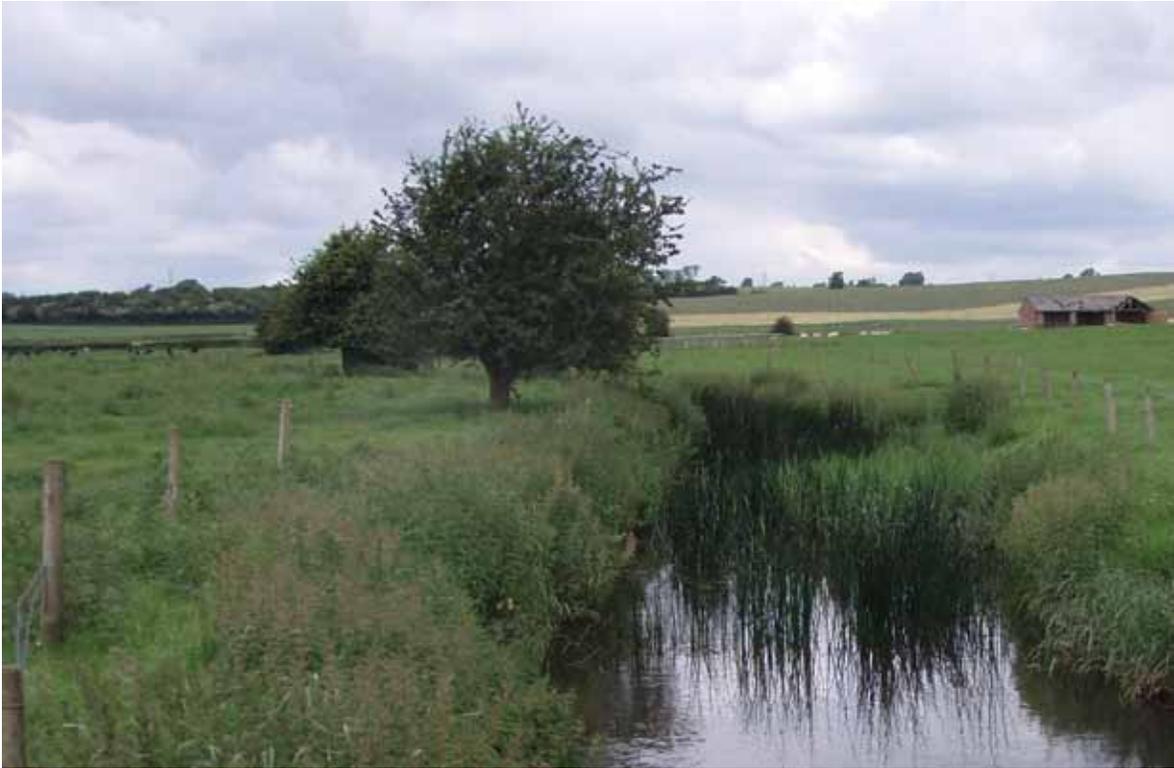
- Over-wide and deeply incised channel with evidence of past dredging activity, resulting in...
- Heavy growth of emergent vegetation including common club-rush *Schoenoplectus lacustris*, reed canary grass *Phalaris arundinacea*, sedge *Carex* spp., and yellow water lily *Nuphar lutea*.
- A river bed dominated by clay substrate with a paucity of gravel.
- The presence of a large automated sluice gate and gauging station at the downstream limit of the fishery (SP 5068 8073), to divert water along a LB channel to feed the Oxford Canal. This structure impounds water for over 1 km upstream and causes rapid fluctuations in level.
- A flashy run-off regime caused by the clay catchment and the presence upstream of large areas of impermeable surfaces: the M1 motorway and Magna distribution centre (at 500 acres, the largest in Europe). The former is reported to now have balancing lakes.

Photo 1 Typical section of the Swift – overwide channel with abundant emergent vegetation

- The combination of channel narrowing and raising river bed levels should be continued in appropriate areas. 'Pinching' the over-wide channel and the introduction of gravel will improve instream habitat quality, reduce deposition of fine sediment and provide suitable habitat for a range of gravel-loving species as well as creating areas of trout spawning and juvenile habitat. Guidance on the techniques for riffle creation and channel narrowing can be found in the *Wild Trout Survival Guide* provided with the Advisory Visit. Professional advice should be obtained regarding the placement of the riffles, including a bed level survey.

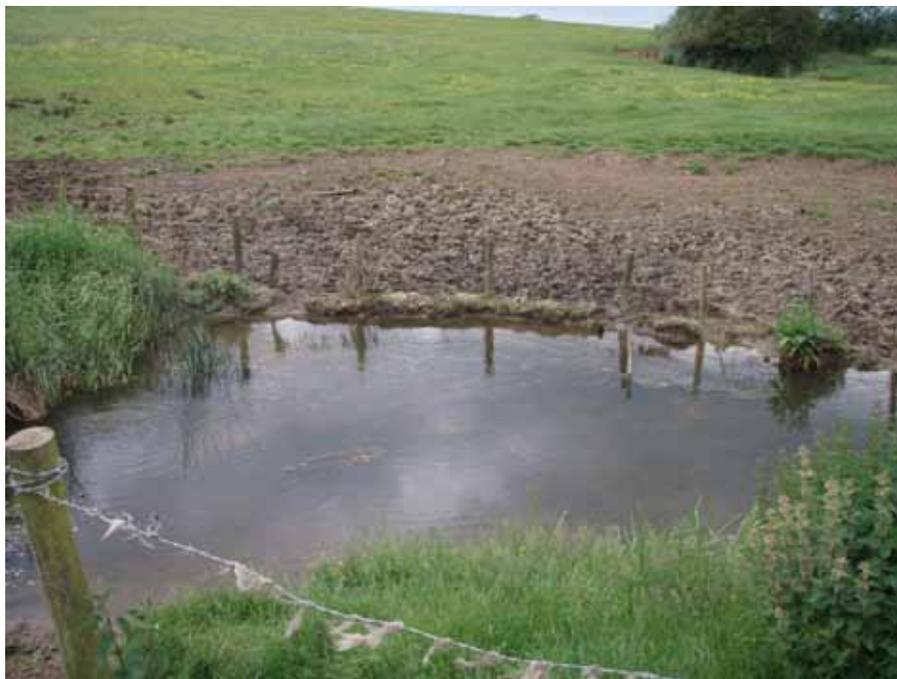
The LB had a double-strand barbed wire fence and was being grazed by cattle. The LB had a drinking area for cattle at a low section of bank which was very trampled and a probable source of soil erosion to the river during wet weather. In addition, the water was not readily accessible to stock at low water levels at this point. In other places the LB fence had failed and stock had trampled areas of bank leaving them devoid of vegetation. The club reported that the LB was owned by an absentee landlord who rented out the grazing.

Photo 2 Trampled cattle drink area

- The riparian fencing should be improved to exclude livestock from the river banks. On the upstream section of the fishery the RB fence should be upgraded to keep the sheep off the bank, and on the LB the fence should be repaired to exclude the cattle and a formalised drinking area created to reduce soil erosion. All fine material should be scraped back and replaced with layer of aggregate approximately 20cm deep. This will allow cattle access to safe clean drinking water, whilst not allowing the ingress of silt into the river.

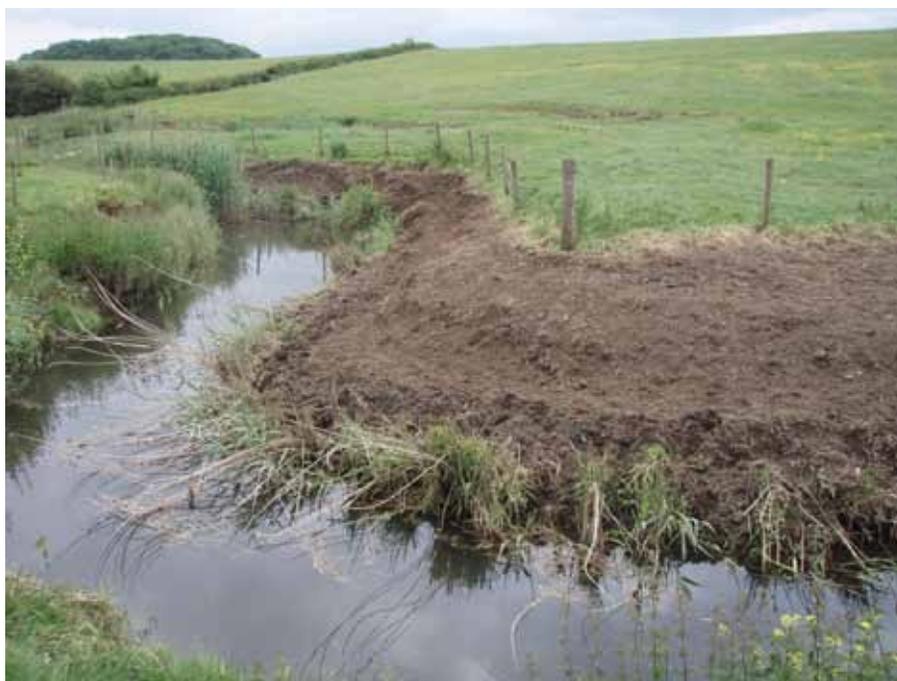
The upper part of the fishery is more open and treeless; the club are talking to the farmer about tree planting in this area. The RB has a single-strand barbed wire fence and was being grazed by sheep; these could get under the fence which is there to prevent encroachment of cattle across the river from the LB.

Photo 3 Livestock damage to left bank, upper part of fishery

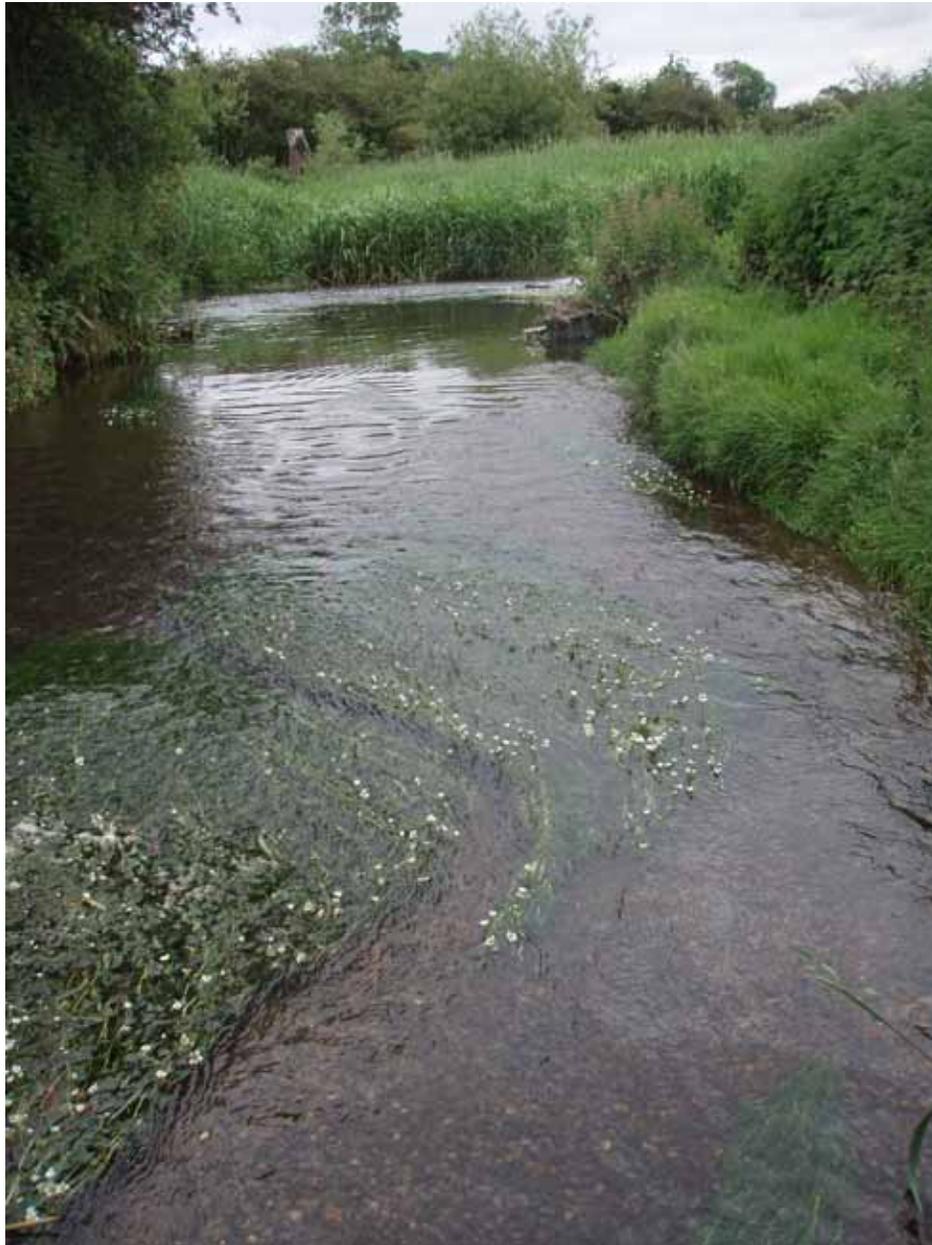
The downstream incubation box is located at SP 51002 81250 and the area immediately downstream was cleared of emergent vegetation and 10 tonnes of gravel introduced. This has created a riffle area with a good growth of *Ranunculus* sp. and the faster flows have prevented the regrowth of emergent vegetation.

Photo 4 Area below the downstream incubation box

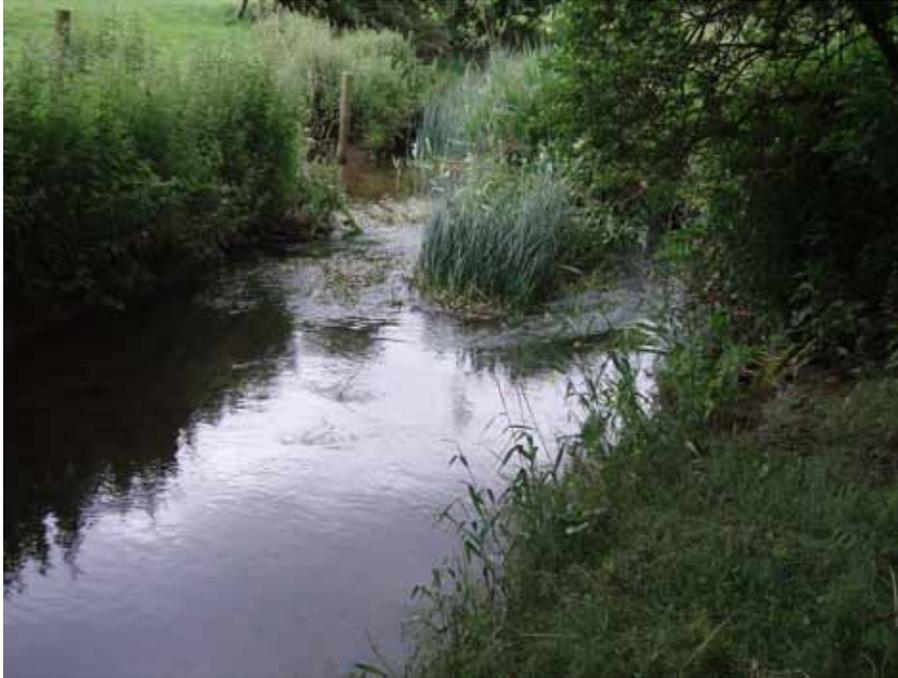
At SP 51161 81357 an island of emergent vegetation has been created at the tail of a pool by cutting a channel down either side, and groynes at the head of the pool have increased flow variability.

Photo 5 Island of emergent vegetation created by cutting channels

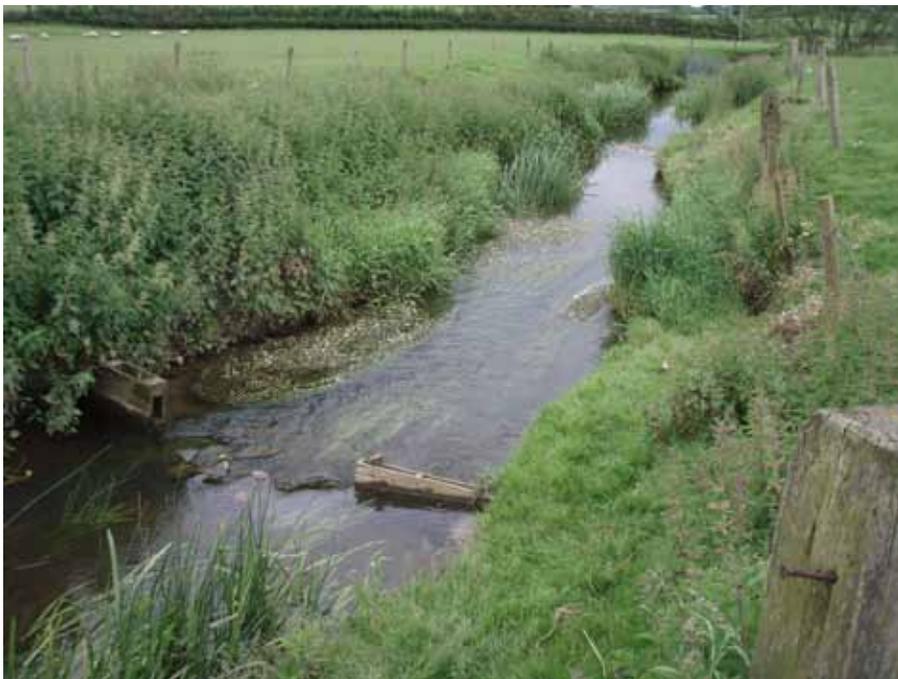
Photo 6 Flow variation created by paired deflectors and bricks, promoting growth of *Ranunculus* sp. and deterring emergent vegetation

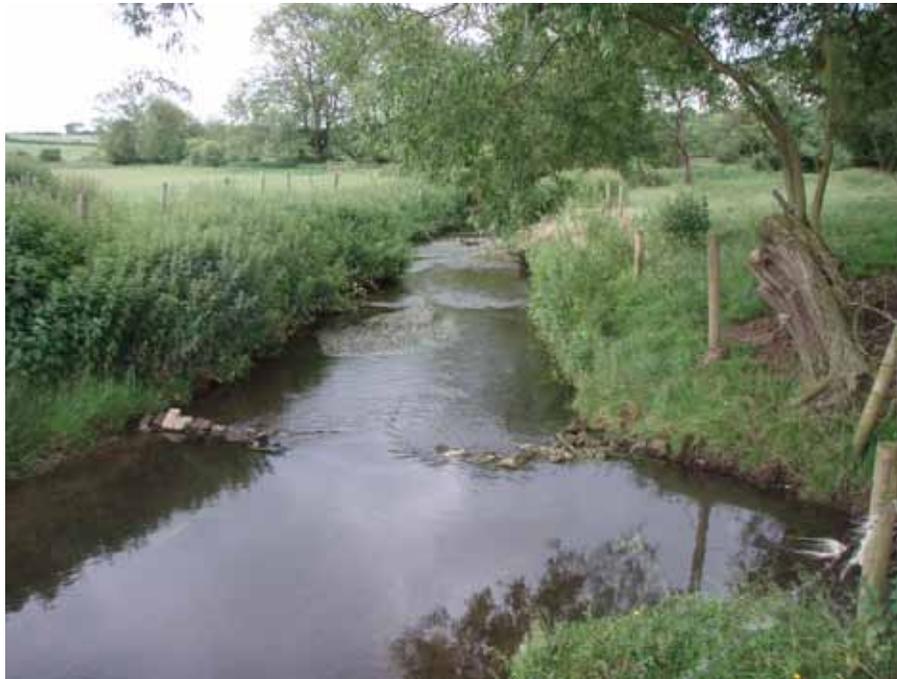
At SP 51159 81492 a section of river has been manually cleared of emergent vegetation, and four sets of paired deflectors have been introduced in combination with 8 tonnes of gravel. This area has remained free of emergent vegetation. Similarly at the middle incubation box (SP 51664 81686) 15 tonnes of gravel have been introduced below the low weir / riffle created to feed the box, producing an area of faster flows supporting growth of *Ranunculus* sp. and creating a good area of habitat for juvenile trout.

Photo 7 Area cleared of emergent vegetation where eight tonnes of gravel was introduced along with four sets of flow deflectors

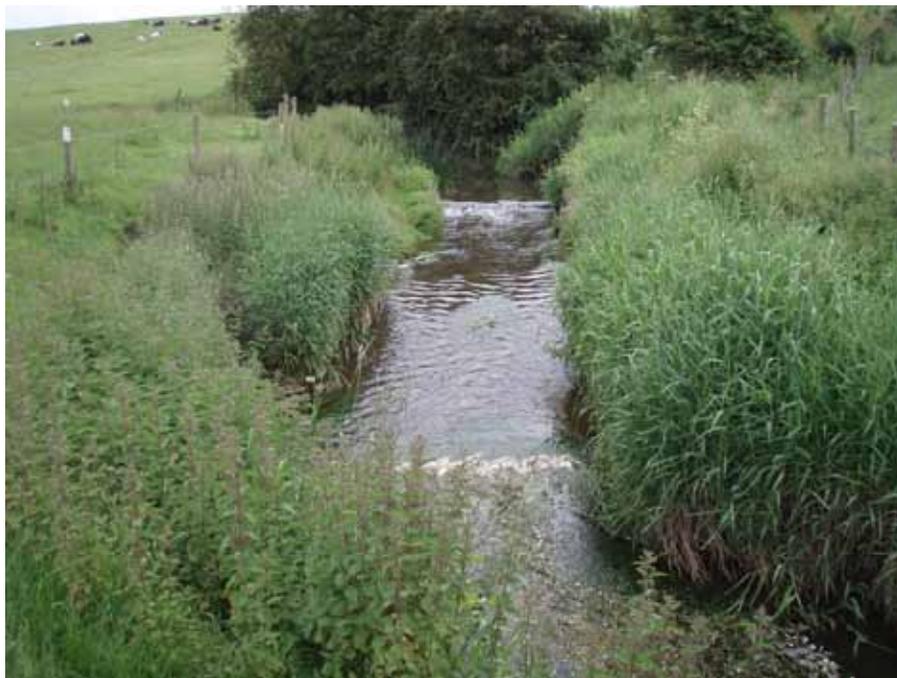
The incubation boxes have been used to introduce 5000 eyed brown trout ova each year, and were modified to include a pre-filter after the first year of operation to reduce the amount of sediment infiltrating the gravel and eggs. The boxes utilise the head of water above small weir-riffles constructed by the club. The head of water has been a problem at the upstream incubation box (SP 51866 82028) which has not been operating satisfactorily.

Photo 8 Low weir constructed to supply head for running incubation box

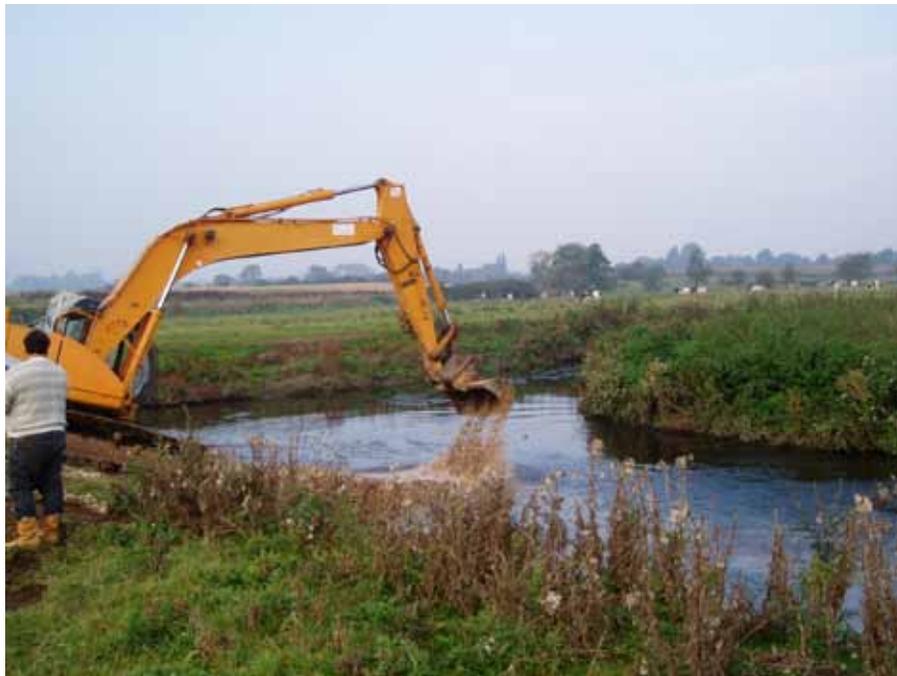
Photo 9 Reintroducing gravel riffles

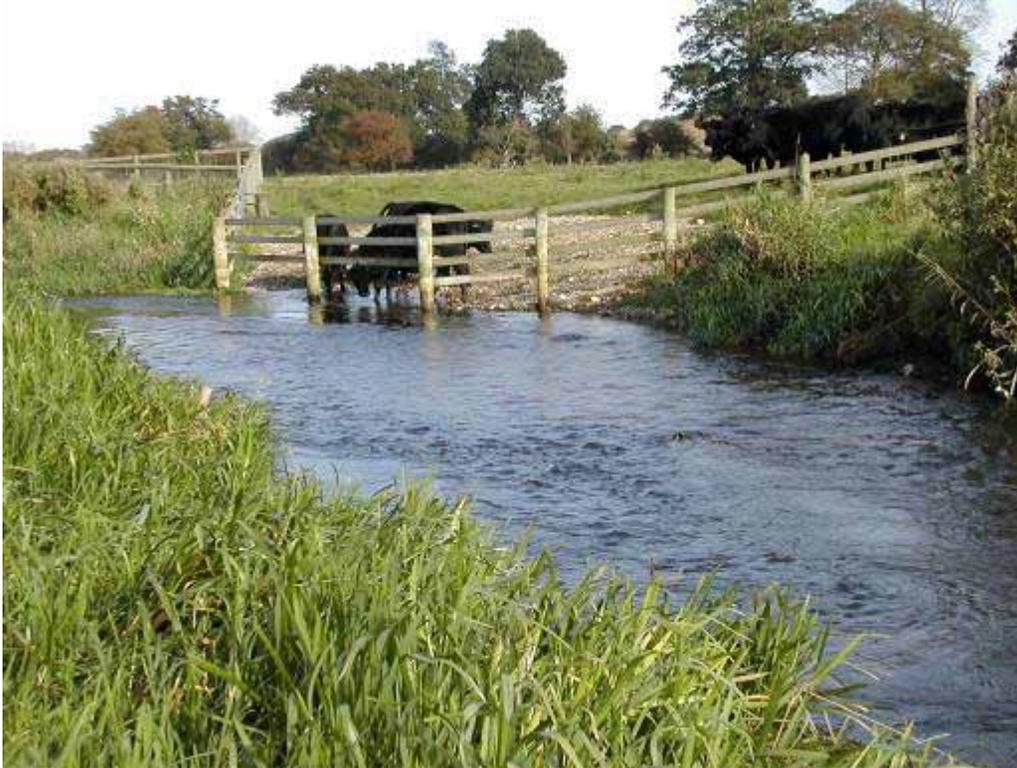
Photo 10 Example of restored cattle drink with fencing to allow safe, clean access for cattle.
