River Tarrant in Dorset

An advisory visit carried out by the Wild Trout Trust – July 2010

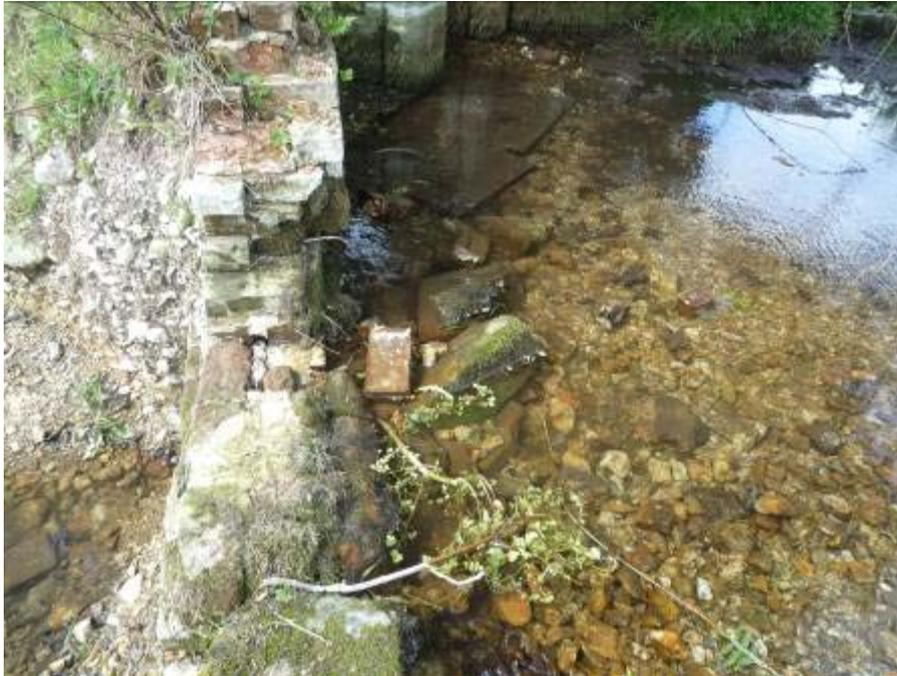
The Tarrant at Tarrant Launceston, just above an old water meadow sluice. Structures like this can act as a trap for fish wishing to migrate downstream as flows drop off

- Work with local landowners and the EA to identify weirs and structures that currently fragment habitat and fish populations.
- Prioritise a list of actions aimed at modifying or removing structures that restrict upstream fish migration and act as a trap for fish wishing to migrate back downstream.
- The Tarrant is a true winterbourne and potential schemes designed to augment surface flow are probably not appropriate or sustainable. That said, assurances should be sought from the water companies and regulator that abstraction pressures will not be allowed to adversely impact on surface water flows.
- On sections of stream that are extensively over grown consider the option of allowing some livestock access for light grazing.

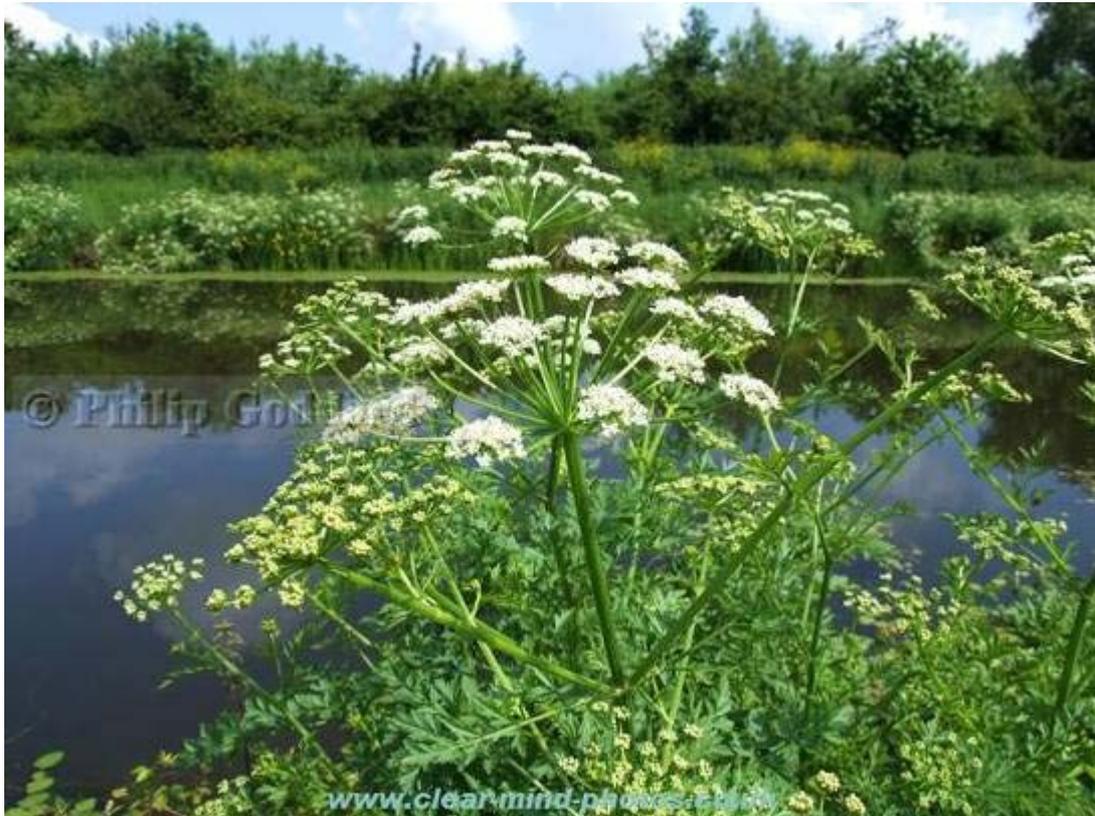
Hemlock water dropwort is a native plant but one which can be very invasive when conditions suit it. Some selective thinning of the plant may well help to promote a more diverse plant community and improve biodiversity within the channel. This plant is known to have toxic properties and plants should not be pulled up and left on the bank-side as they can be lethal if consumed by livestock. It is recommended that if the plants are being hand pulled by

Hemlock Water Dropwort. A native plant that can dominate the channel flora.

volunteers then gloves should worn and hands thoroughly washed following any contact with the plant.

- Discourage clumps of marginal emergent plants from growing in central channel locations.
- Remove clumps of non native plants, such as Himalayan balsam and reduce the density of Water dropwort hemlock where it forms monocultures.

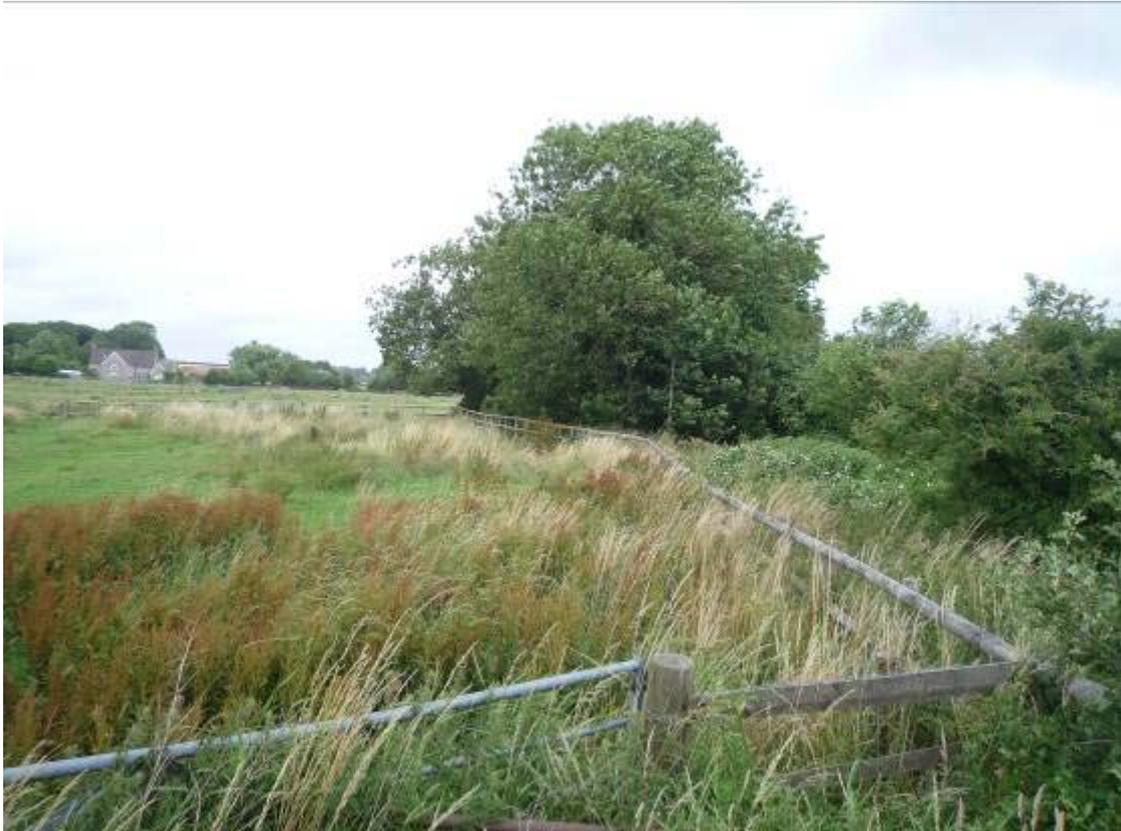
A similar contrast in habitats was observed on the next section inspected just above Launceston Farm. Above the access bridge the stream had been fenced some time ago to exclude all grazing livestock. Here the channel was completely

shaded by a range of trees, shrubs and marginal emergent plants, so much so that it was virtually impossible to view the channel. The only exception was where one or two mature ash trees had grown out over the channel, promoting pool habitat below the trunk and providing sufficient low shading to the channel to restrict heavy marginal plant growth. Shaded pool habitats such as these can provide a refuge for fish when the stream shrinks and flows drop off.

The channel looking upstream of the access bridge near Launceston Farm. The lack of any maintenance or grazing pressures has resulted in the channel being completely shaded and hidden from view by a range of trees, shrubs and marginal scrub.

On sections where there is no access for grazing animals, a light maintenance regime is required to punch some holes in the canopy to promote a dappled light and shade 60% shading overall is a good ratio to aim for. Conversely on the reaches where there is currently full unfettered access to livestock then some tree planting and either temporary, or permanent fencing to enable some small blocks of cover to become established is recommended. The ideal scenario is access for low density grazing. Achieving an ideal grazing regime is extremely difficult unless the riparian landowners are fully committed to the aims and objectives of improving the stream habitat and adjusting stock densities accordingly.

- Some occasional thinning of the tree canopy in sections of heavy tunnel shading is recommended.

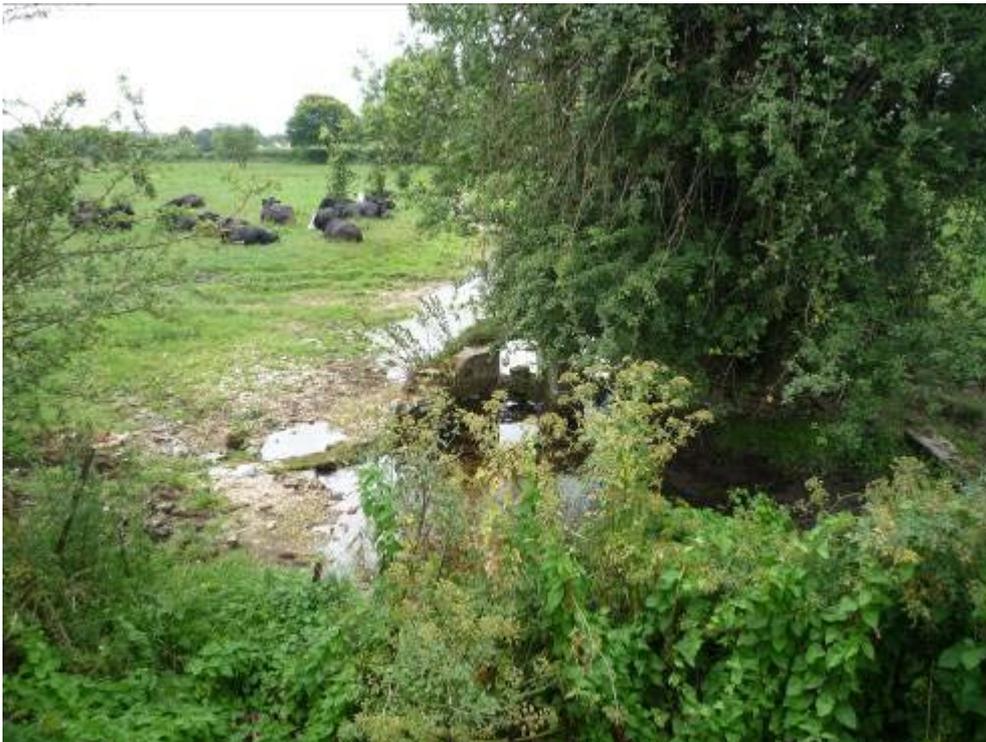
In looking downstream from this vantage point a stark contrast could be seen, where the channel was virtually devoid of any plant cover due to unfettered access by grazing cattle. The stream was carrying a small trickle of water, but it is highly unlikely that this section could sustain a viable trout population. Any fish wishing to reside in this section would be extremely vulnerable to bird predation and would possibly also suffer from unacceptably high water temperatures due to the lack of any significant shade, exacerbated by little or no flow.

Not a great photo but this is the section of channel running downstream from the bridge. Apart for the tree in foreground the channel here enjoys no shading at all.

- On sections of commercial farmland, where the stream is unfenced and the stream margins excessively grazed and trampled, create some occasional refuge areas by planting small blocks of marginal native trees such as willow, alder or thorns and protect the area with fencing.

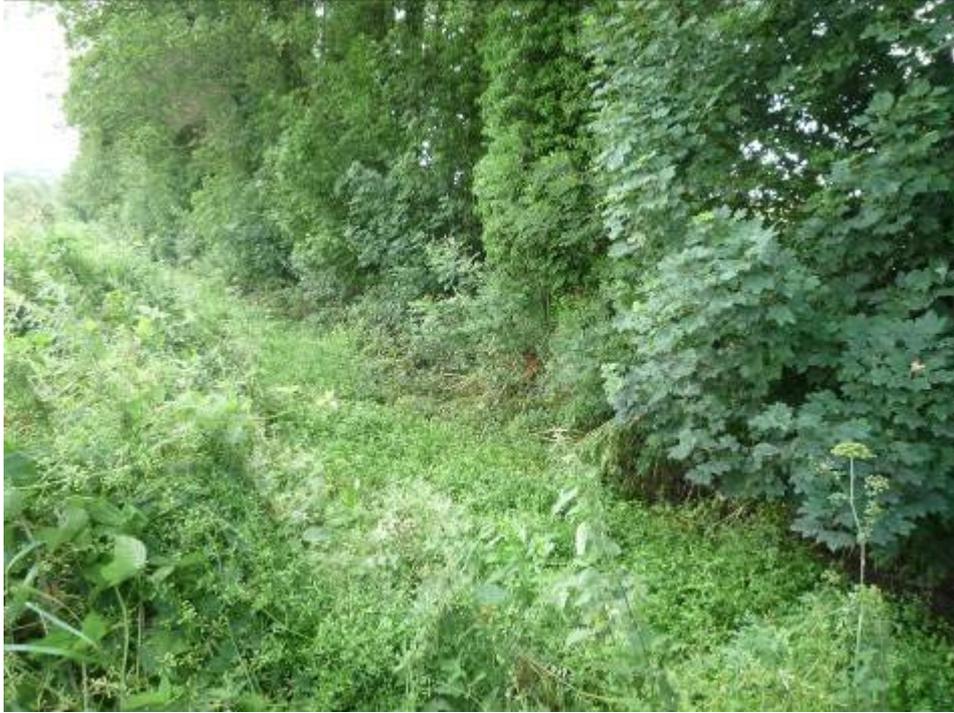
The legacy of an old agricultural irrigation system was evident, with a straightened, perched channel for "drowning" the adjacent meadows and a corresponding low level channel running parallel on the "down slope" side of the meadows. The majority of the flow was carried in the high level channel, which was impounded by a typical sluice type structure .

The perched channel was typically over wide and uniform in nature and dominated by a thick growth of mainly cress (*Rorippa sp*) and fools cress (*Apium*

Wide flat channel choked with cress below Tarrant Monkton.

- Where the channel runs in parallel channel consider prioritising the flow in favour of one single, low level channel.
- Where the channel is wide, flat and choked with emergent plants, secure large woody debris flow deflectors made from tree trunks or branches to concentrate flows into a pinched channel.

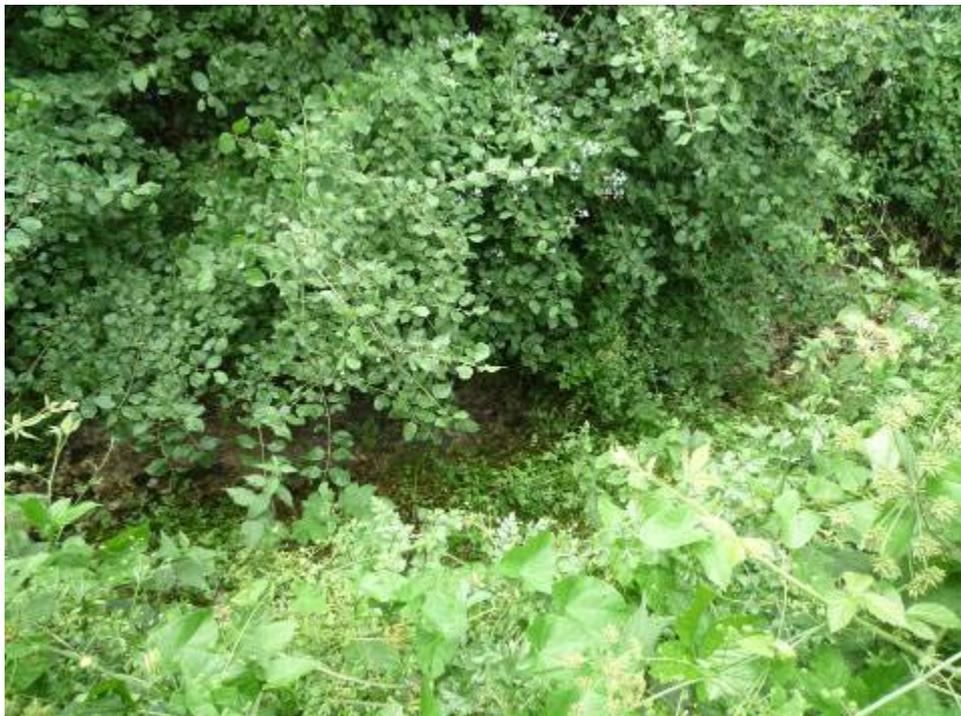
Open channel habitat can be seen running under the shaded RB margin

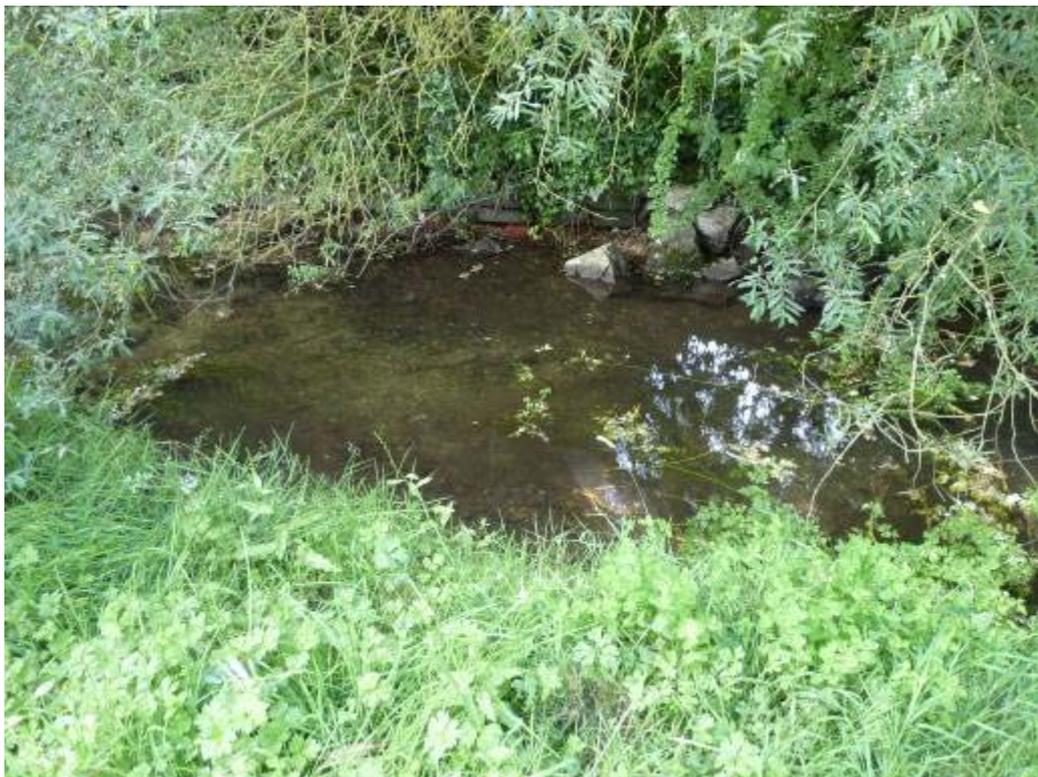
The next section of river inspected was at Tarrant Rawston. This section would appear to be the upstream limit of the permanently flowing section of stream. This was also evident by the large numbers of trout that were observed holding up in shaded pools at various locations in this area. The high densities of fish present are almost certainly artificially concentrated due to the shrinkage of upstream sections, resulting in a downstream displacement of fish looking for a suitable territory. Trout are not by nature a shoaling fish and even in an environment where there is sufficient water for them they will still experience stress related problems if they are concentrated together in short sections for long periods of time.

This pool in Tarrant Rawston was home to approximately a dozen trout before fleeing for cover. A pool like this would normally only support one or two fish.

- On flowing perennial sections, where large numbers of trout can at times be concentrated together, retain as much brash or coarse woody debris within the channel as possible to reduce predation pressures.

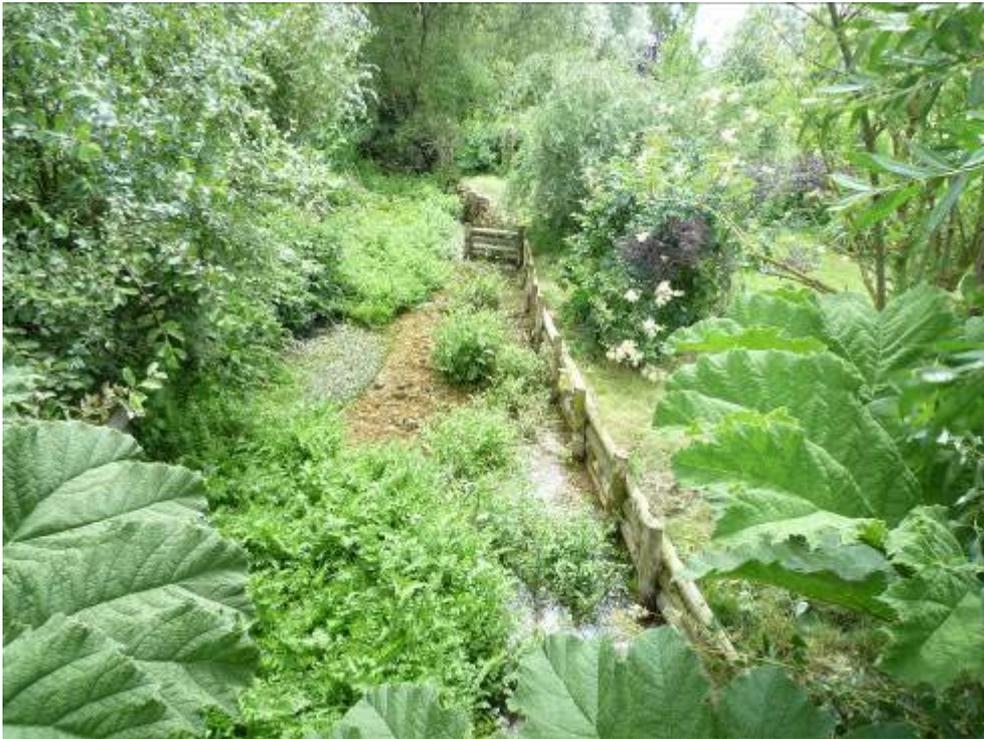
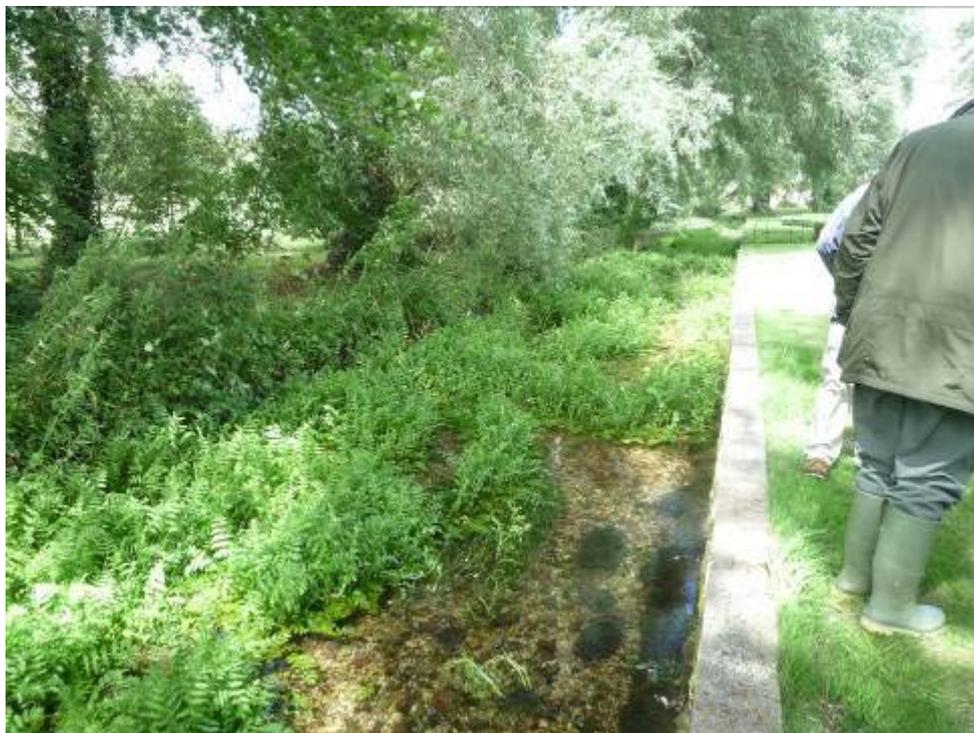
Many marginal sections of bank on the Tarrant were revetted with a variety of materials such as wooden poles or stone.

Many sections of bank along the whole length of the Tarrant are revetted with hard materials. Hard revetment is a hostile environment for native plants, invertebrates and mammals such as water vole. Where possible, low soft banks should be retained and protected with a fringe of native plants that absorb the energy of the stream during high flow conditions and provide critically important habitats for a range of species throughout the year.

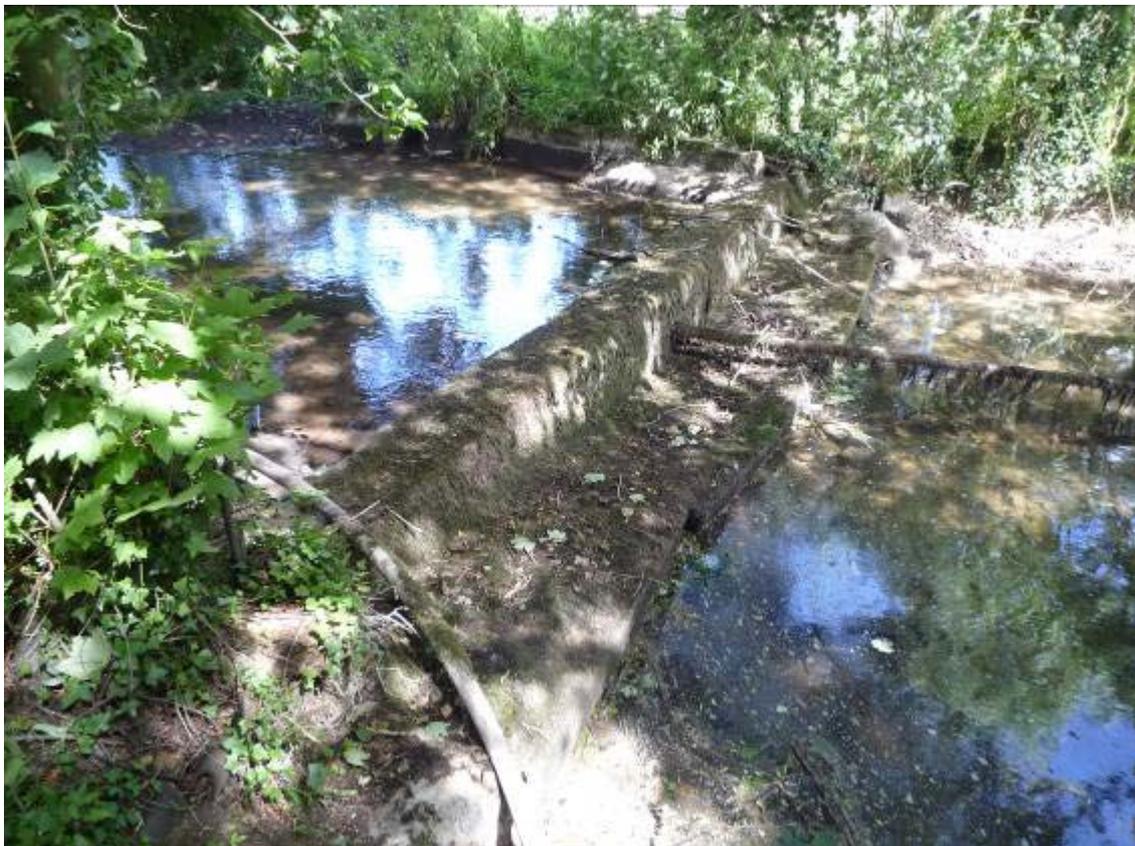
An additional problem for the stream and resident fish communities are the number of in-channel structures (e.g. weirs) that fragment populations and damage in-channel habitats.

A large impoundment presumably installed to facilitate an old abstraction. Structures like this fragment fish populations and damage in-channel habitat by promoting siltation upstream
